# Non Traditional Example Residential Building Survey

NON TRADITIONAL CONSTRUCTION STRUCTURAL FRAME HOUSE

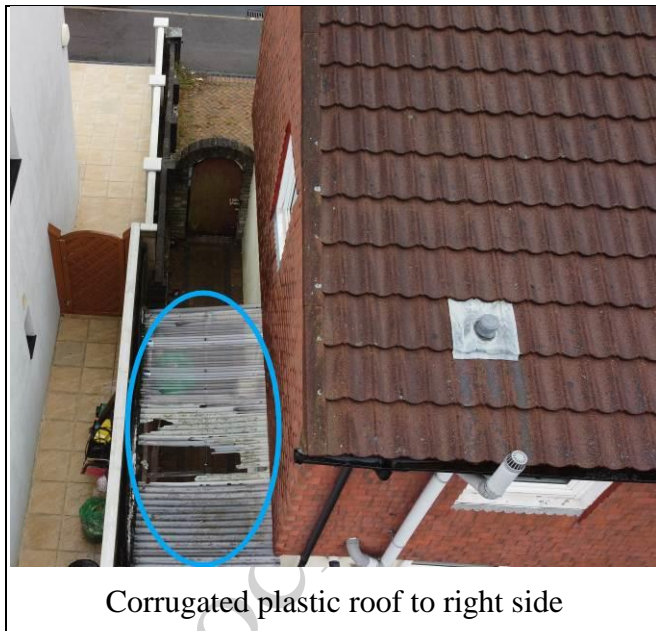
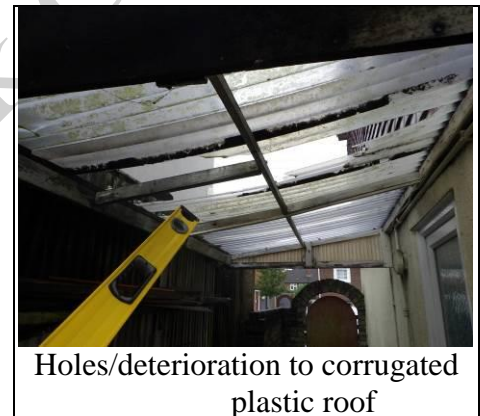
The corrugated plastic to the roof on the right hand side passageway is deteriorating/in need of replacing.

**ACTION REQUIRED:** We recommend this is replaced. At the same time we would also replace the structural frame which holds the roof in place.

**ANTICIPATED COST:** £1,000 - £2,000; please obtain quotations before you legally commit to purchase the property.

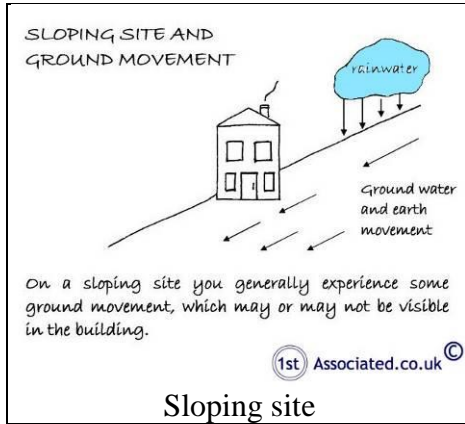
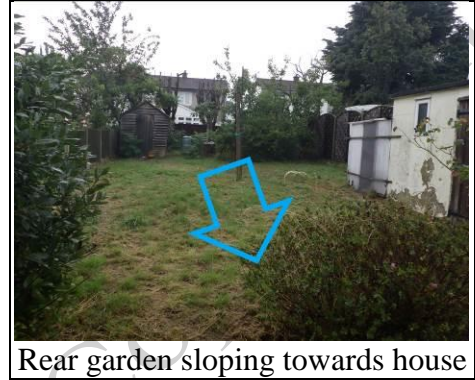
We can see that whoever has lived in the house has tried to resolve the problem of the slope by adding a running gully to the rear. However, having said that, there is still vegetation growing against the base of the building.

Unfortunately, as this is a metal frame building it can cause damage and deterioration to the metal frame of the structure, particularly as the concrete raft acts as blotting paper, drawing dampness in.

**ACTION REQUIRED:** Due to this building being on a sloping site and water likely to be causing problems to the rear, we recommend opening up the walls to one metre squared in three areas to see the condition of the metal frame. In this particular case at least one of the areas, depending upon what was found, would be to the rear of the property. The benefits of opening up the structure is several reasons:

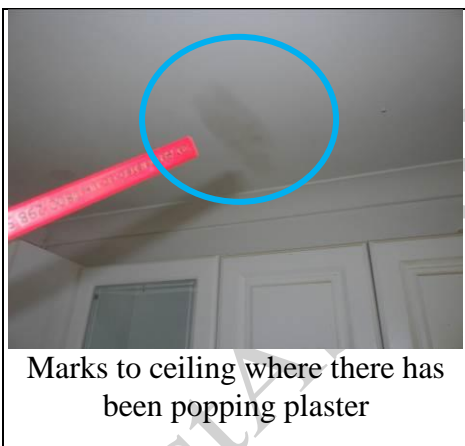
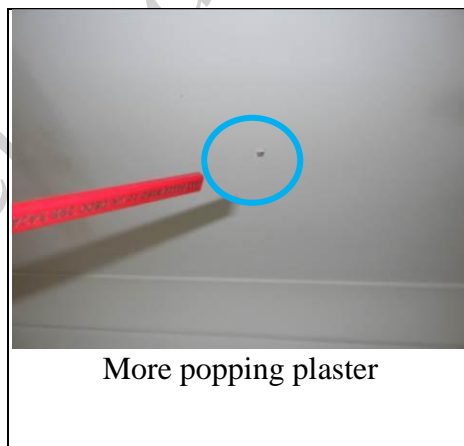
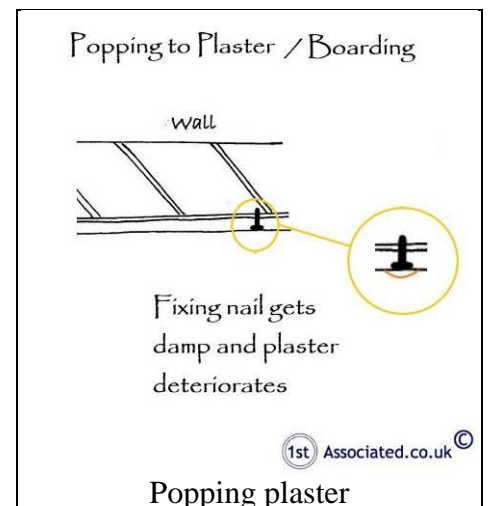
We noted popping in some of the ceilings, such as the kitchen ceiling which may be due to dampness from the bathroom which is directly above. However, we think it is also likely to relate to condensation/humidity occurring in the areas; known as popping, where the area around the nail comes away/pops off.

The dampness may have come from the bathroom above, however we also think it may be caused by humidity and condensation in the property.

**ACTION REQUIRED:** As already mentioned, the adding of large good quality humidity controlled extract fans to the kitchen, the bathroom and any areas that are used for drying clothes internally during winter months should help (we would assume that clothes will be dried externally during the warmer months). By large extract fans we mean 150mm.

**ANTICIPATED COST:** We would anticipate costs between £250 - £500 per extract fan depending upon the wiring required. We always recommend quotes are obtained before work is agreed/commenced and a few hundred pounds for re-plastering. Please obtain quotes before you legally commit to purchase.

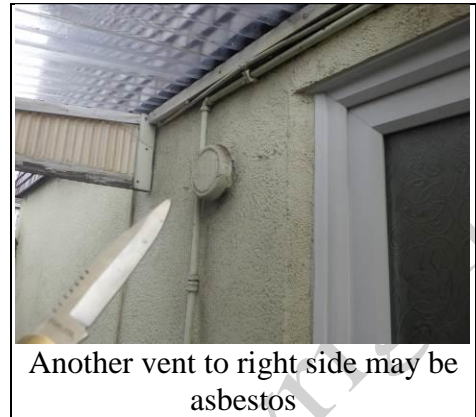
Vent may be asbestos

Another vent to right side may be asbestos

**ACTION REQUIRED:** We recommend you have an Asbestos Report confirming if there is any asbestos in the property remaining. This will also be valuable when you come to sell the property in the future as of course it will ensure you do not have any health risks from asbestos.

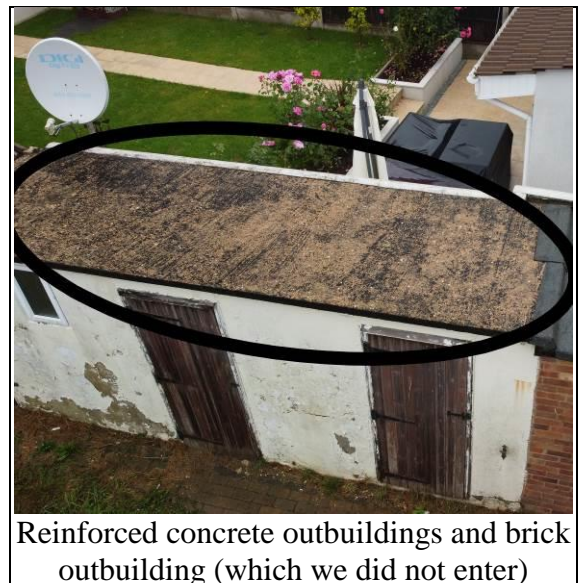
Most of the outbuildings structures are formed with reinforced concrete. To the roof of these the tar has weathered which will lead to water getting into the concrete roofs and concrete wall structures, which in turn can lead to the reinforcement within them deteriorating, causing the concrete to spall, flake and deteriorate.

Reinforced concrete outbuildings and brick outbuilding (which we did not enter)

**ANTICIPATED COST:** In the region of £250 - £500 for re-tarring the concrete roof, not including any concrete repairs. To redecorate the outbuildings £250 - £500 and fill the cracks with a suitable mastic; please obtain quotations before you legally commit to purchase the property.

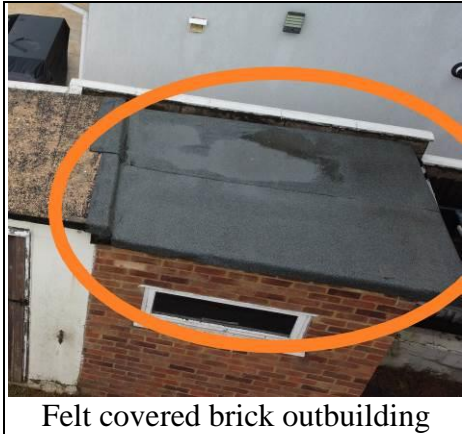
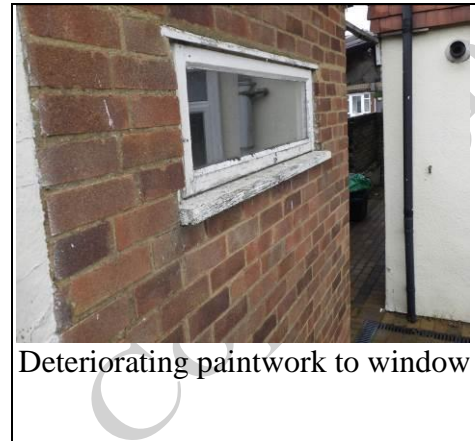
The brick outbuilding next to the concrete outbuildings has a felt roof and timber windows and a timber door which need work.

**ACTION REQUIRED:** Repair, prepare and redecorate in the summer/warmer months of 20XX.

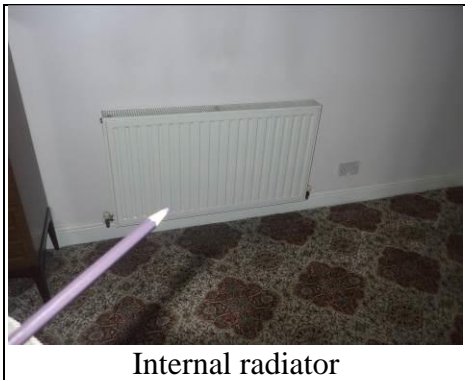
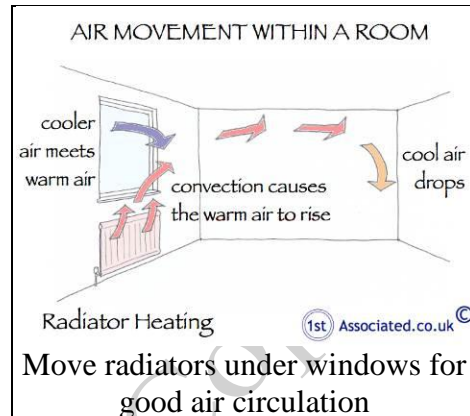
Many of the radiators are internal. We much prefer to see radiators positioned under windows for good air circulation.

**ACTION REQUIRED:** We recommend radiators are moved under windows where possible for better air movement, which will in turn will reduce humidity.

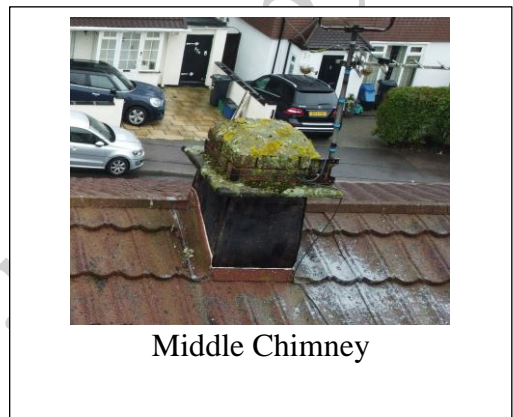
Middle Chimney

We noted an aerial attached to the chimney which we are not keen on as it can destabilise the chimney.

Also, please note that it looks like the chimney has been removed in part internally.

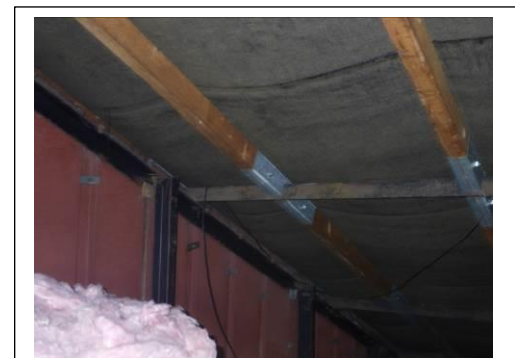
When we inspected the loft space, we found a Hessian based bitumen membrane. This type of membrane has been used since the 1960s. We generally found it to be in average condition with damage in some areas which is what we typically find.

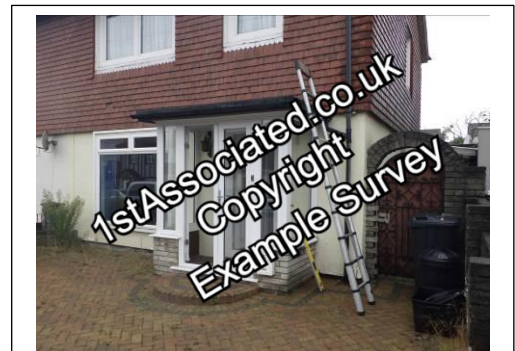
Front flat porch roof

The flat roof is located to the front right and is covered with mineral felt. We would comment it is in below average condition for its age, type and style, with the felt starting to deteriorate.

**ACTION REQUIRED:** We recommend replacing with a good quality felt. We would always recommend that lead flashings are used.

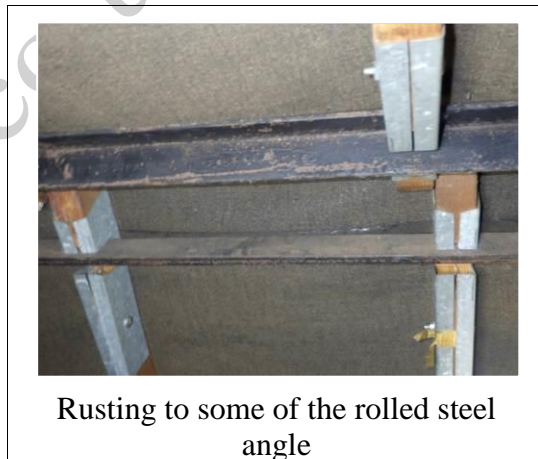
Rusting to some of the rolled steel angle

Ideally, the metal work in the roof space needs to be rubbed back, prepared, repaired and redecorated with a red oxide paint or equivalent rust stopping paint. This needs to be carried out during the cooler/winter months of the year.

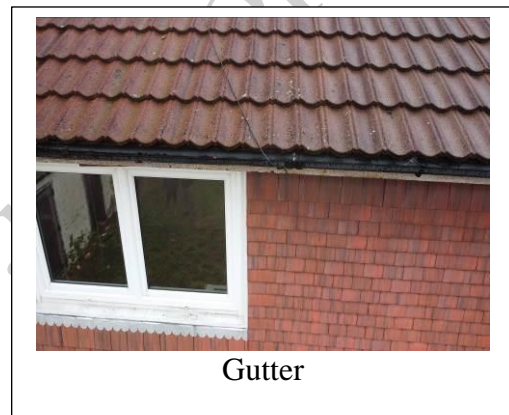
Gutter to porch full of moss

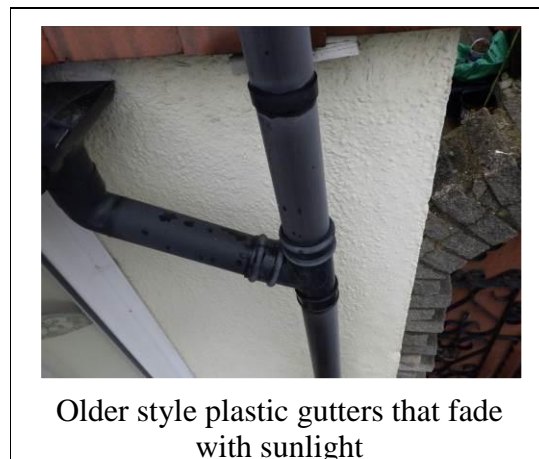
Older style plastic gutters that fade with sunlight

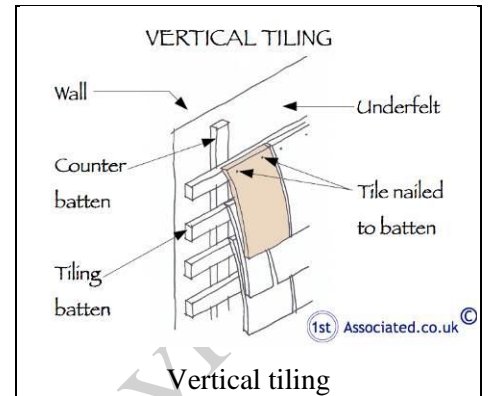
Missing tile to front

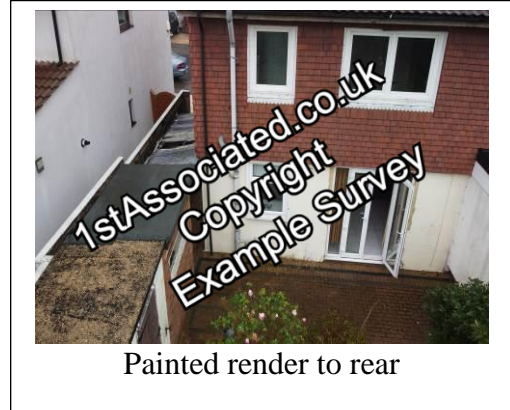
We have carried out a tap test (literally hitting the render with the back of a hammer). We found it to be in below average condition for its age, type and style, with deterioration and paint peeling.

Painted render to rear

Paint coming off

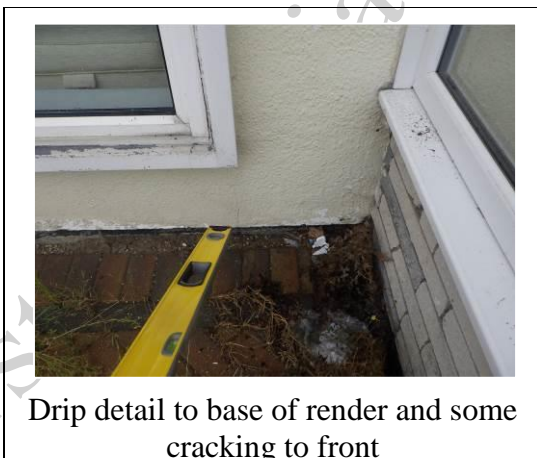
Drip detail to base of render and some cracking to front

To the base of the render there was a small drip detail however we would prefer a larger drip detail.

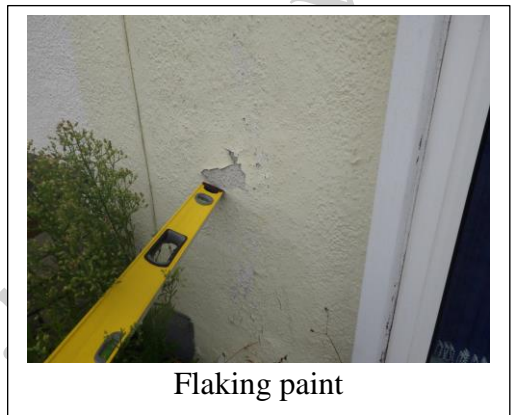
The external decorations are in below average condition and we recommend redecoration as soon as possible.

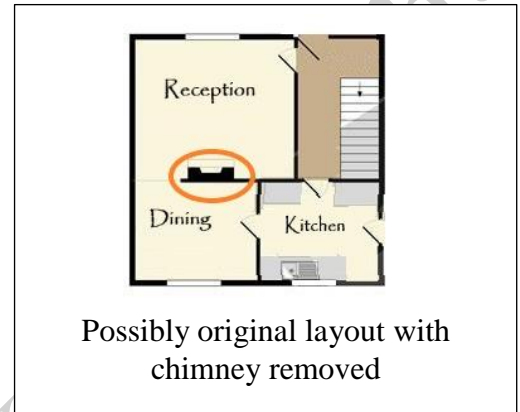
The chimney is capped. The chimney looks to have been removed from within the roof space; there may be some of the original chimney remaining. You need to be aware that sometimes these, as we understand it, were lined with asbestos.

**ACTION REQUIRED:** Please see our comments in the Executive Summary with regards to having an asbestos test and report on the property.

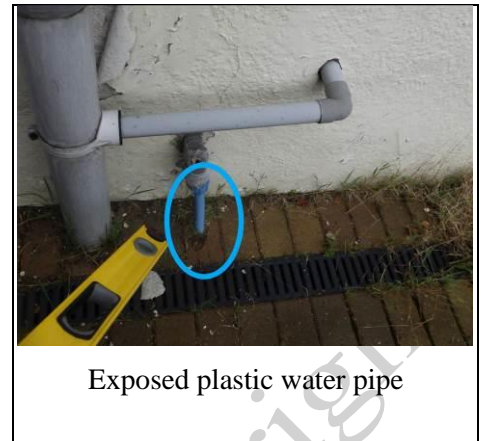
Externally we noted several exposed plastic water pipes all of which need to be insulated properly to stop frost attack.

**ACTION REQUIRED:** Insulate all external plastic pipework.

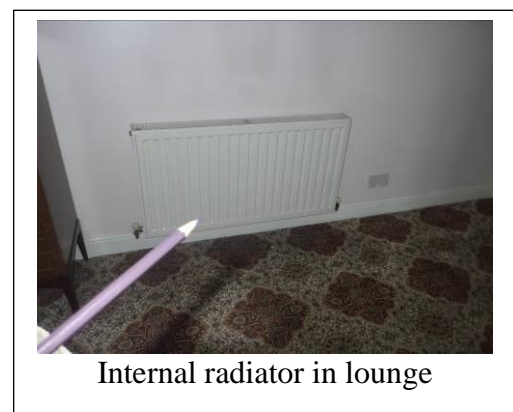
Some of the radiators are on internal walls, we prefer to see them under windows for better air circulation/reducing humidity.

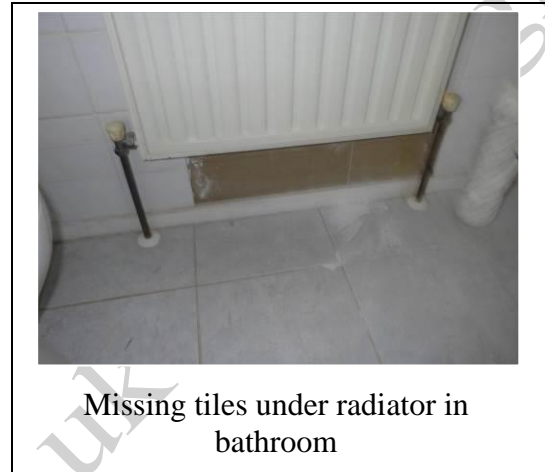
The property has a three-piece bathroom suite, consisting of a shower cubicle, wash hand basin and WC, which looks in slightly below average condition. We noted some missing tiles under the radiator.

**ACTION REQUIRED:** Replace missing tiles.

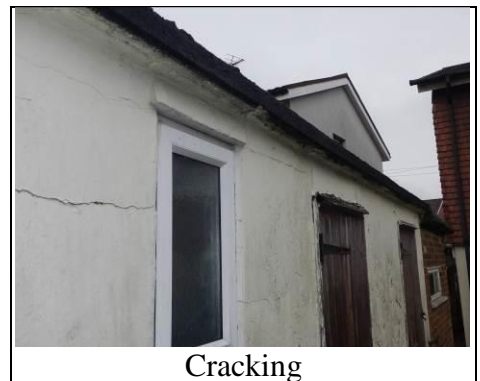
Three concrete outbuildings and brick outbuilding

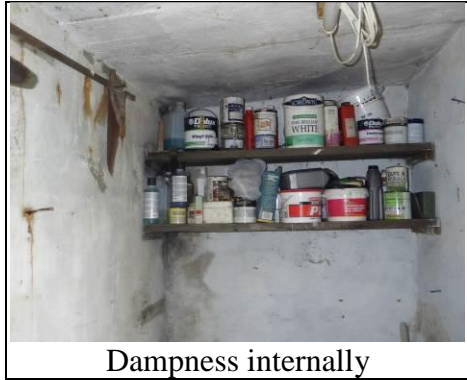
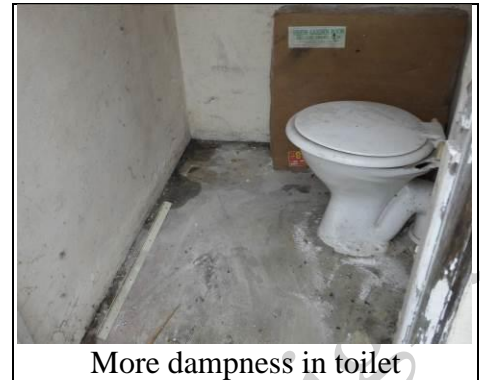
Cracking

**ACTION REQUIRED:** Please see our comments in the Executive Summary. We would recommend nothing valuable is stored in the outbuildings.

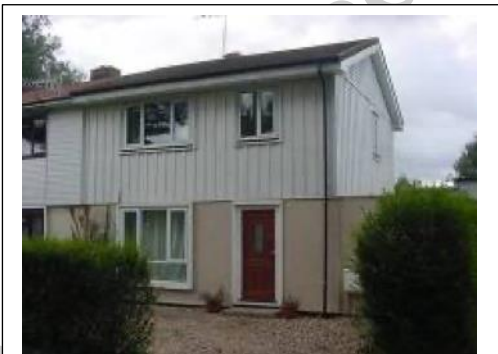
Rusting to profile metal cladding

Metal frame house with profile metal sheeting at top and render at bottom. Roof has been changed.
