## Residential Building Survey

NON TRADITIONAL CONSTRUCTION  
STRUCTURAL FRAME HOUSE

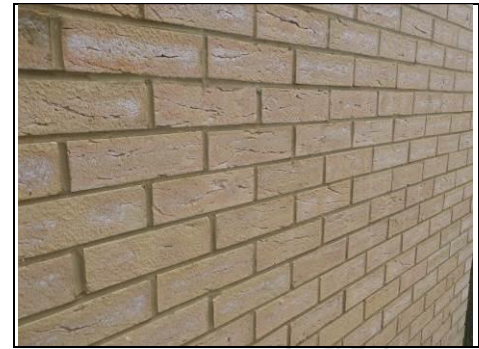
We noted efflorescence to the brickwork in many areas which is a salt coating. This is a fairly common factor in timber frame buildings.

Efflorescence

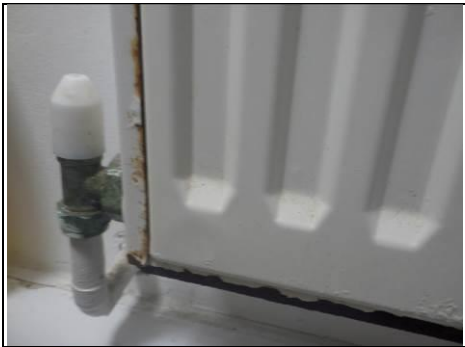
We believe there are problems with ventilation and black mould particularly around the en-suite shower room and the bedroom.

Radiator rusting due to dampness

**ACTION REQUIRED:** We would recommend adding a large humidity controlled extract fan in the shower room. By large extract fans we mean 150mm. Unfortunately, this is quite a difficult job and will need some sort of air vent externally.

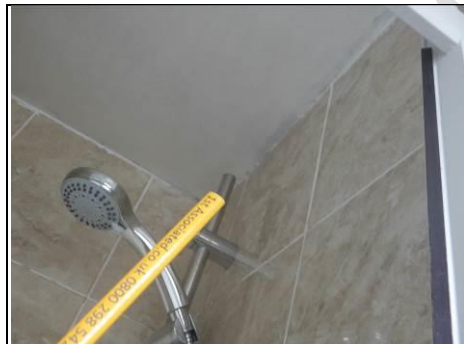
Black mould painted over and deteriorating paintwork

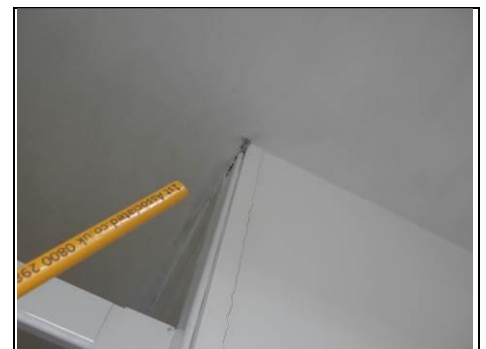
Black mould and hairline crack in plaster of en-suite

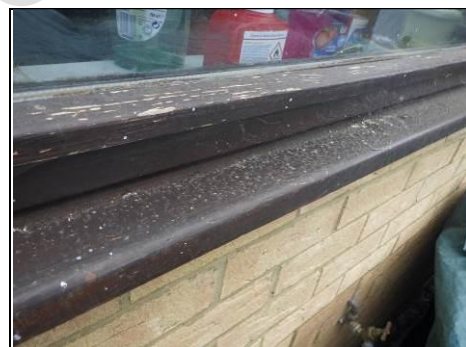
*For example, the top floor rear window has a very stiff lock that will simply no longer open.*

Weathered window

**ACTION REQUIRED:** The windows need to be eased and adjusted, prepared, repaired and redecorated. There will be some high level work and it is likely that scaffolding will be needed for the upper floors.

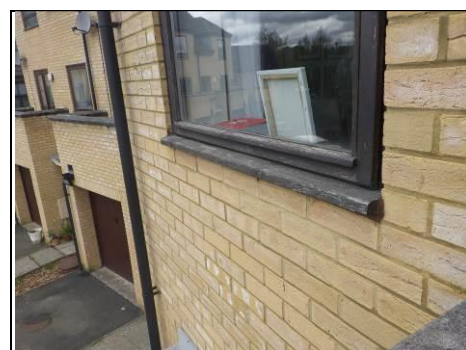
Flaking paint and bare timber

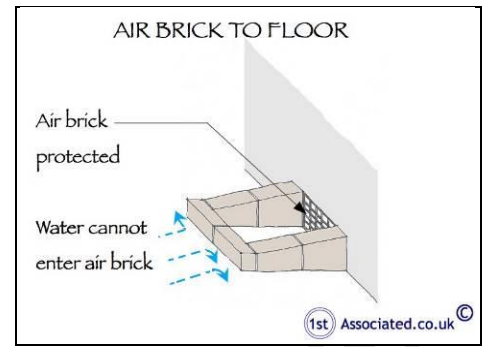
Protect airbrick

**ACTION REQUIRED:** Protect airbricks and ensure that no water gets into the property. Also, ideally we would recommend the floors are opened up. You need to speak to whoever has the shared ownership of the property and see if they will open up the floors or if there is a known about problem.

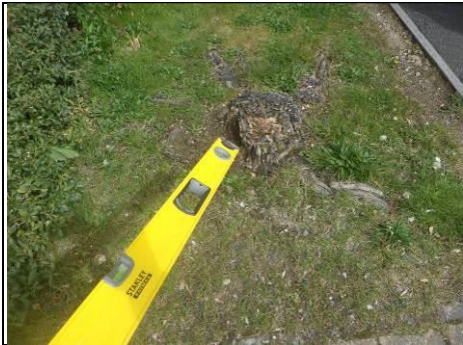
There is a tree cut down to the front of the drive on the left side which looks to have been quite a large tree. Cutting down trees can affect buildings particularly the foundations and equally leaving the tree without maintaining it can also affect the building.

Tree cut down

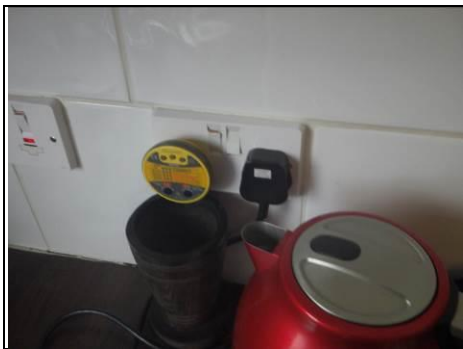
The electrics tripped when we carried out our usual earth test. We also noted the need for extra socket points.

Earth test failed

**ACTION REQUIRED:** The Institution of Engineering and Technology (IET) recommend a test and report when properties change hands, to be carried out by an NICEIC registered and approved electrical contractor or equivalent.

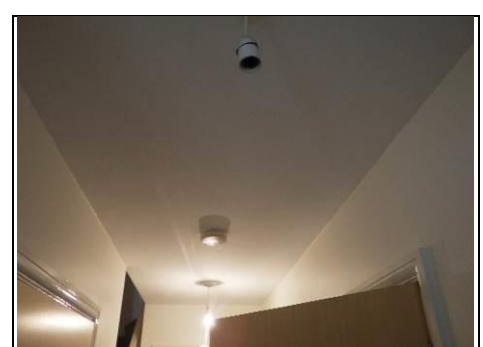
Lightbulbs missing

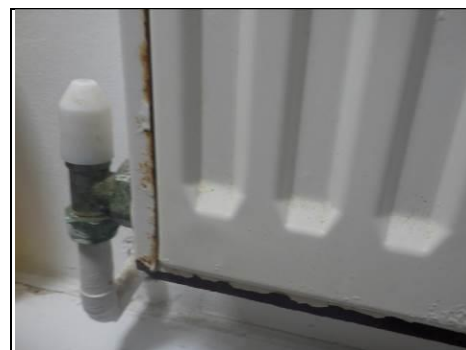
Rusting radiator

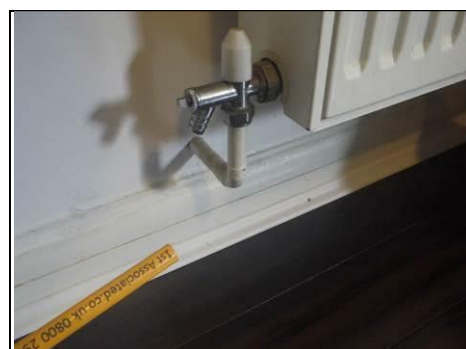
The heating system uses microbore pipes. From our experience these tend to get blocked more easily than a traditional heating system that uses a 12/13mm pipe. However, microbore pipes are cheaper than a traditional system and easier to install from a plumber's point of view, which is possibly why they are so popular with plumbers!

Microbore pipes

**ACTION REQUIRED:** We recommend a power flush from time to time to ensure they are working satisfactorily. You need to be aware that we generally do not feel they work as well as a traditional system.

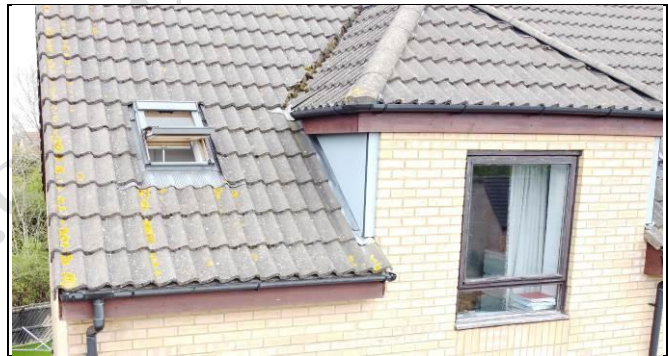
Concrete tiles  
~ Aerial View - 360 Photo ~

There is some slight moss on the roof. The moss can hold water against the tiles and cause them to have accelerated deterioration.

We recommend removing moss with a soft brush, we do not recommend high pressure cleaning or chemicals are used on the roof tiles as they can damage the tiles.

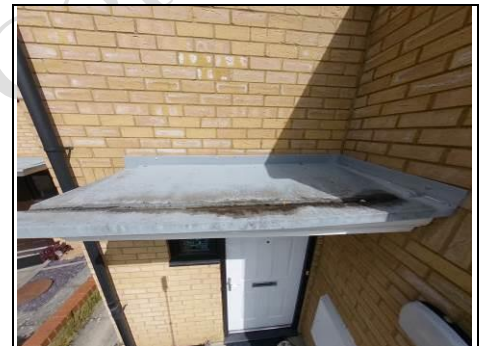
The entrance canopy has a flat roof covered with GRP (glass-reinforced plastic) which looks in average condition. There is some water sitting on it where there is a central drain. Note; this discharges off the end, there is no downpipe.

Front entrance canopy

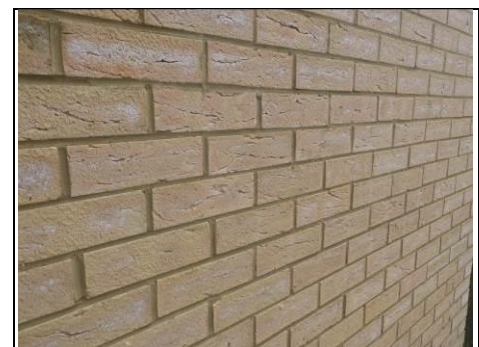
We noted efflorescence which is often a sign that it is likely to be a timber frame construction.

Efflorescence

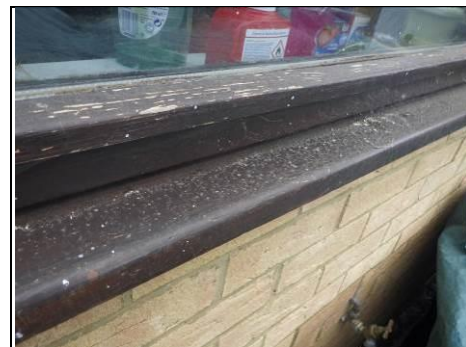
Weathered window

**ACTION REQUIRED:** Please see our comments in the Executive Summary.

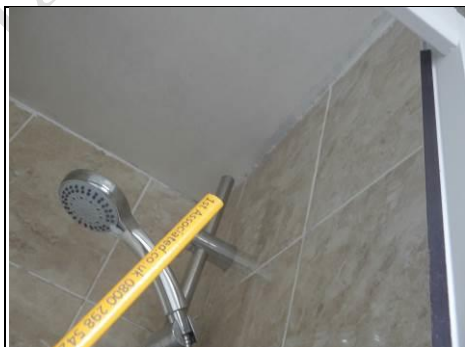
At the time of the inspection there were signs of condensation in the en-suite shower room on the top floor which looks to have been painted over. It may well be getting into the bedroom as well.

Black mould in en-suite shower

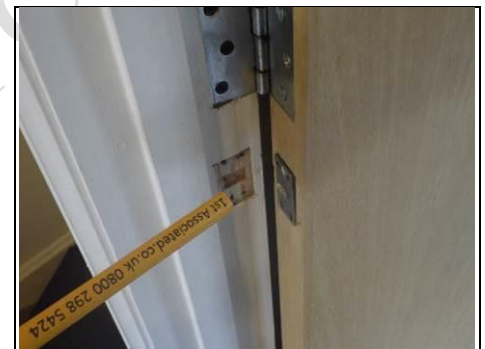
We noted various fire doors have had the central door closer (Perco is the generic name) removed. Fire doors generally are required on a staircase as this is a protected area to stop the staircase acting like a chimney and transferring the fire from one floor to the next.

Door closer removed

**ANTICIPATED COST:** £1,000 - £2,000 depending upon whether the existing doors are fire doors and can be repaired or replaced; ask the owners/shared ownership. Please obtain quotations before you legally commit to purchase the property.

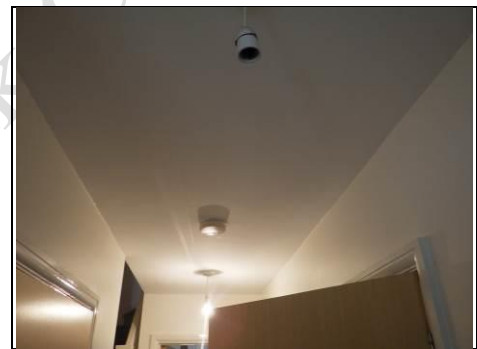
Smoke alarm

**ACTION REQUIRED:** We would recommend, for your own safety, that additional smoke detectors are installed.

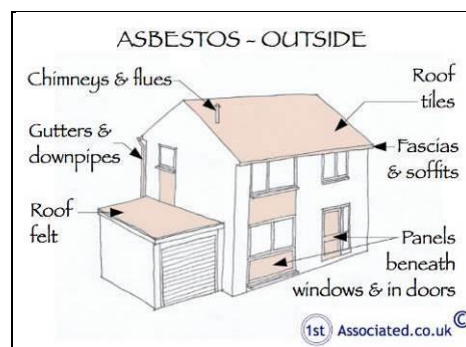
Asbestos externally

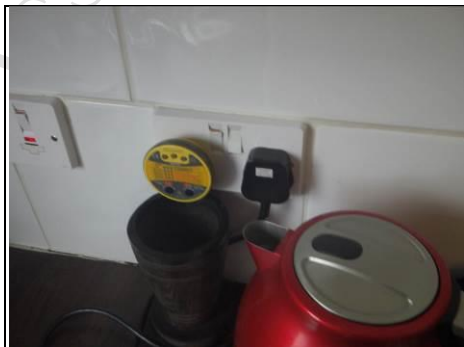
We carried out an earth test in the kitchen area to the socket point that is normally used for the kettle. On our first test the electric tripped and passed on the second attempt.

Earth test failed
