Non Traditional Example Residential Building Survey

INTRODUCTION

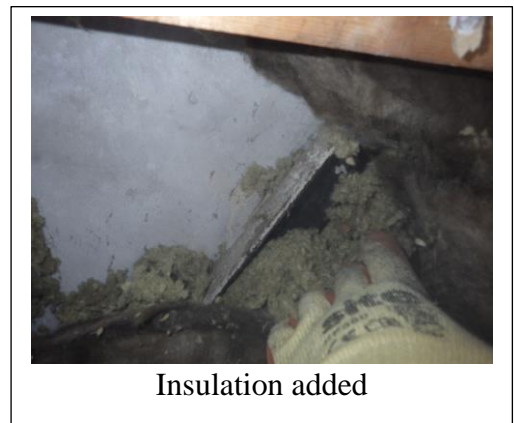
Added insulation – at some point someone has added insulation to this property. At first it may seem like adding insulation is a good thing to do and it usually is in a modern traditionally built house. However, this is a non-traditional metal frame house and as such adding insulation can cause interstitial condensation which in turn causes corrosion and rusting of the frame that holds the property together.

Insulation added

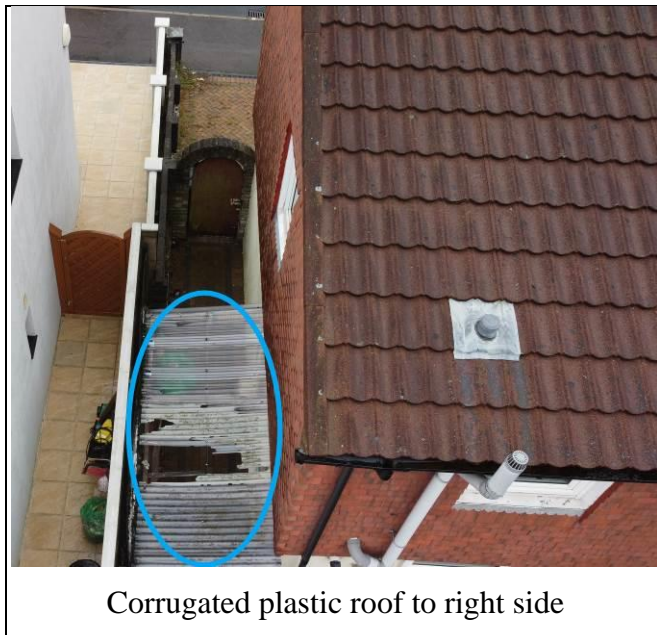
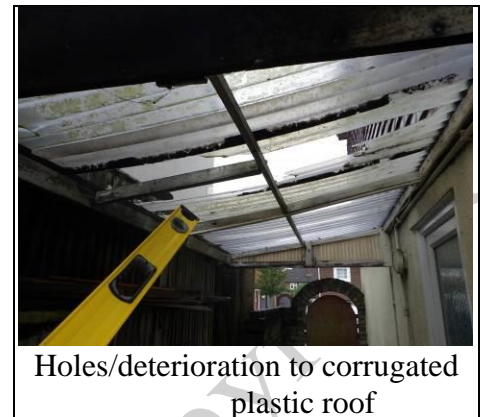
The corrugated plastic to the roof on the right hand side passageway is deteriorating/in need of replacing.

ACTION REQUIRED: We recommend this is replaced. At the same time we would also replace the structural frame which holds the roof in place.

ANTICIPATED COST: £1,000 - £2,000; please obtain quotations before you legally commit to purchase the property.

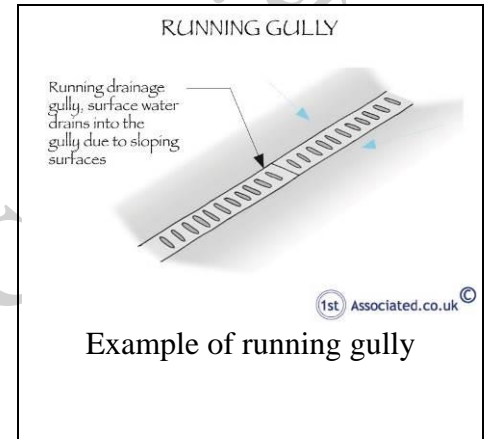
Running gully to rear right

Example of running gully

ACTION REQUIRED: Due to this building being on a sloping site and water likely to be causing problems to the rear, we recommend opening up the walls to one metre squared in three areas to see the condition of the metal frame. In this particular case at least one of the areas, depending upon what was found, would be to the rear of the property. The benefits of opening up the structure is several reasons:

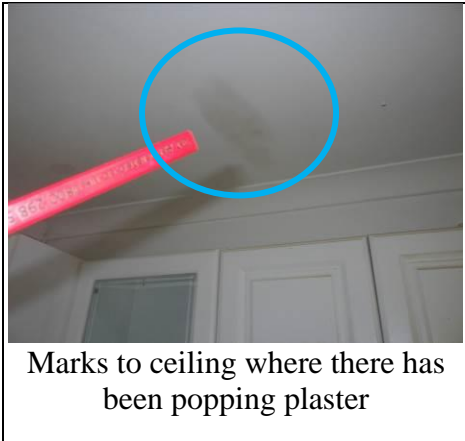
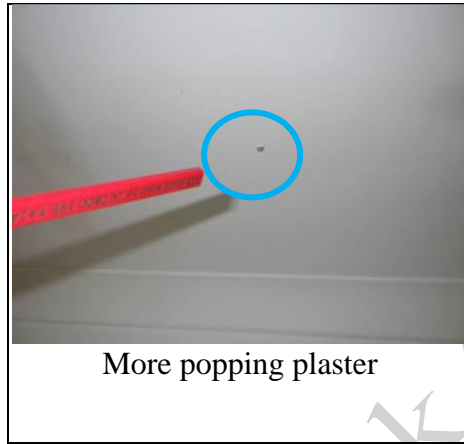
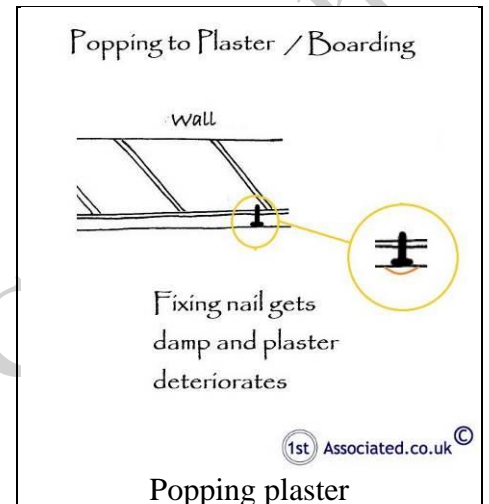
We noted popping in some of the ceilings, such as the kitchen ceiling which may be due to dampness from the bathroom which is directly above. However, we think it is also likely to relate to condensation/humidity occurring in the areas; known as popping, where the area around the nail comes away/pops off.

The dampness may have come from the bathroom above, however we also think it may be caused by humidity and condensation in the property.

ACTION REQUIRED: As already mentioned, the adding of large good quality humidity controlled extract fans to the kitchen, the bathroom and any areas that are used for drying clothes internally during winter months should help (we would assume that clothes will be dried externally during the warmer months). By large extract fans we mean 150mm.

ANTICIPATED COST: We would anticipate costs between £250 - £500 per extract fan depending upon the wiring required. We always recommend quotes are obtained before work is agreed/commenced and a few hundred pounds for re-plastering. Please obtain quotes before you legally commit to purchase.

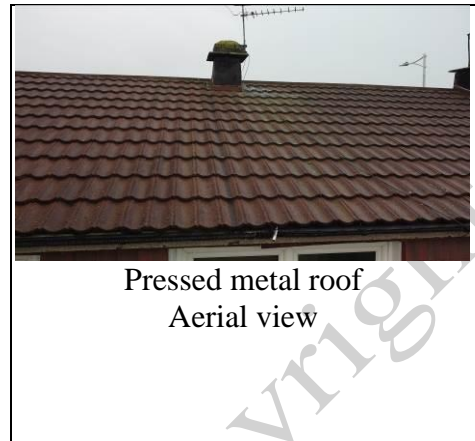
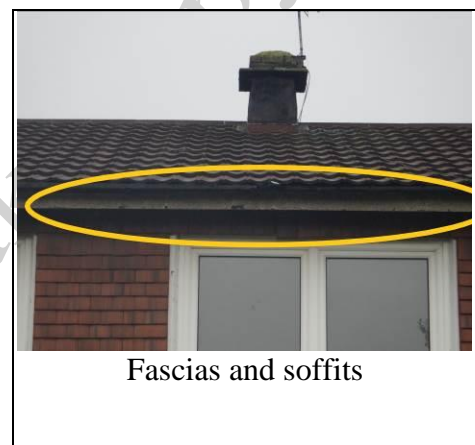
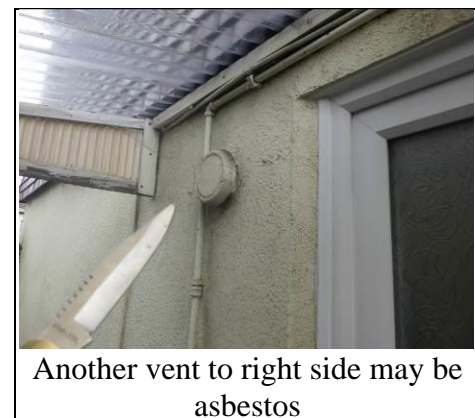
As mentioned originally the roof would have been formed with asbestos, we can now see it has been replaced with a pressed metal roof.

Often other elements were formed in asbestos, such as the fascias and soffits and the vents. We are not certain; this needs to be investigated and other areas.

ACTION REQUIRED: We recommend you have an Asbestos Report confirming if there is any asbestos in the property remaining. This will also be valuable when you come to sell the property in the future as of course it will ensure you do not have any health risks from asbestos.

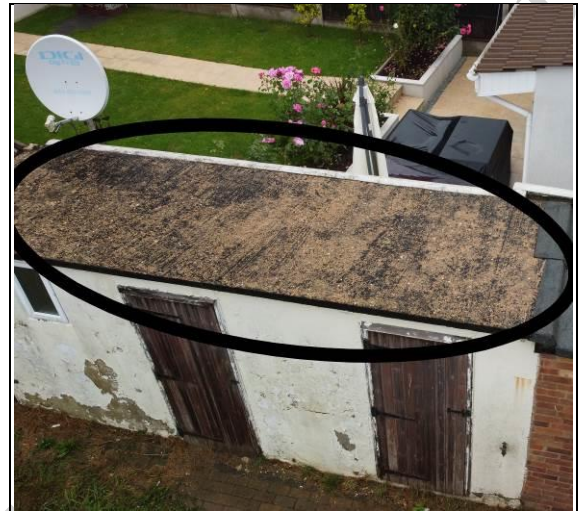
Most of the outbuildings structures are formed with reinforced concrete. To the roof of these the tar has weathered which will lead to water getting into the concrete roofs and concrete wall structures, which in turn can lead to the reinforcement within them deteriorating, causing the concrete to spall, flake and deteriorate.

Reinforced concrete outbuildings and brick outbuilding (which we did not enter)

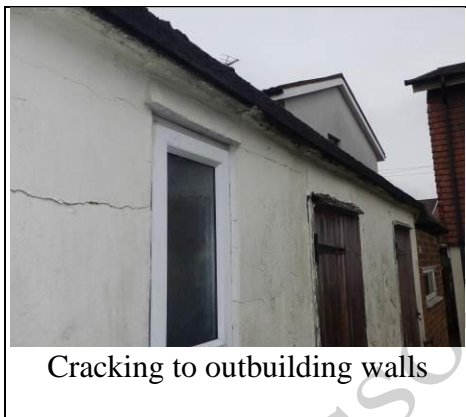
Cracking to outbuilding walls

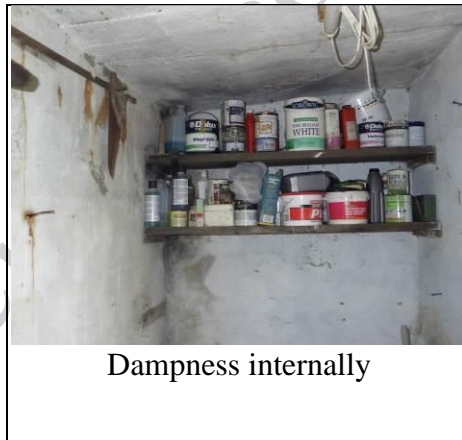
Dampness internally

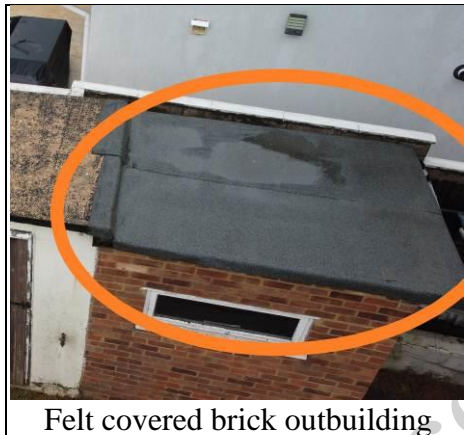
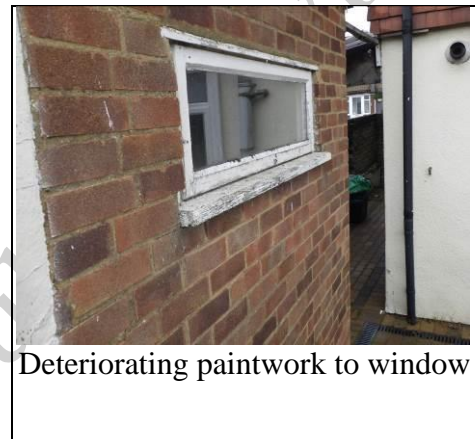
The brick outbuilding next to the concrete outbuildings has a felt roof and timber windows and a timber door which need work.

ACTION REQUIRED: Repair, prepare and redecorate in the summer/warmer months of 20XX.

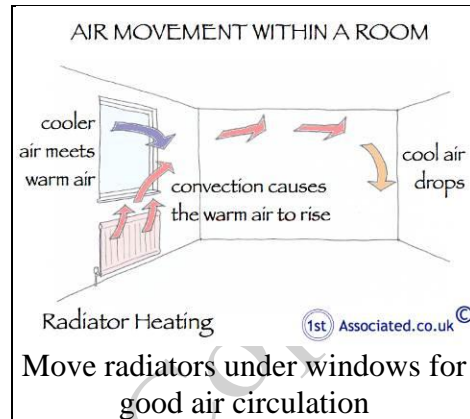
Many of the radiators are internal. We much prefer to see radiators positioned under windows for good air circulation.

ACTION REQUIRED: We recommend radiators are moved under windows where possible for better air movement, which will in turn will reduce humidity.

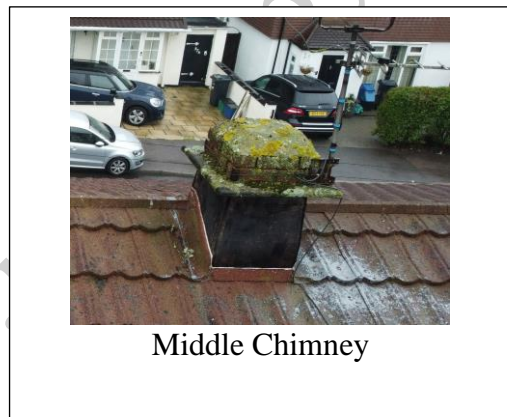
Middle Chimney

Also, please note that it looks like the chimney has been removed in part internally.

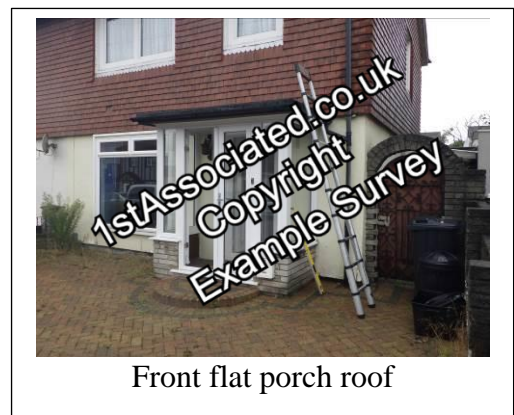
The flat roof is located to the front right and is covered with mineral felt. We would comment it is in below average condition for its age, type and style, with the felt starting to deteriorate.

ACTION REQUIRED: We recommend replacing with a good quality felt. We would always recommend that lead flashings are used.

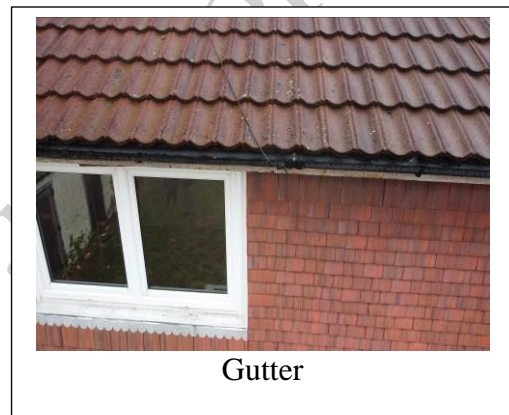
Gutter

Gutter to porch full of moss

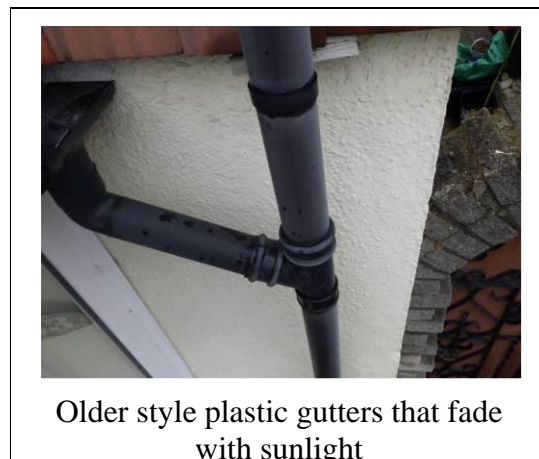
Older style plastic gutters that fade with sunlight

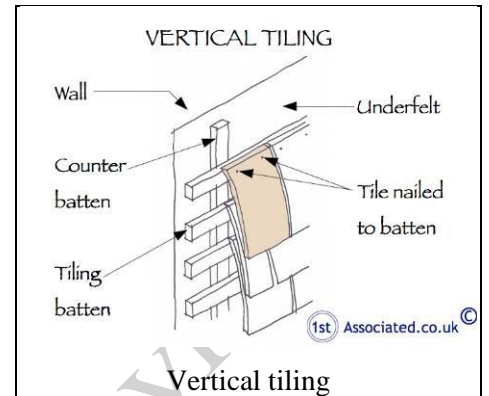
It is generally in average condition, but we did note a missing tile or two to the front.

Missing tile to front

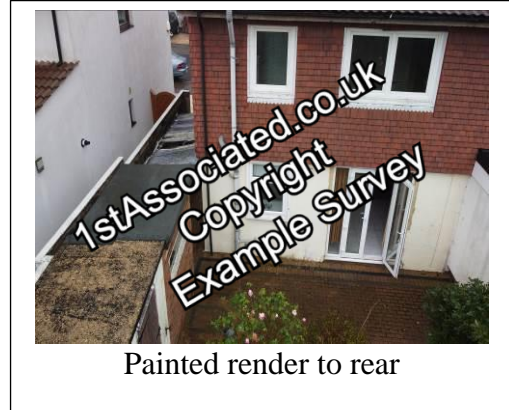
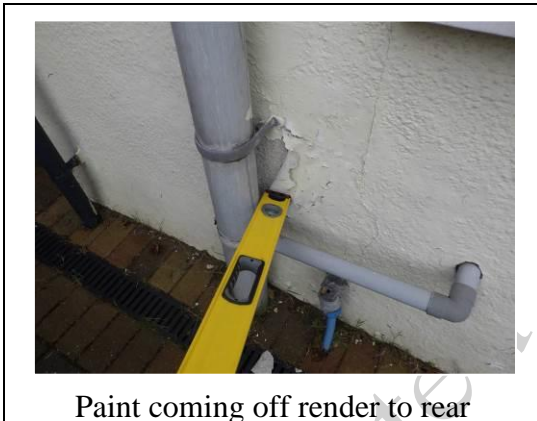
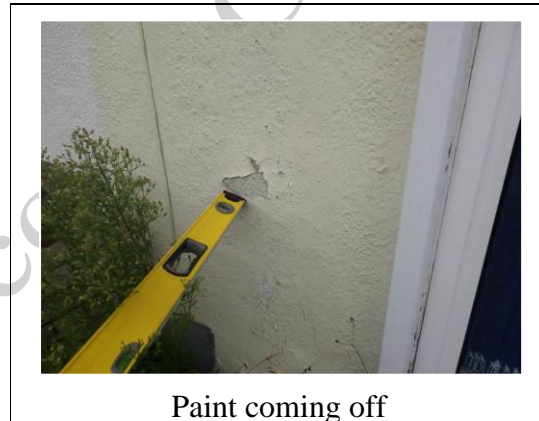
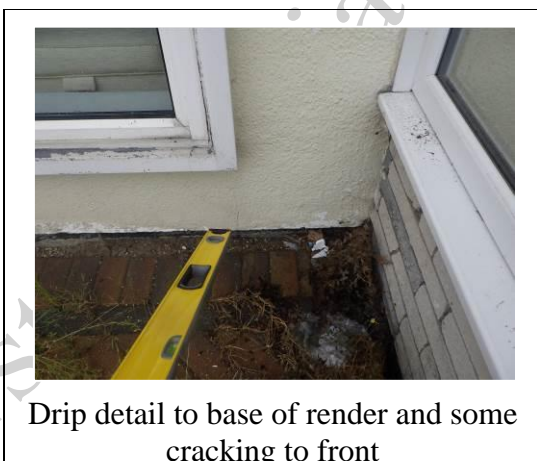
We have carried out a tap test (literally hitting the render with the back of a hammer). We found it to be in below average condition for its age, type and style, with deterioration and paint peeling.

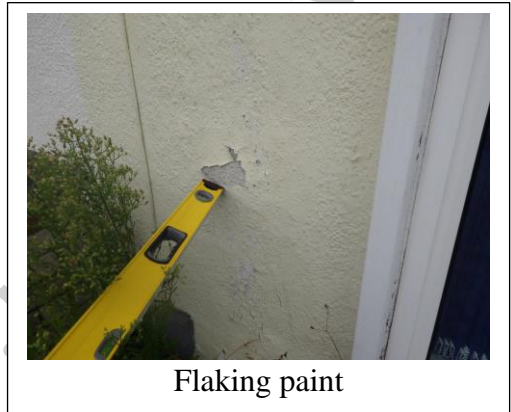
The external decorations are in below average condition and we recommend redecoration as soon as possible.

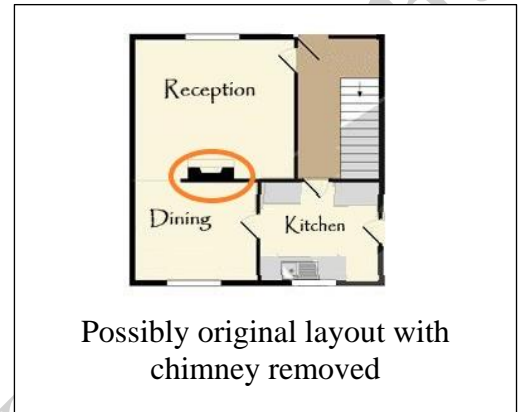
The chimney is capped. The chimney looks to have been removed from within the roof space; there may be some of the original chimney remaining. You need to be aware that sometimes these, as we understand it, were lined with asbestos.

ACTION REQUIRED: Please see our comments in the Executive Summary with regards to having an asbestos test and report on the property.

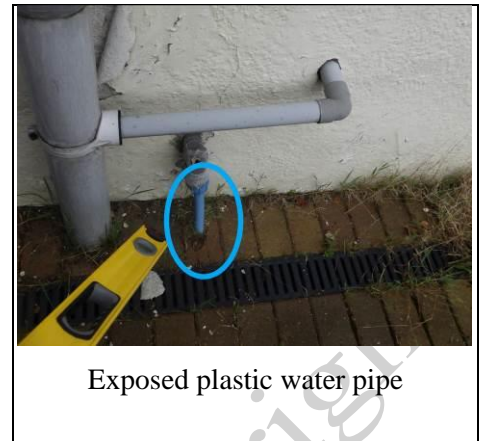
Externally we noted several exposed plastic water pipes all of which need to be insulated properly to stop frost attack.

ACTION REQUIRED: Insulate all external plastic pipework.

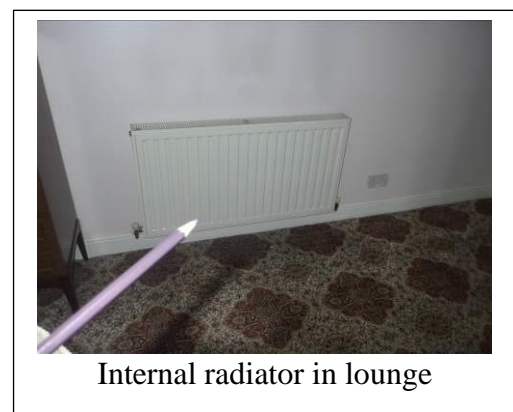
Some of the radiators are on internal walls, we prefer to see them under windows for better air circulation/reducing humidity.

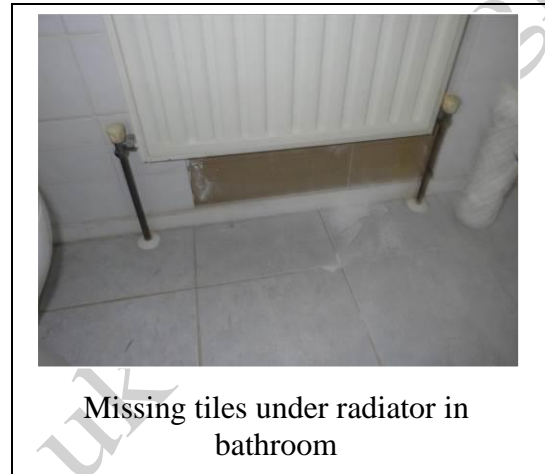
The property has a three-piece bathroom suite, consisting of a shower cubicle, wash hand basin and WC, which looks in slightly below average condition. We noted some missing tiles under the radiator.

ACTION REQUIRED: Replace missing tiles.

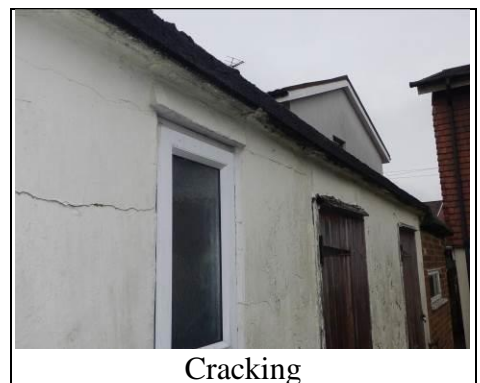
Cracking

ACTION REQUIRED: Please see our comments in the Executive Summary. We would recommend nothing valuable is stored in the outbuildings.
