Non Traditional Example Residential Building Survey

This is a modern timber frame property which were typically built in the 1980's till today (we have found sales going back to 2006 on Rightmove of nearby properties therefore we assume this is the approximate date of construction although they may have been built quite a bit earlier than this). If the age of the property interests you your Legal Advisor may be able to find out more information from the Deeds.

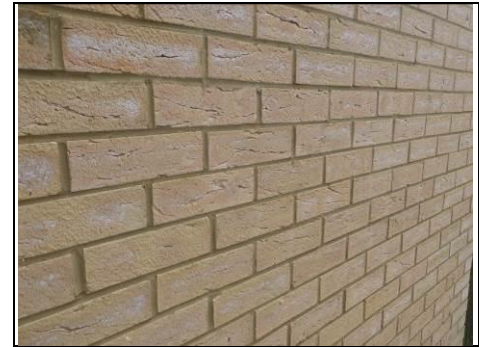
We noted efflorescence to the brickwork in many areas which is a salt coating. This is a fairly common factor in timber frame buildings.

Efflorescence

This is caused by the walls never drying out. This, we believe, is a combination of external weather factors and the internal environment of humidity created inside such as showers, baths, cooking, breathing, etc as to the appearance of salts. This is a personal opinion, we have never seen any technical information on it, we have seen efflorescence regularly on timber frame buildings brick walls.

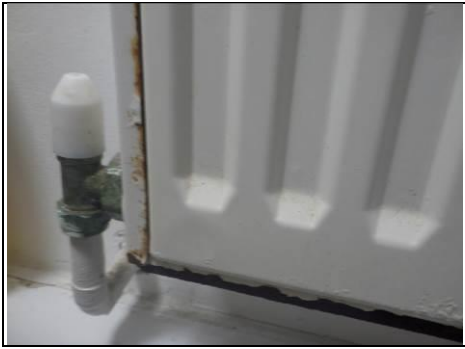
We believe there are problems with ventilation and black mould particularly around the en-suite shower room and the bedroom.

Radiator rusting due to dampness

ACTION REQUIRED: We would recommend adding a large humidity controlled extract fan in the shower room. By large extract fans we mean 150mm. Unfortunately, this is quite a difficult job and will need some sort of air vent externally.

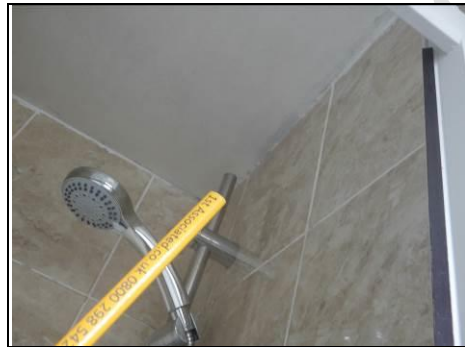
Black mould painted over and deteriorating paintwork

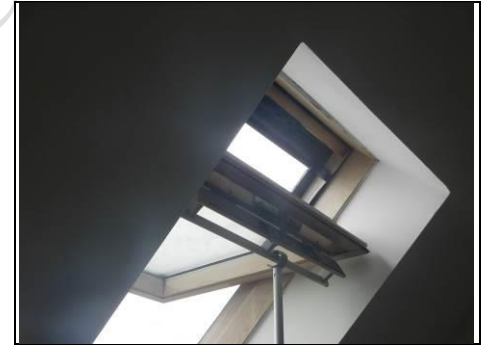
En-suite roof window open at time of survey

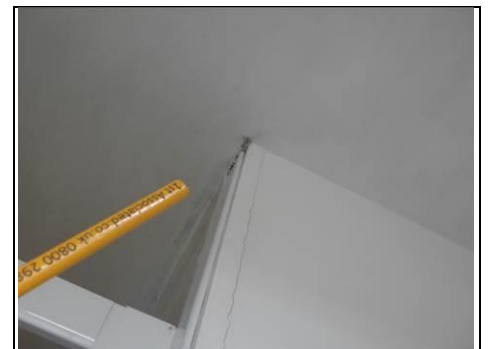
Black mould and hairline crack in plaster of en-suite

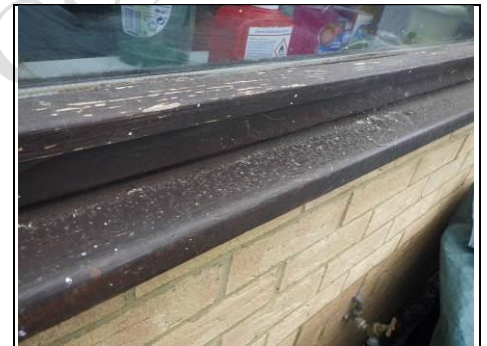
For example, the top floor rear window has a very stiff lock that will simply no longer open.

Weathered window

ACTION REQUIRED: The windows need to be eased and adjusted, prepared, repaired and redecorated. There will be some high level work and it is likely that scaffolding will be needed for the upper floors.

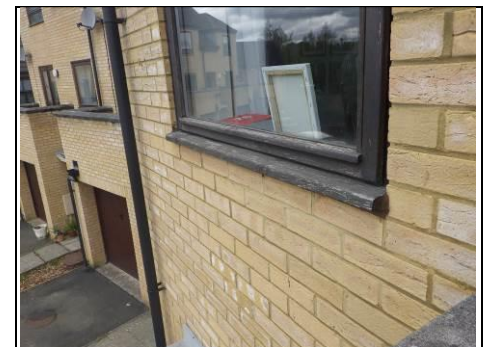
Flaking paint and bare timber

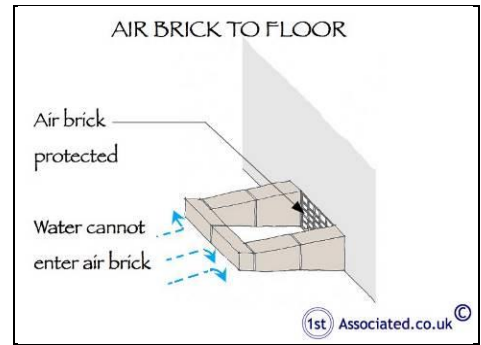
Protect airbrick

ACTION REQUIRED: Protect airbricks and ensure that no water gets into the property. Also, ideally we would recommend the floors are opened up. You need to speak to whoever has the shared ownership of the property and see if they will open up the floors or if there is a known about problem.

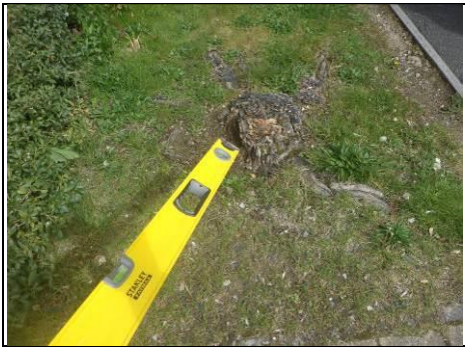
There is a tree cut down to the front of the drive on the left side which looks to have been quite a large tree. Cutting down trees can affect buildings particularly the foundations and equally leaving the tree without maintaining it can also affect the building.

Tree cut down

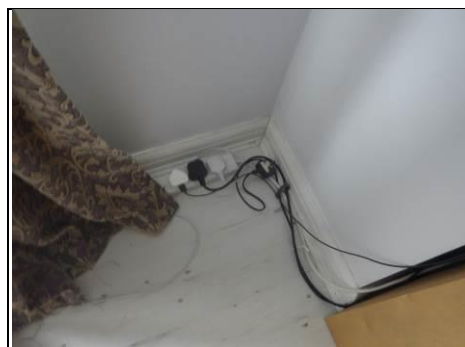
The electrics tripped when we carried out our usual earth test. We also noted the need for extra socket points.

Extension lead

ACTION REQUIRED: The Institution of Engineering and Technology (IET) recommend a test and report when properties change hands, to be carried out by an NICEIC registered and approved electrical contractor or equivalent.

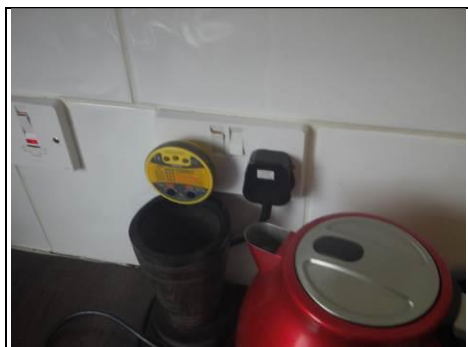
Earth test failed

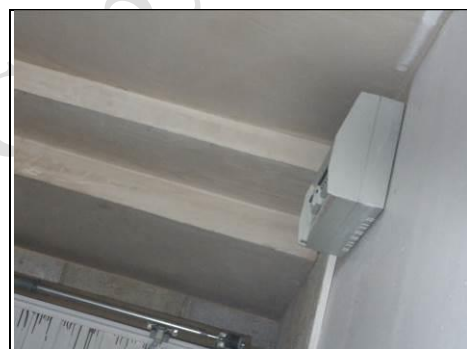
Fuse board in garage

There were a lot of stored items which restricted our view, for example we were unable to get in the garage properly or the WC. There looks to be an older/original fuse board and we noted some lightbulbs were missing meaning that we had to use torchlight to view some areas.

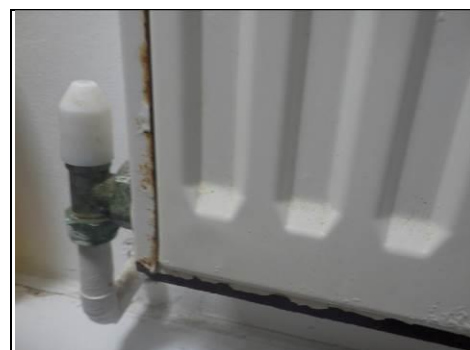
Rusting radiator

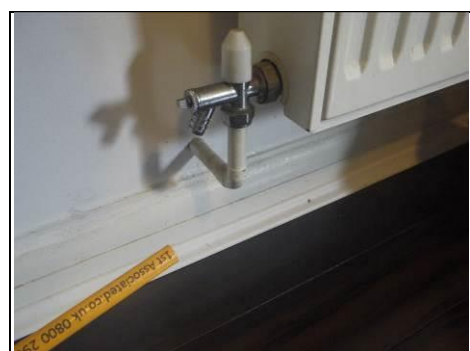
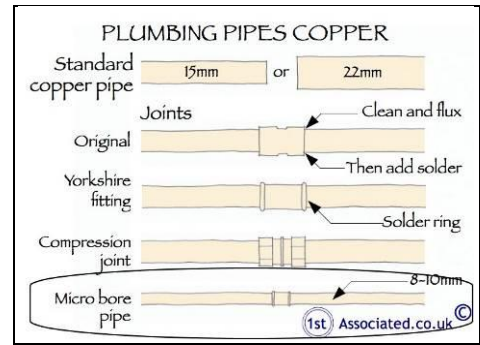
The heating system uses microbore pipes. From our experience these tend to get blocked more easily than a traditional heating system that uses a 12/13mm pipe. However, microbore pipes are cheaper than a traditional system and easier to install from a plumber's point of view, which is possibly why they are so popular with plumbers!

Microbore pipes

ACTION REQUIRED: We recommend a power flush from time to time to ensure they are working satisfactorily. You need to be aware that we generally do not feel they work as well as a traditional system.

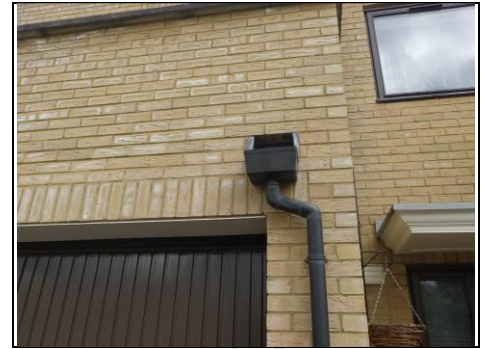
There are some relatively poor details here such as drainage from the balcony area. This type of property is relatively modern (i.e., less than one hundred years old) but nevertheless still requires ongoing maintenance and repair. A budget for such work must be allowed to ensure it is maintained in a good condition. This will prevent undue and unnecessary deterioration.

Hopperhead to balcony

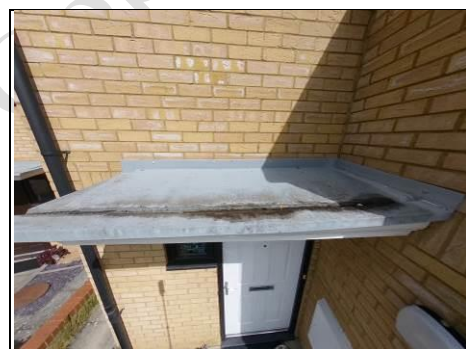
The entrance canopy has a flat roof covered with GRP (glass-reinforced plastic) which looks in average condition. There is some water sitting on it where there is a central drain. Note; this discharges off the end, there is no downpipe.

Front entrance canopy

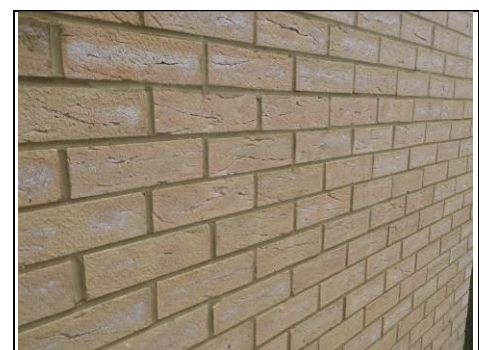
We noted efflorescence which is often a sign that it is likely to be a timber frame construction.

Efflorescence

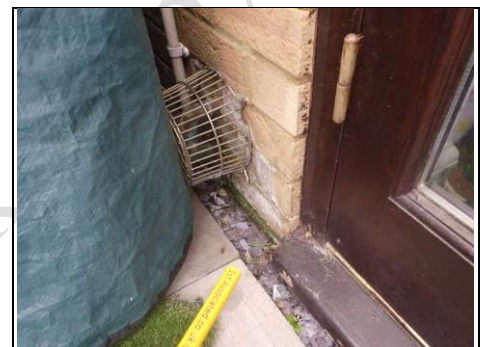
Moss to rear base

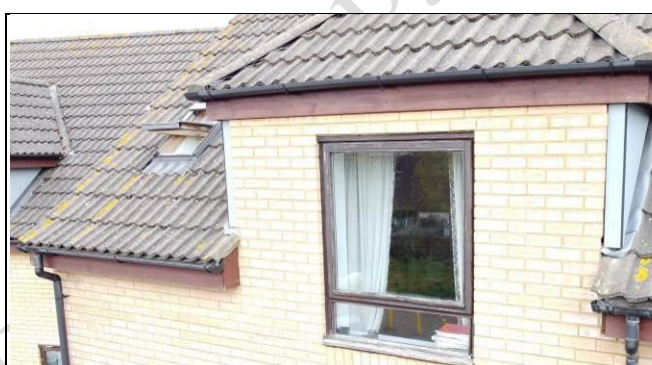
The fascias and soffits are timber. They are stained and we would comment they are in weathered condition for their age, type and style.

Fascias and soffits
~ Aerial View - 360 Photo ~

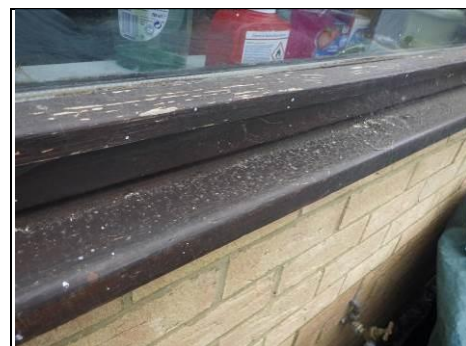
Weathered window

ACTION REQUIRED: Please see our comments in the Executive Summary.

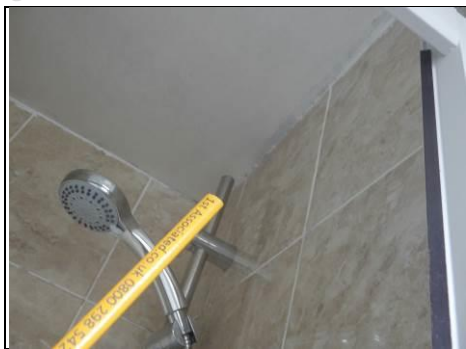
At the time of the inspection there were signs of condensation in the en-suite shower room on the top floor which looks to have been painted over. It may well be getting into the bedroom as well.

Black mould in en-suite shower

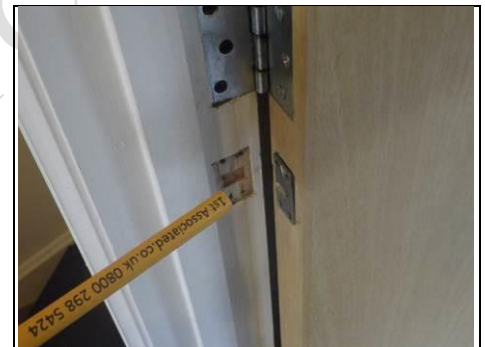
We noted various fire doors have had the central door closer (Perco is the generic name) removed. Fire doors generally are required on a staircase as this is a protected area to stop the staircase acting like a chimney and transferring the fire from one floor to the next.

Door closer removed

ANTICIPATED COST: £1,000 - £2,000 depending upon whether the existing doors are fire doors and can be repaired or replaced; ask the owners/shared ownership. Please obtain quotations before you legally commit to purchase the property.

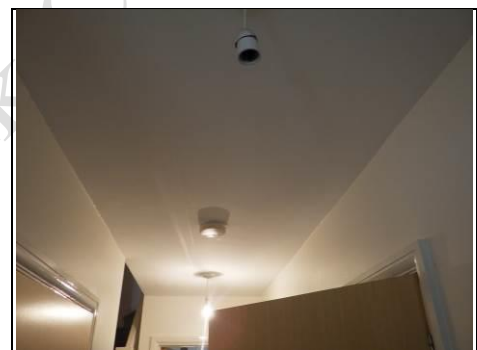
Smoke alarm

ACTION REQUIRED: We would recommend, for your own safety, that additional smoke detectors are installed.

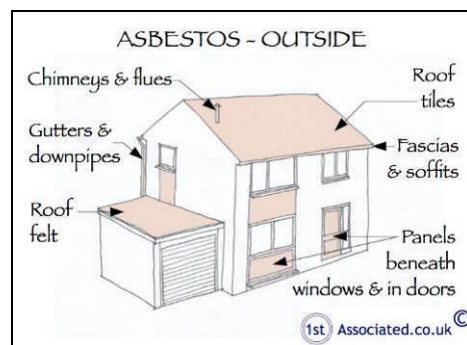
Asbestos externally

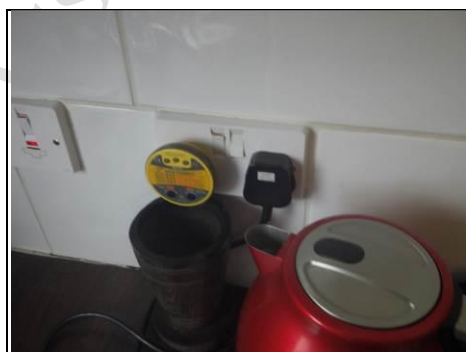
We carried out an earth test in the kitchen area to the socket point that is normally used for the kettle. On our first test the electricians tripped and passed on the second attempt.

Earth test failed
