# Non Traditional Example Residential Building Survey

NON TRADITIONAL CONSTRUCTION STRUCTURAL FRAME HOUSE

## BISF FRAME

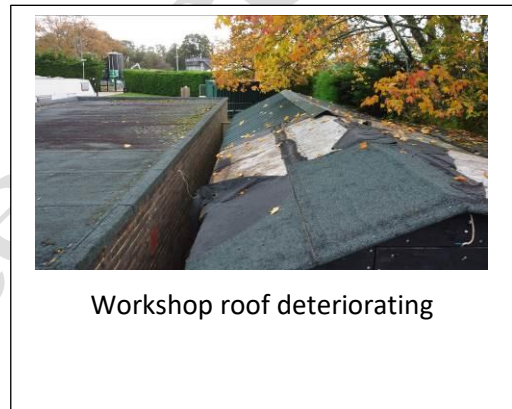
Workshop roof deteriorating

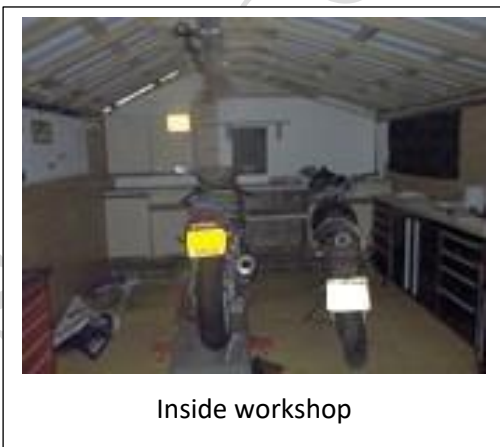
Inside workshop

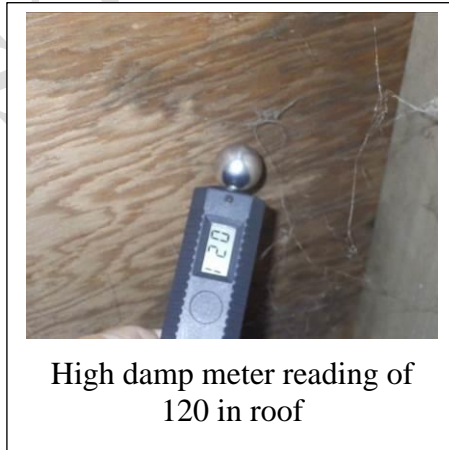
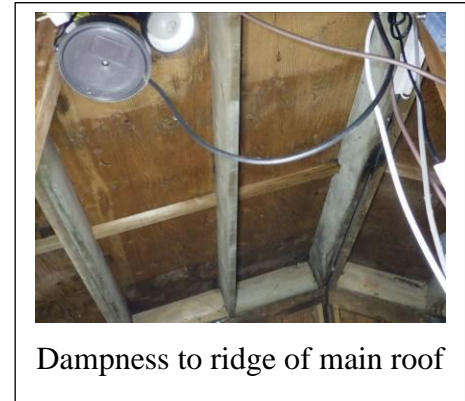
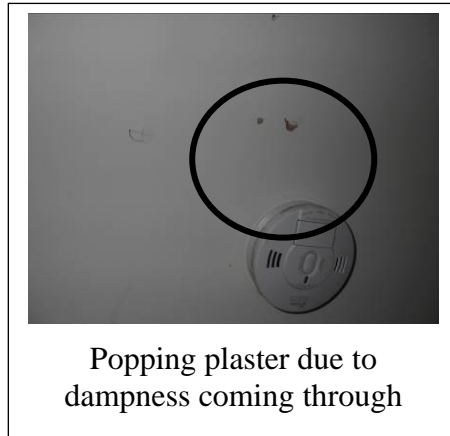
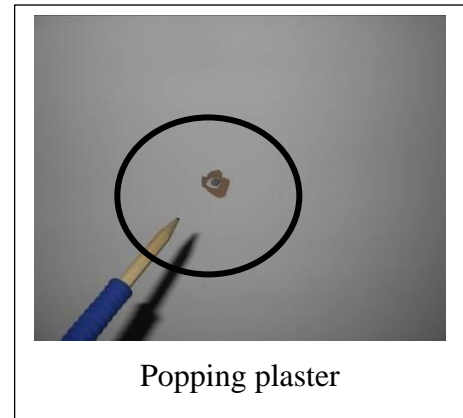
The property has a shallow pitched roof clad with flat concrete tiles which is letting in water. We can see areas of dampness from within the roof space and we could see popping and deterioration of the plasterboard ceilings.

**ACTION REQUIRED:** The roof is obviously letting dampness in in one way or another. We would start by removing the moss from the roof which there seems to be quite a lot of and see whether there are any obvious cracked tiles, etc and replace these as necessary to leave the roof watertight. If there isn't any obvious defects then it may be that you are getting wind driven rain. If this is the case there is a major defect in the roof, there is certainly black mould visible in the roof.

**ANTICIPATED COST:** A worst case scenario is if you had to completely re-roof this building, assuming that you would have some tiles that you could re-use but that you would have to replace the decking and add ventilation in; see sketch in the form of vented soffits, we would expect costs in the region of £10,000 - £15,000.

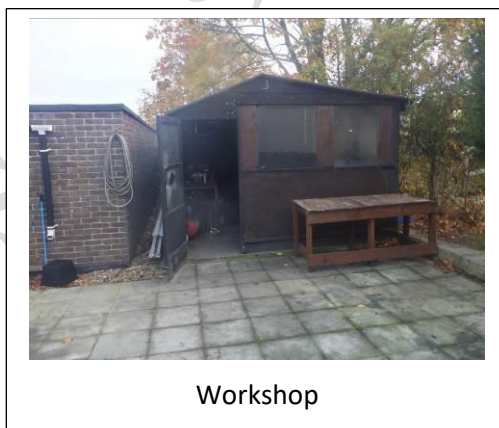
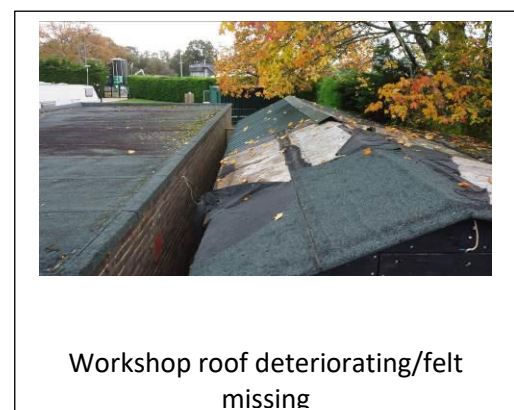
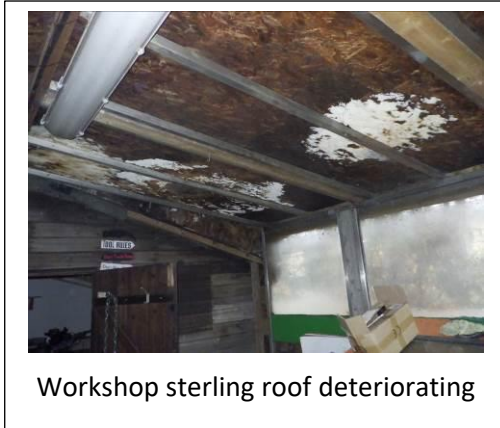
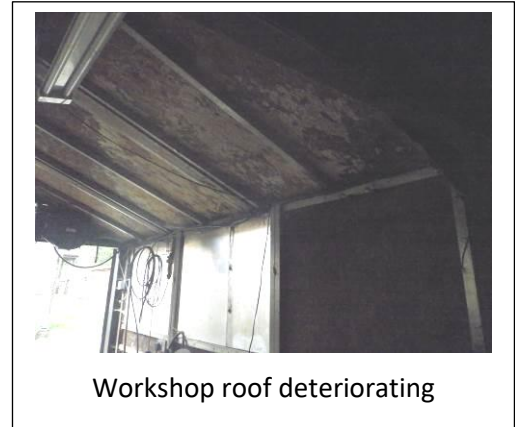
We would advise the roof is deteriorating and needs repair. Also the electric fuse board looks dated. The timber work looked like it hadn't been redecorated for some time.

**ACTION REQUIRED:** Re-roof and replace any decking as necessary.

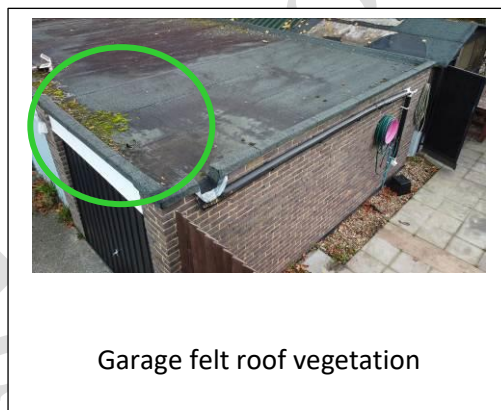
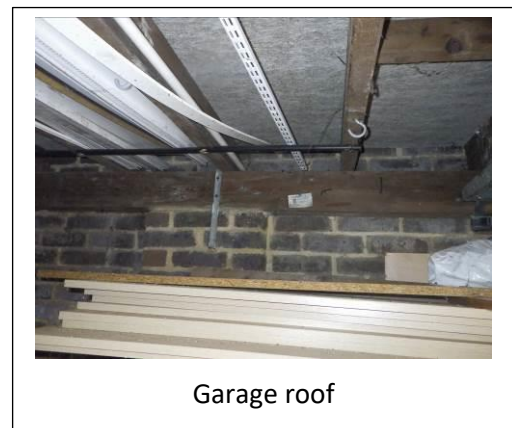
The garage has a mineral felt roof. We could see this is weathered as the black is coming through. What the mineral felt normally has is a protective green layer which tends to be a smaller stone-like material. Where this is missing and you can see the darker areas you tend to get blistering during the hotter weather. The roof looked to be allowing water in from our aerial photographs.

**ACTION REQUIRED:** It may be possible to patch repair this roof but in the long term you should look to re-roof. Again, it depends upon what you will ultimately be using this for.

**ANTICIPATED COST:** To re-roof £2,000 - £4,000 depending upon the quality of the roof that you want and the amount of roof decking which needs to be repaired.

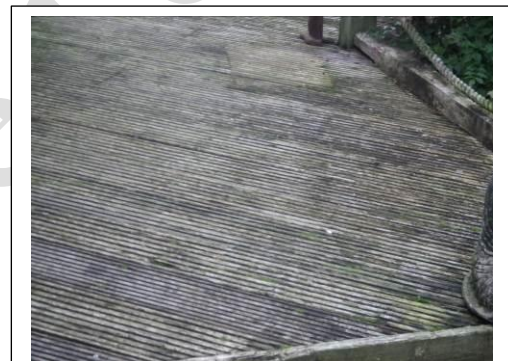
Decking in front of bar

Moss to decking

**ACTION REQUIRED:** We personally would always remove all decking and replace with paving.

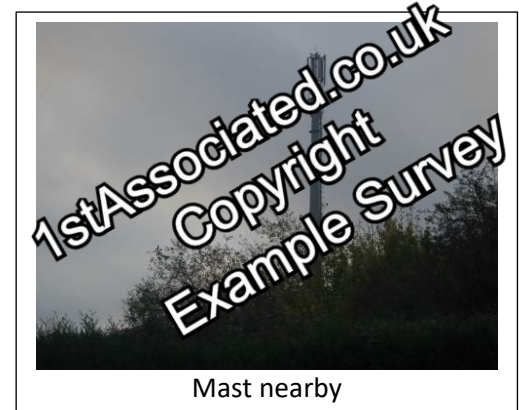
There is a mast nearby. There have been various reports on masts over the years as to whether they are a health hazard or not. It is probably fairest to say the jury is still out as to whether they are harmful. Sometimes they can affect the saleability of a property.

Mast nearby

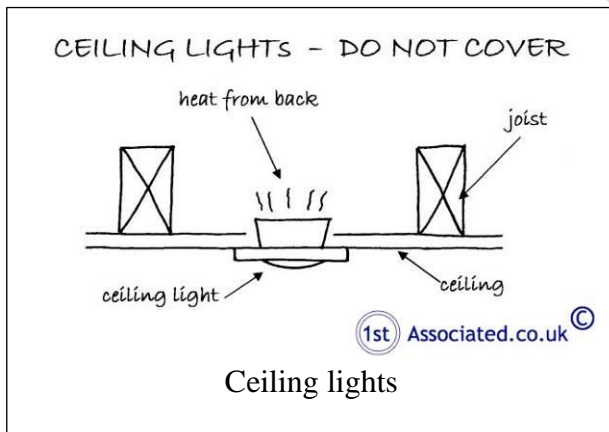
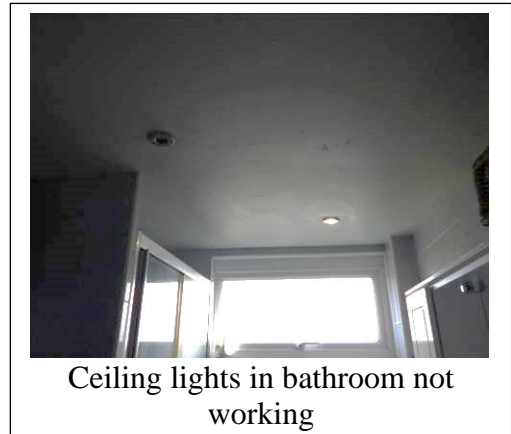
We noted the bathroom lights are not working. This could relate to roof leaks.

**ACTION REQUIRED:** We recommend replacing older style ceiling lights (once the roof leaks/condensation have been resolved).

**ANTICIPATED COST:** A few hundred pounds depending upon the quality and type of light and any repairs needed; please obtain quotations before legally committing to purchase the property.

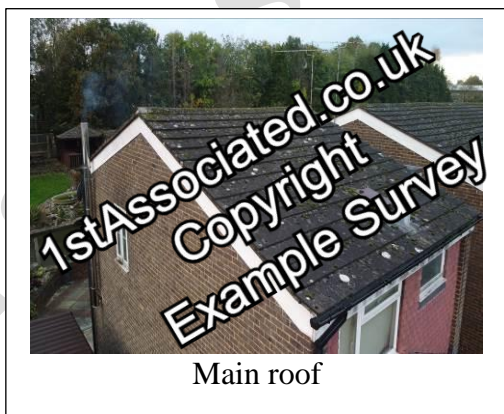
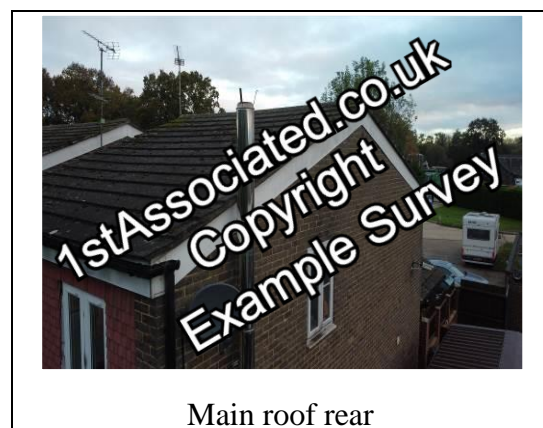
The roof is pitched and clad with flat concrete tiles and, from ground level, this looks in below average condition considering the roof's age, type and style. We can see dampness and mould within the roof space. The roof could be allowing wind driven rain in; please see our comments in the Executive Summary.

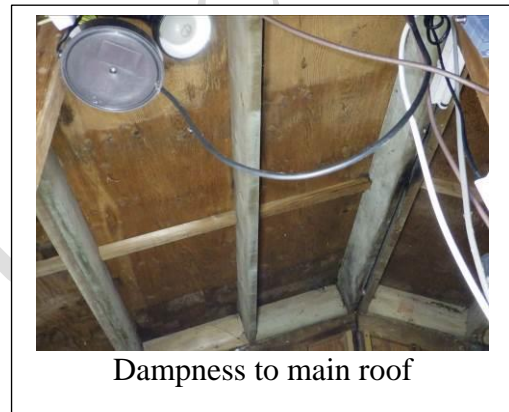
When we inspected the loft space, we found timber decking with no protective underlayer. We generally found it to be in below average condition with dampness visible.

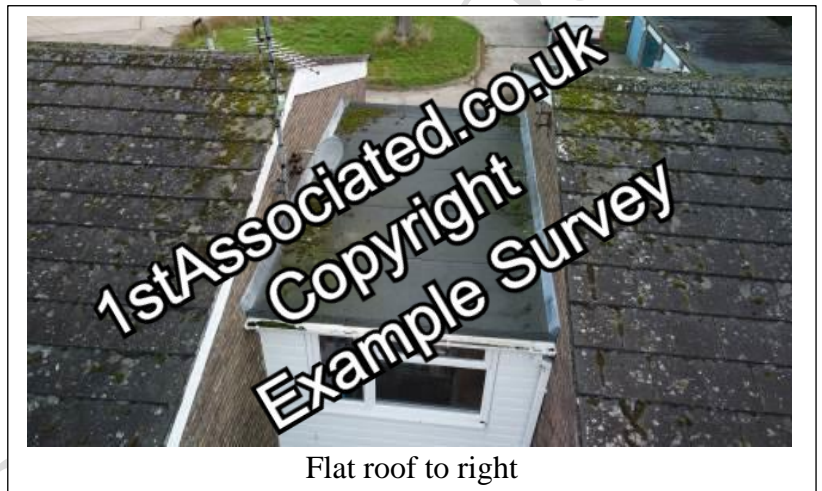
Flat roof to right

The flat roof is located to the right side and is covered with mineral felt. We would comment it has moss sitting on it that we think is coming from nearby pitched roofs. It also means that the roof is a flat flat roof and that water will sit on the roof and then you get accelerated deterioration.

**ACTION REQUIRED:** A worst case scenario would be re-roofing but we think also you could patch repair this roof.

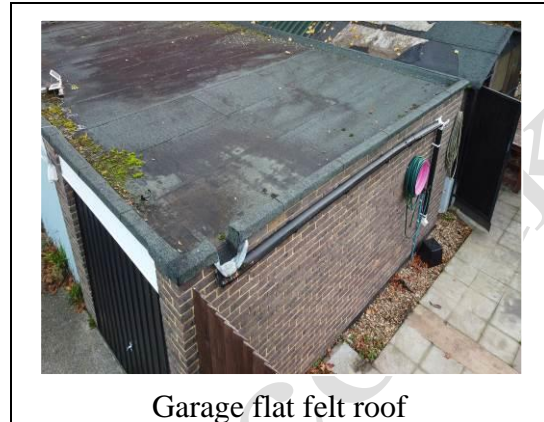
The garage has a felt flat roof which looked in below average condition with deteriorating sterling board internally.

Garage flat felt roof

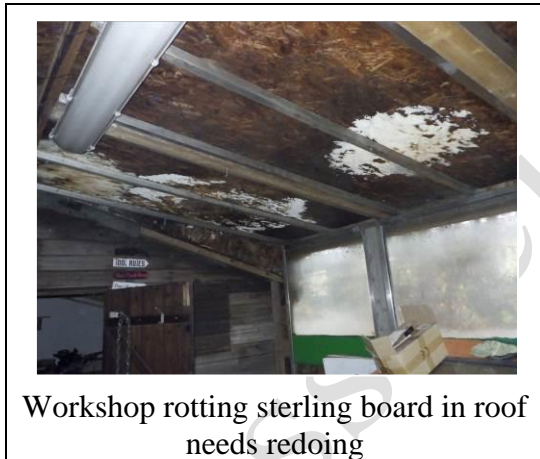
Workshop rotting sterling board in roof needs redoing

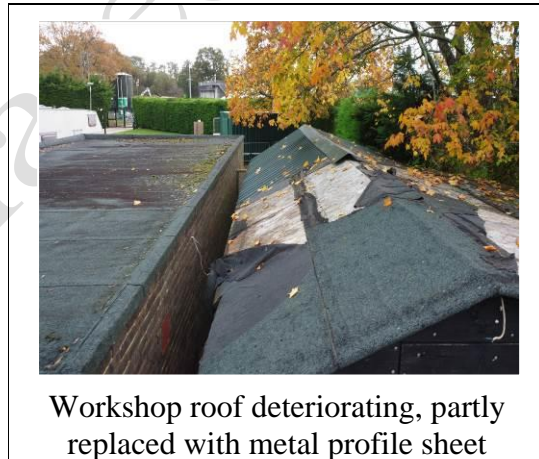
Workshop roof deteriorating, partly replaced with metal profile sheet

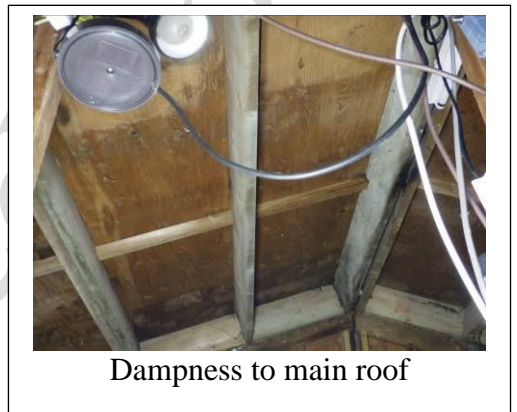
Dampness to main roof

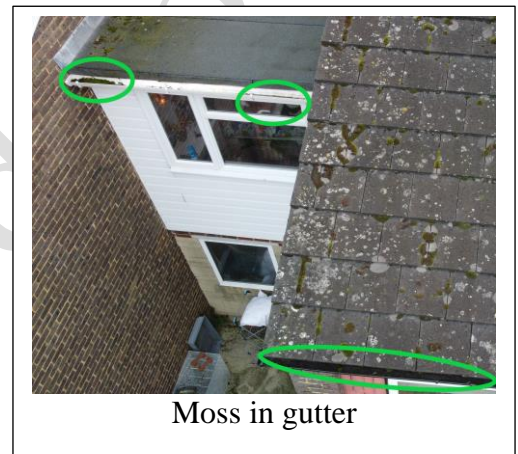
Moss in gutter

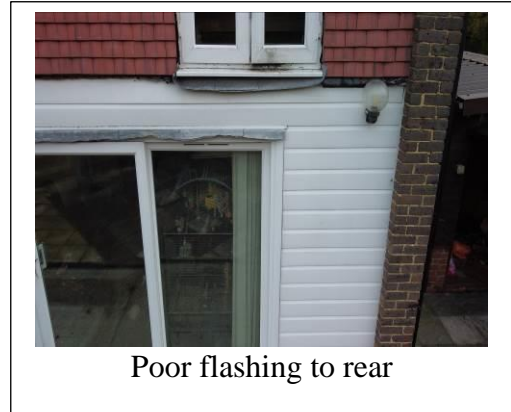
There is a loose flashing which needs re-bedding.

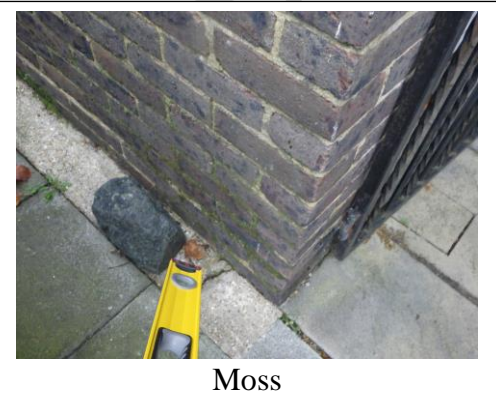
In this era of property typically they were built in as work proceeded. There were no obvious signs of a DPC visible. We noted signs of moss to the walls at the base which indicated that there is a fair amount of water passing by the property (or in this case it could also be the leaking of the gutters we mentioned earlier).

Moss

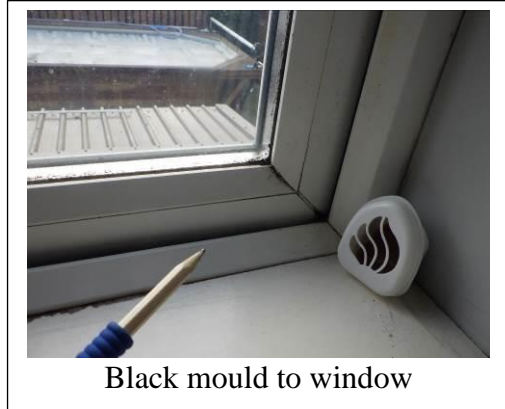
We noted black mould to some of the windows.

Black mould to window

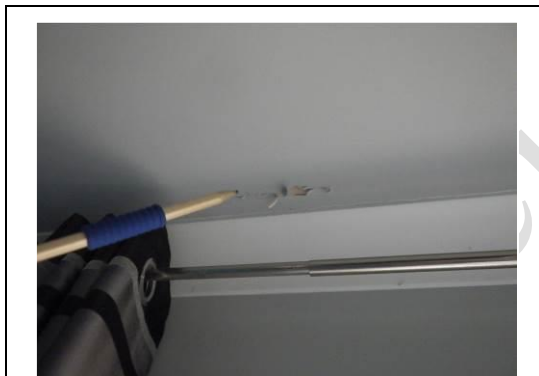
At the time of the inspection there were significant signs of condensation/black mould.

Dampness or condensation to main bedroom on rear left

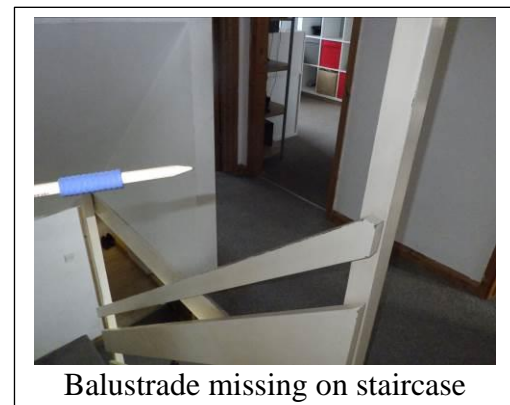
Balustrade missing on staircase

**ACTION REQUIRED:** Please see our comments in the Executive Summary.

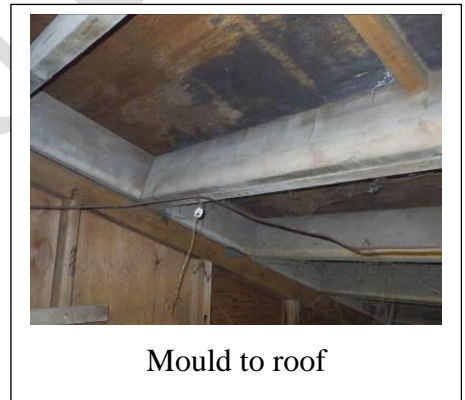
Mould to roof
