Non Traditional Example Residential Building Survey

NON TRADITIONAL CONSTRUCTION STRUCTURAL FRAME HOUSE

BISF FRAME

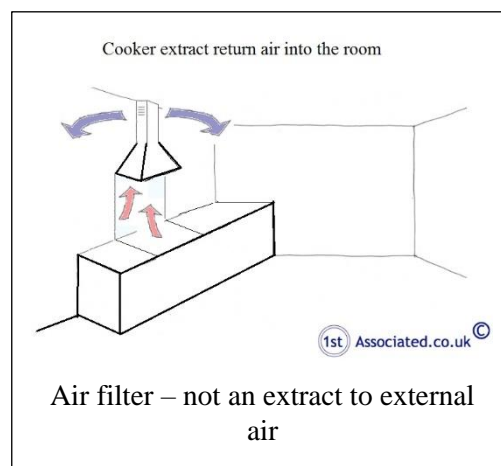
Generally it is best not to have humid air and condensation conditions in a pre-cast concrete frame building such as this one, as we believe it can accelerate problems. In this particular case, we are going to look at two of the humidity generating areas; the kitchen and bathroom.

ACTION REQUIRED: We recommend humidity controlled extract fans are added, also an air removal air filter in the kitchen.

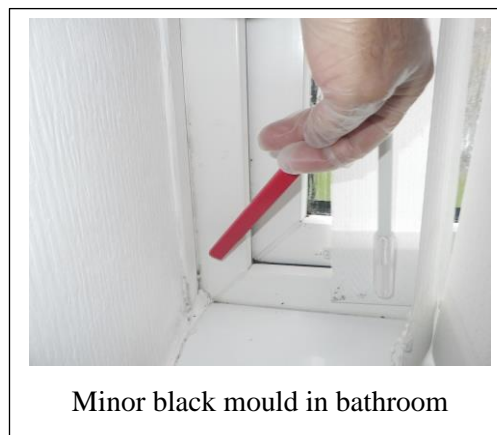
If you recall we showed you there was no extract fan in the area other than a window to open and there was some black mould in the window. This area also needs a humidity controlled extract fan added which is easier said than done.

ANTICIPATED COST: We would anticipate costs between £250 - £500 per extract fan depending upon the wiring required. We always recommend quotes are obtained before work is agreed/commenced.

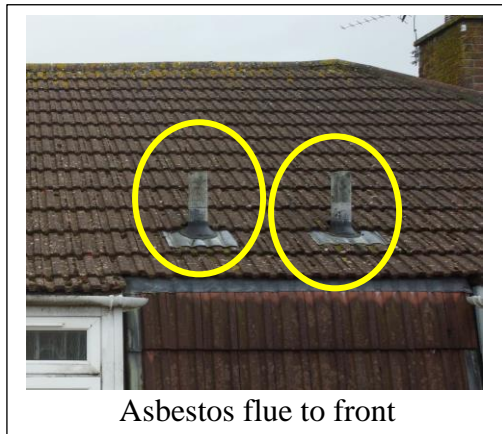
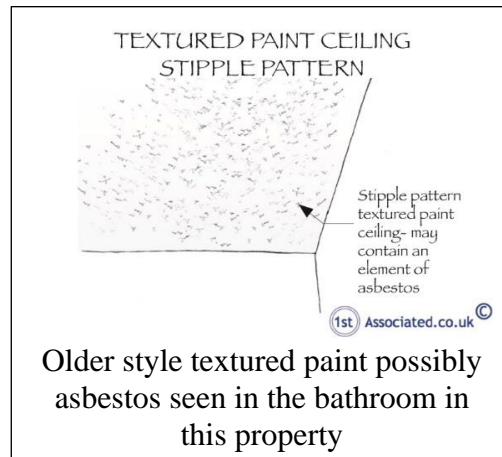
There is an asbestos flue to the front of the property and the textured paint in the bathroom is older style which may contain asbestos. You need to be aware that properties of this era can contain hidden asbestos.

- 1) Your legal advisor to specifically ask in writing if insulation has been added to the cavity.
- 2) Your legal advisor to specifically ask if asbestos reports have been carried out and if so what date and whether the asbestos test took samples. If they have not then you need to carry out an asbestos report with samples taken and the recommended action carried out.

We would always recommend any asbestos is removed from a property as it is generally considered dangerous and also it can affect the value of a property.

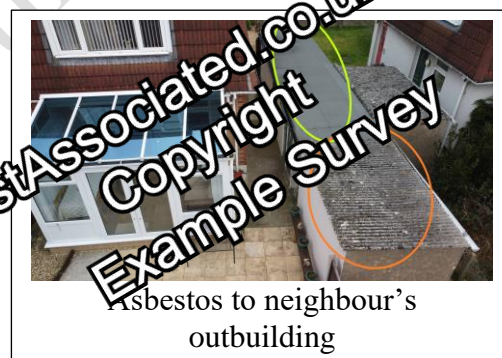
Also, we noted asbestos to next doors outbuilding roof which is effectively in your garden.

Key for above photo	
Green oval	Mineral felt roof to this property
Orange oval	Next door's outbuilding asbestos roof

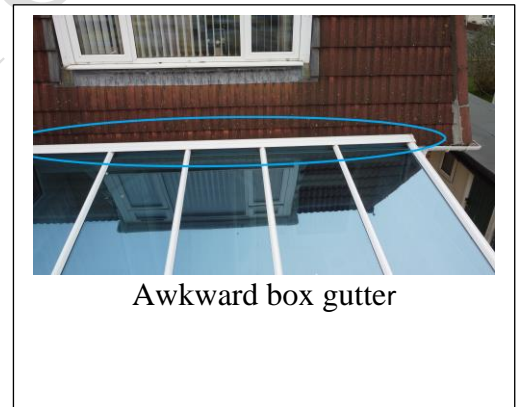
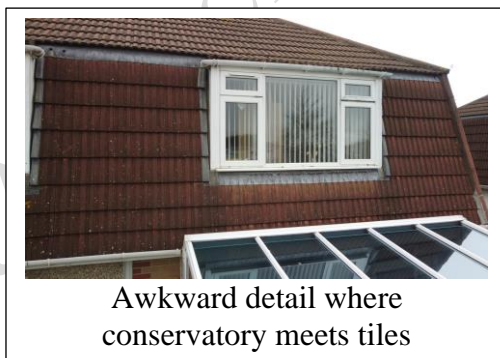
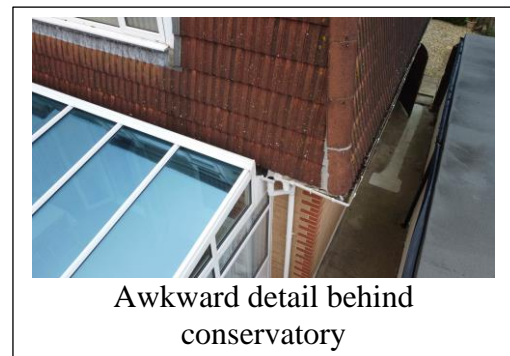
7.0) Awkward box gutter

There is an awkward box gutter between the main building and the rear conservatory. Due to the way the roof is finished (known as a hipped mansard roof) it means it is an awkward detail where the conservatory meets the main roof, in fact it doesn't meet the main roof as there is a box gutter separating them. This can get blocked over time if not regularly cleaned. There were no obvious signs of staining at the time of our inspection but the area did look to have opened up slightly.

ACTION REQUIRED: Regularly keep the box gutter clean to ensure that it doesn't block particularly during the autumn and winter months (when leaves, etc fall). If you have a window cleaner you could ask them to clean it (we would recommend you get them to take a photograph of the clean gutter).

ANTICIPATED COST: A few hundred pounds per year. You just need to make sure you have someone to regularly carry out cleaning of the box gutter, or indeed that you do this, but you do need to make sure it is carried out regularly as it a job that can be forgotten. Please obtain quotations before legally committing to purchase the property.

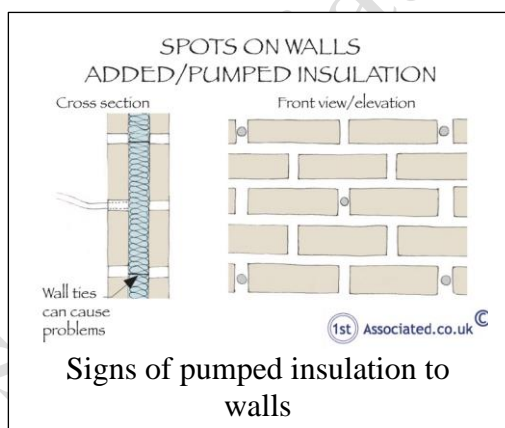
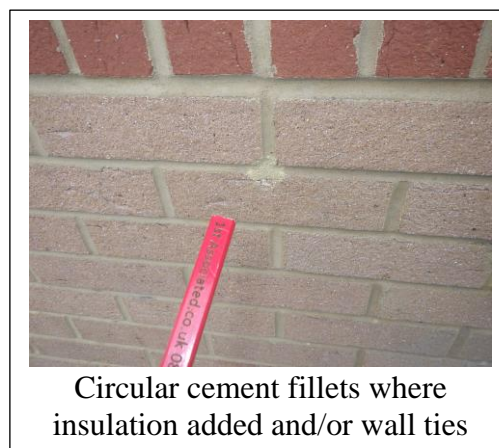
We noted spots to the brickwork which is likely be where insulation has been inserted or there is an outside chance it is wall tie replacement.

What was unusual was that there was no regular pattern of the type we normally come across.

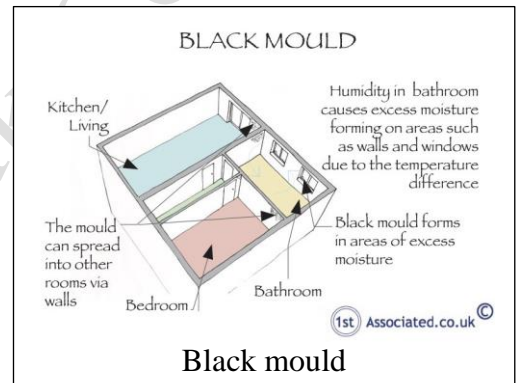
3) As already discussed, there is a lack of humidity extraction in the humidity generating areas of the bathroom and kitchen which leads to humidity travelling around the property picking up dust particles and skin particles and leading to black mould.

You need to be aware that black mould can occur behind furniture.

ACTION REQUIRED: It is best to remove humidity as quickly as possible and we would recommend large good quality humidity controlled extract fans are added to the kitchen, bathrooms, plus any humidity generating areas:

ANTICIPATED COST: We would anticipate costs between £250 - £500 per extract fan, depending upon the wiring required. We always recommend quotes are obtained before you legally commit to purchase the property.

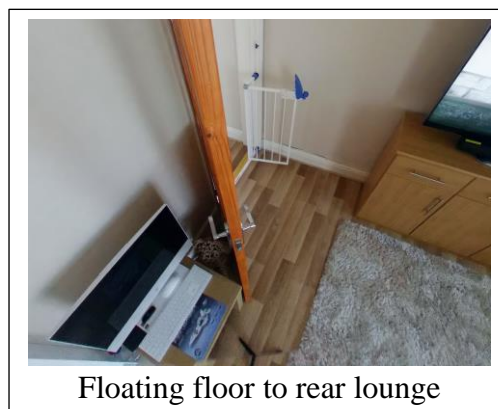
The property has a floating floor. It looks to be a vinyl plank finish, sometimes also known as laminate flooring. It has some soft spots (hollow areas)/bubbling where the floor is lifting from the floor below. This is fairly common with this quality of flooring, particularly in the high use areas. If you recall, we discussed this at the survey.

Floating floor to rear lounge

ACTION REQUIRED: If you want a floor that sits very flat then you will need to replace this flooring with an engineered wood floor or be happy with a

repair. There are various ways of sliding the vinyl panels together (such as using suction pad tools) and then drilling into the laminate and injecting in a flexible material to fill up the soft/hollow spots. This is not as good as replacing the floor but it is cheaper.

ANTICIPATED COST: To repair it we would expect costs in the region of £250 to £1,000 and to replace it expect costs around £2,500 to £5,000 depending upon the type of timber you choose and the quality of engineered floor. Please obtain quotations before legally committing to purchase the property.

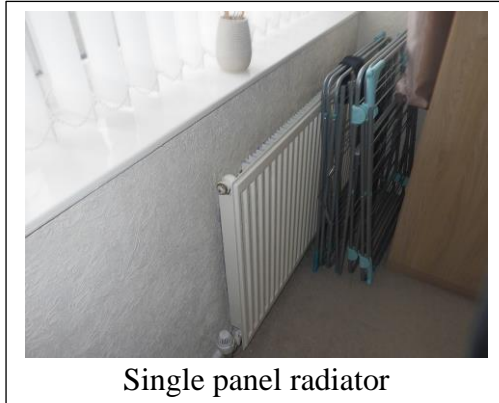
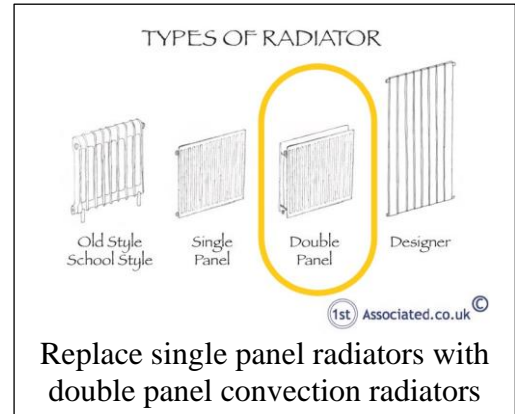
The property has single panel radiators. These may not warm the property to the heat that you desire. We much prefer to see double panel convection radiators.

ACTION REQUIRED: We recommend you upgrade to double panel convection radiators and move the radiators underneath the windows as this gives a better circulation of air and reduces the chance of condensation.

ANTICIPATED COST: In the region of £150 - £300 (one hundred and fifty to three hundred pounds) per modern double panel convection radiator and a few hundred pounds for power flushing.

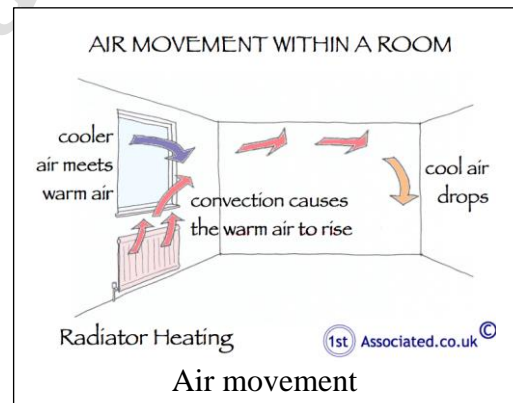
Internal radiators

In addition, we noted the radiators in some areas are internal/not under the windows which is the usual position. This is often carried out on cheaper central heating systems to save the labour and piping costs of positioning the radiators underneath the windows. However, it then reduces the air movement in the room which can lead to black mould.

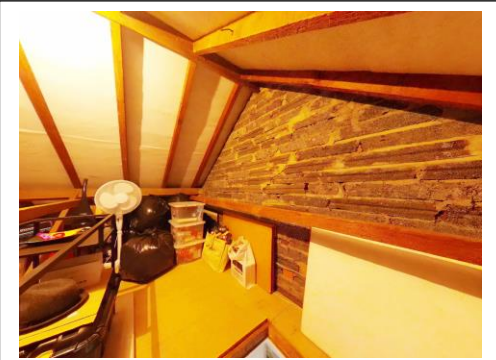
Specifically, in this case it is a blockwork fire wall which looks to have had some repair work.

Fire wall

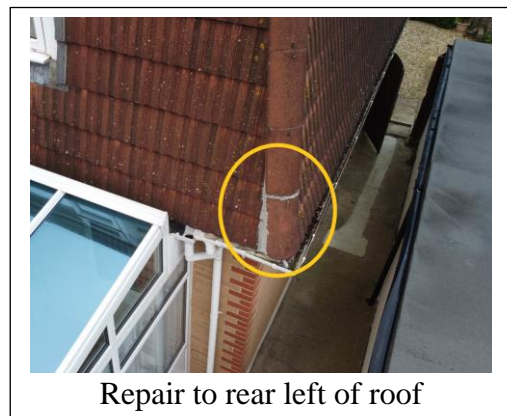
The roof is clad with a concrete tile and, from ground level, this looks in slightly below average condition considering the roofs age, type and style. We noted a repair to the rear left.

Repair to rear left of roof

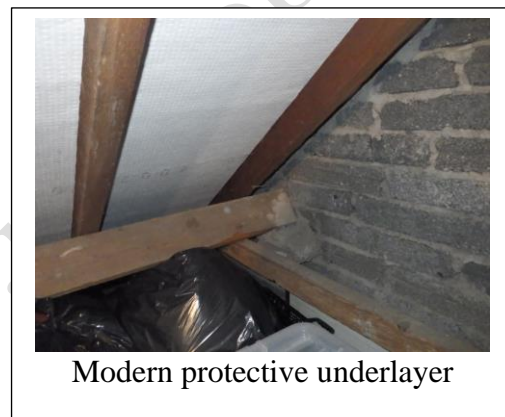
When we inspected the loft space, we found a modern breathable protective underlayer. This type of protective underlayer, as far as we are aware, has been used since 2002 and is meant to allow the roof to breathe and to minimise condensation, which is becoming more prevalent in highly insulated properties. We generally found it to be in average condition with damage in some areas which is what we typically find.

ACTION REQUIRED: It does intrigue us as it would seem the property has been re-roofed. Your legal adviser to specifically ask the existing owner about that.

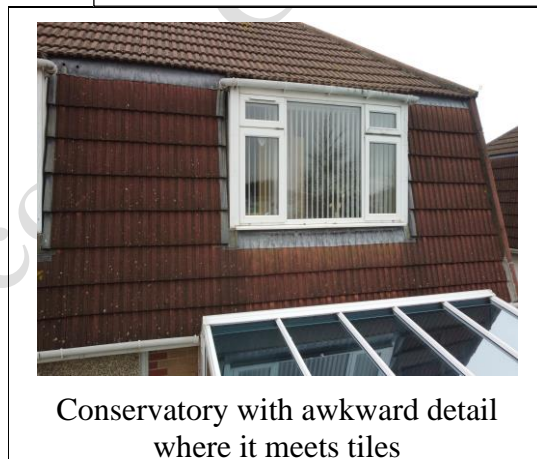
Conservatory with awkward detail where it meets tiles

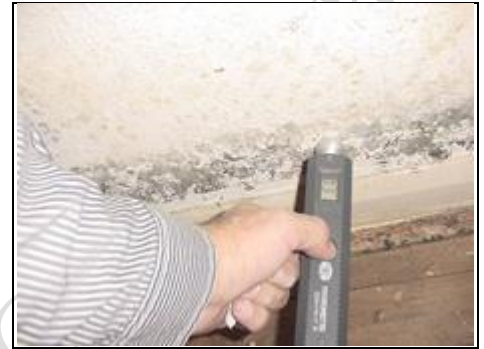
Black mould and high damp meter readings
