# Non Traditional Example Residential Building Survey

## INTRODUCTION

Firstly, may we thank you for your instructions of xxx; we have now undertaken an independent Building Survey (formerly known as a Structural Survey) of the aforementioned property. This Survey was carried out on xxx.

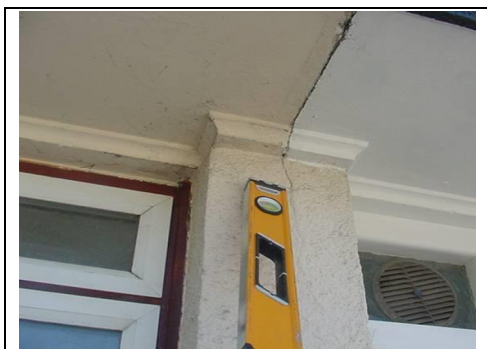
Crack to the front door

Externally there are cracks to the concrete, although we don't consider this to be excessive.

**ACTION REQUIRED:** All external cracks should be sealed as soon as possible to make them watertight and avoid damage and deterioration of the surface and more importantly damage and corrosion to the reinforcement within.

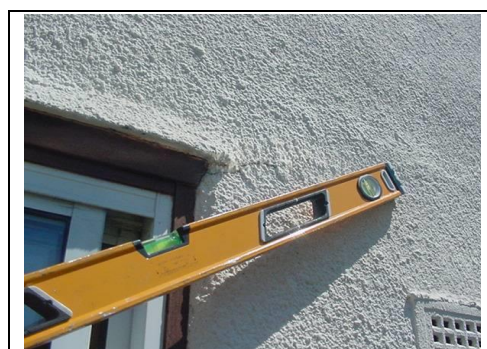
Crack to the rear sliding door

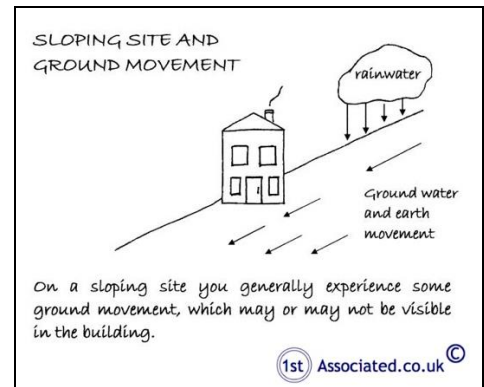
The rear garden slopes and therefore all water will travel towards your back door. We would recommend that you watch the rear of the property next time it rains heavily to see how much rain is getting through to the back end of the property. If there is a fair amount of rainwater then we would recommend a French drain is added (as sketch overleaf). We noted there is already a drain in this section but it does not seem to be running towards the patio. There are potential problems with the patio.

Sloping site

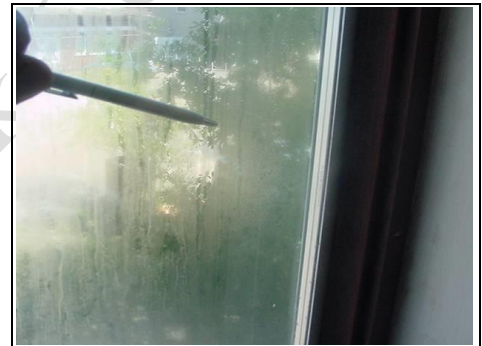
Misting over to front double glazed window

**ACTION REQUIRED:** Replace with a modern window with a trickle vent.

**ANTICIPATED COST:** In the region of £700 - £1,500 depending upon the quality of windows being used; please obtain quotations.

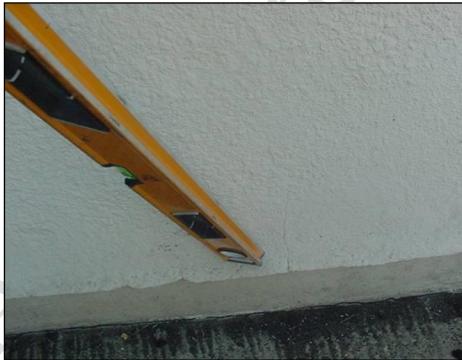
We noted that there are undulations in the driveway and also a crack just to the front of the property and several cracks throughout it.

Vertical cracks indicating possible subsidence

We also noted a gap in the concrete in the front of the property and vertical cracks which we believe indicate subsidence. We note that no underpinning has been carried out on the property or similar. We spoke to both neighbours and they did not recall anything but we do not know how long they have been in their properties.

**ACTION REQUIRED:** We recommend that your legal advisor asks the existing owners to place an insurance claim advising of the cracks within the property and that you legally take over this insurance claim. This should be at a zero cost to the present owners and it should limit any future possible cost to the premium with regard to subsidence in the property. Unfortunately from one off inspections such as this it is impossible to confirm whether this movement is progressive from the lines that we have seen.

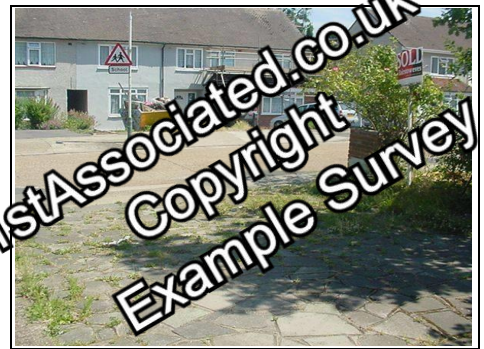
Front driveway

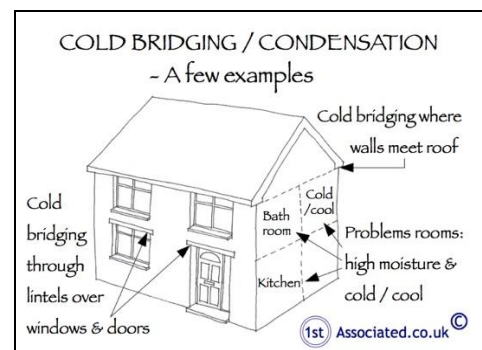
This property is far more likely to have thermal/cold bridging problems than a traditional property. There are various things you can do to help to reduce the change of condensation, however the characteristic of a concrete property means you are likely to get condensation.

Cold bridging

**ACTION REQUIRED:** We would recommend the addition of large humidity controlled extract fans in the bathroom and the kitchen and any rooms that you use for drying. However condensation is a characteristic of a concrete property.

**ANTICIPATED COST:** In the region of £100 to £150 per extract fan.

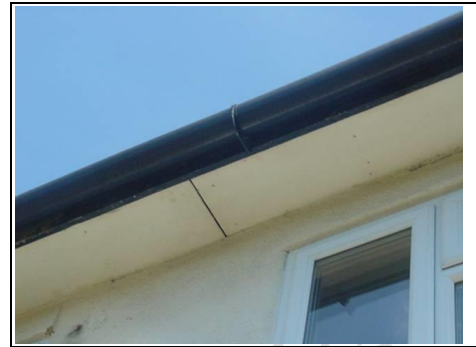
Asbestos soffit

Our insurance company requires us to advise we are not asbestos surveyors and recommend you have your own asbestos survey.

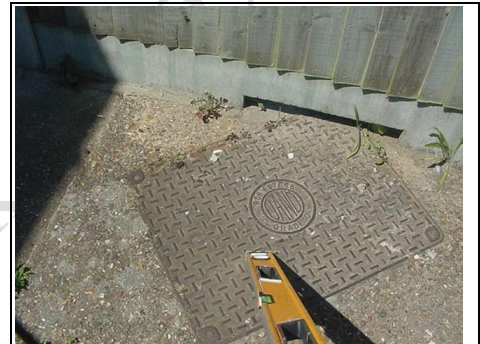
We could not lift the manhole we always recommend a closed circuit TV camera report. Manholes are used where there is a change in direction of pipes or new pipes join the main run. It is therefore a good location for clearing any blockages.

Manhole double sealed to front  
of property that we could not  
unscrew

**ACTION REQUIRED:** We would recommend a closed circuit TV camera report of the drains.

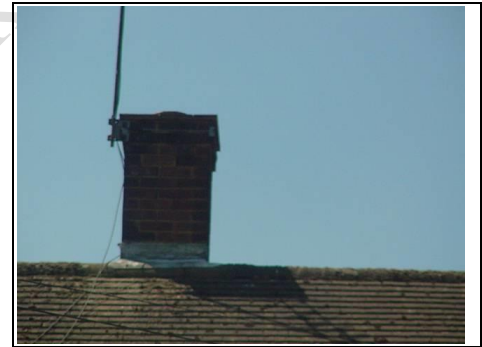
This chimney is brick finished with a lead flashing. From what we could see from ground level the pointing looked to be weathered and in below average condition considering its age, type and style with repointing required in due course.

We noted that there are aerials on this chimney which can cause damage and cut into it like a cheese wire into cheese.

Chimney

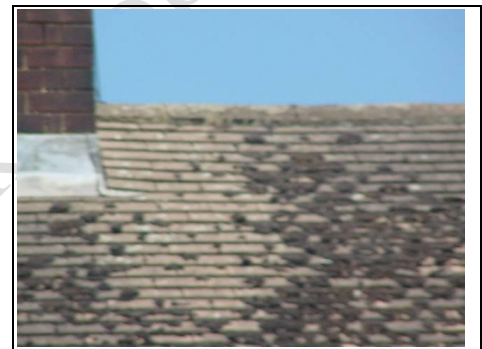
The main roof is pitched and clad in a concrete tile. From ground level, this looks in average condition considering the roofs age type and style. As with many concrete tiles there is a layer of moss. This can if it gets excessive block the gutters.

Main roof

**ACTION REQUIRED:** Clear gutters of any loose moss using a soft brush and carry out periodic inspections and maintenance of the roof, as required.

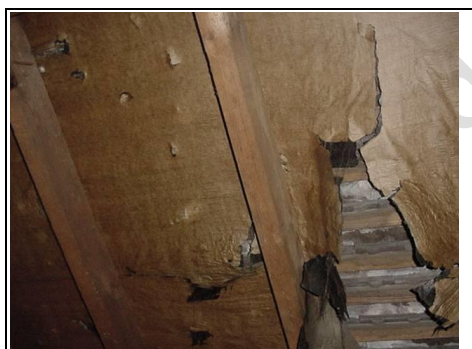
When we inspected the loft space we found one of the older types of sarking felt that is made out of a bitumen-backed paper. This type of sarking felt was first used in the 1940s until the 1950s. We found it in poor condition even considering its age.

Older style building paper in roof

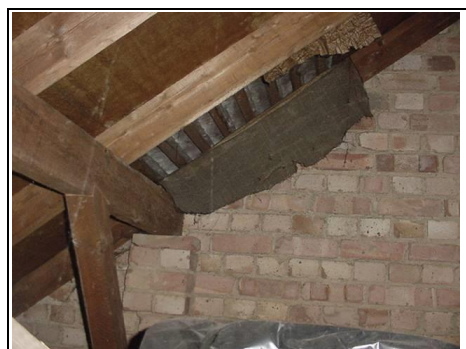
Building paper coming away exposing back of tiles

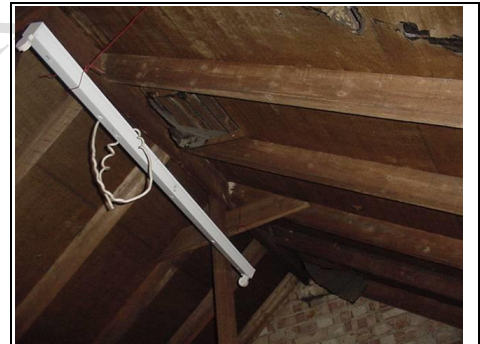
The main roof is accessed via the loft hatch located on the landing. There was an electric light but it was not working. There is no loft ladder, working light or secured floorboards. We recommend that these be added, as it will make the loft space safer and easier to use. Please see our comments in the Executive Summary with regard to secured floorboards.

Light not working

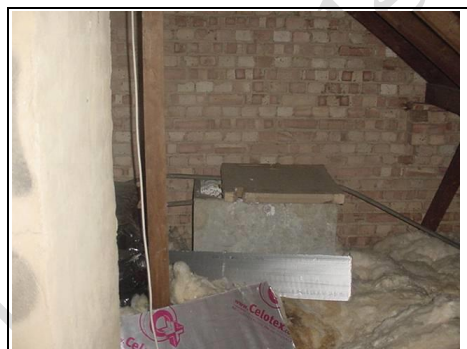
Old cast iron water tank still in roof

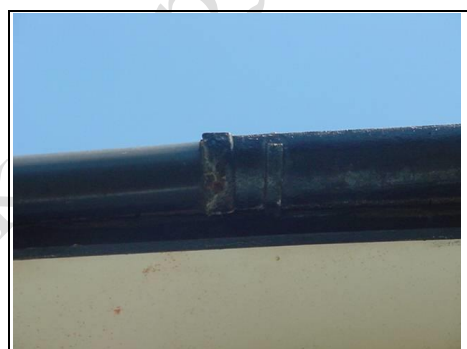
Your gutters and downpipes are in average condition for their age, type and style. The problem is where the plastic gutter meets the cast iron gutter next door, which in our experience never works.

Problem where plastic meets cast iron

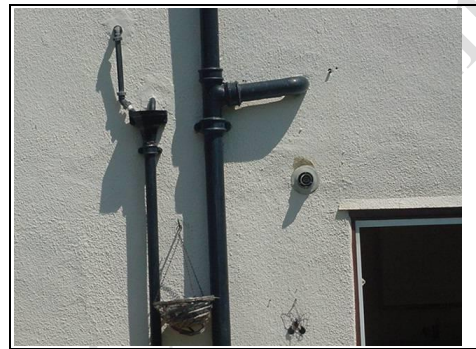
The property has cast iron soil and vent pipes. Cast iron of this age will need regular maintenance if not it will rust like next door's gutters.

Cast iron soil and vent pipe

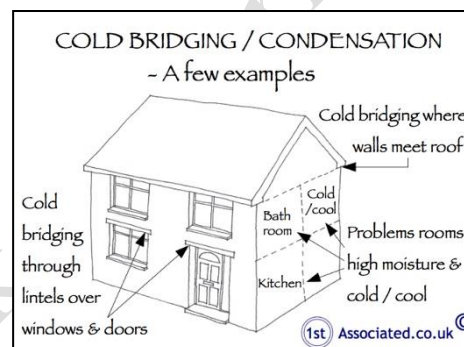
Cold bridging is caused by a colder element in the structure allowing coldness to pass through the structure much quicker when warm moist air is present in the property, often caused by things like having a shower or a bath, cooking or washing, particularly if you are drying washing on the radiators. This is also caused by the general climate which results in condensation on the element.

Cold bridging / thermal bridging

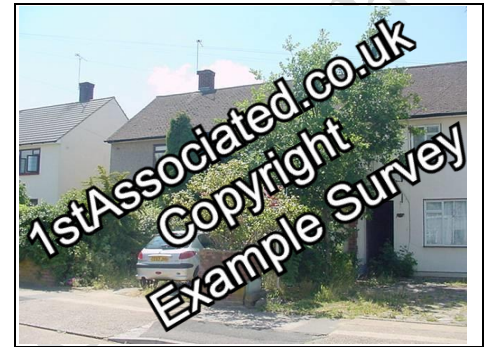
There is a tree in the front garden that would benefit from maintenance. You may also have to advise your insurance company of it.

Tree in front garden

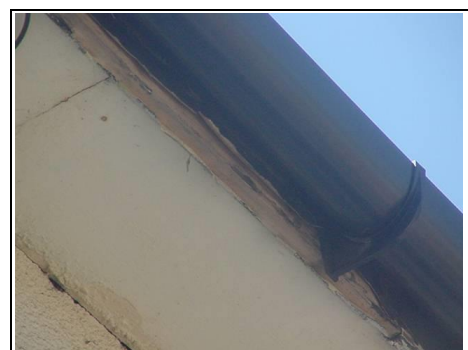
Flaking paint

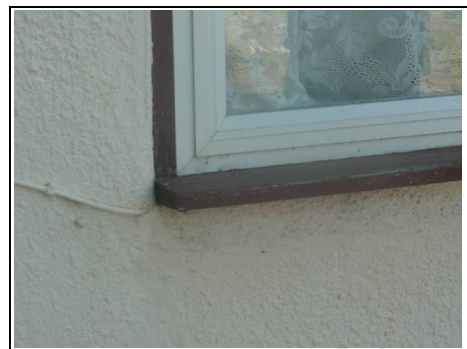
Front windows are older style plastic into timber with no trickle vents

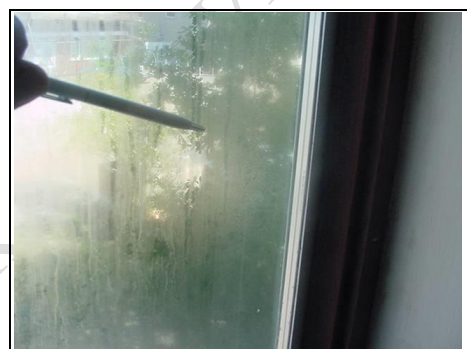
We would draw your attention to the fact that sealed double glazed units can fail, particularly as a result of poor workmanship during installation. Failure of the seal leads to condensation between the two panes of glass and simply replacing the affected units may not provide a satisfactory long-term solution. In this case misting could be seen to the front windows.

Misting over to front double glazed window

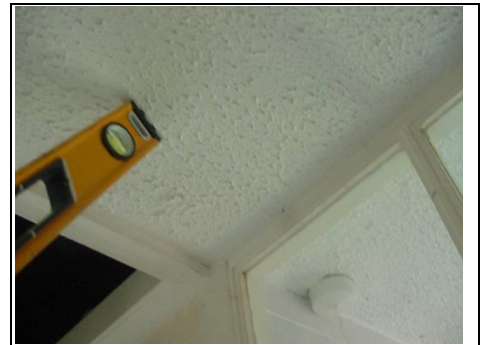
There is textured paint throughout the property which was very popular in the 1970's. It was also popular in the 1960's but tended to have an element of asbestos. Whilst the majority of artex within the property looks like a 1960's style, the artex at the bottom of the stairs does look to be painted over.

Artex/textured paint to ceiling

**ACTION REQUIRED:** We would recommend a skim-coat of plaster to all the artex. Whatever you do, do not rub it down; have a coat applied over the top of it and then redecoration. This should limit even the slightest chance of any problems.

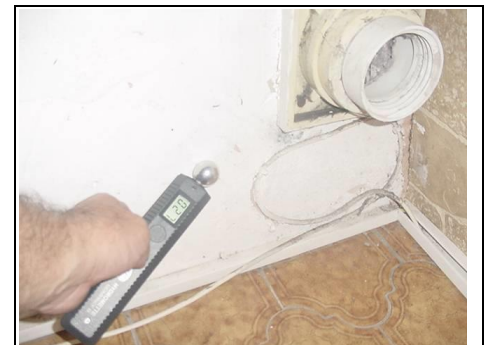
A visual inspection and tests with a moisture meter have been taken to the perimeter walls. In this particular case we have found no significant rising damp. We did find some minor rising damp to the rear of the property.

Testing for rising damp

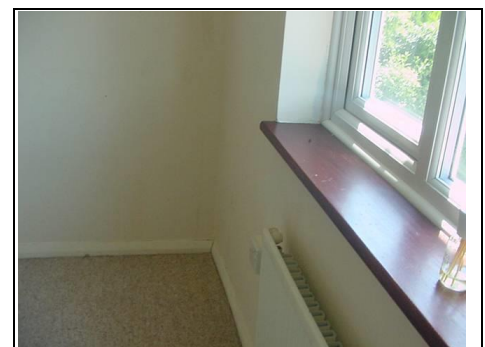
We noted that there are a fair number of single panel radiators. These may not warm the property to the heat that you desire. In most modern installations double panel radiators are used and often double panel convection radiators, which are more efficient, are utilised.

Single panel radiator

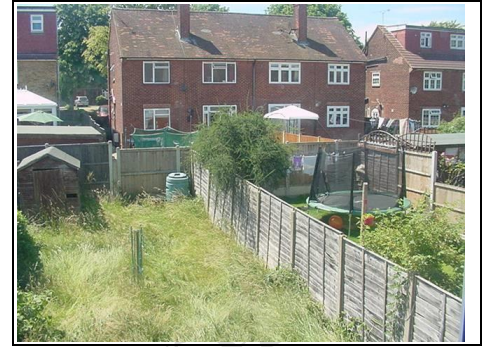
Fence needs staining
