RESIDENTIAL BUILDING SURVEY

Non-evasive inspection

XXX
Corby,
Northants
NN17 XXX

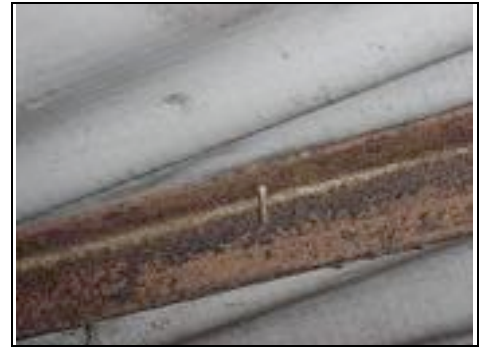
Example of what we would term as excessive rusting on another property

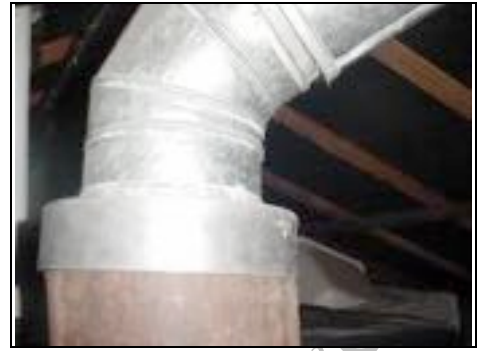
Flue possibly asbestos

ACTION REQUIRED: Your solicitor needs to make a formal written request to the Council for confirmation that all asbestos has been removed. If a survey report is not available from the Council the only way to be a hundred per cent certain with regards to Asbestos in a property is to have an Asbestos report with samples taken and the recommended action carried out.

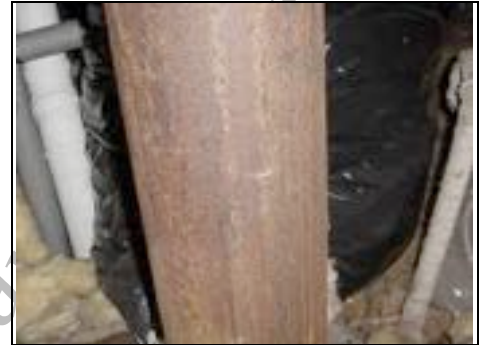
Flue

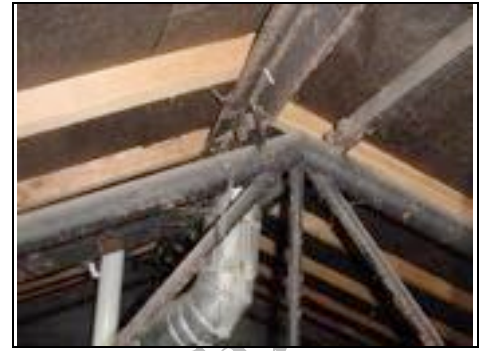
We have examined the steel tubular framework that forms the roof structure truss and found it to be in average condition for this age, type and style of property. We could see and feel that it had rust which is patchy. None of the areas we inspected we would term as structurally affecting the property at present.

Tubular roof system and timber batons

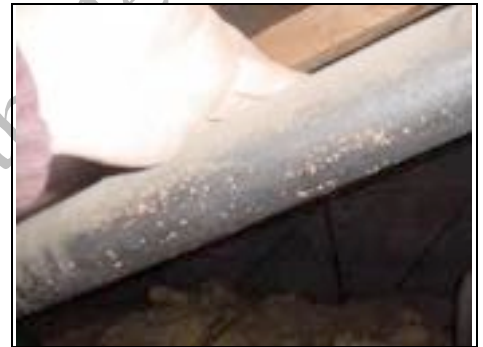
We feel that the over insulation of the roof and the lack of ventilation to the roof has helped cause the situation where condensation is being caused within the roof.

Checking for rust

ACTION REQUIRED: We would recommend that the existing insulation is all removed and new insulation is put in the roof to current standards of 300mm (you currently have in excess of this in many areas).

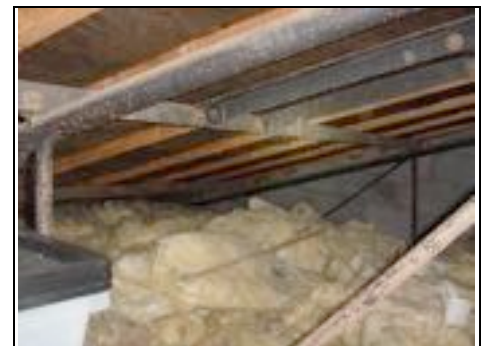
Mass of insulation

ACTION REQUIRED: We recommend that the fascias and soffits are removed or repaired and add vented soffits.

Note; the fascias and soffits may be asbestos. We would recommend an asbestos survey is carried out and that you review the asbestos survey first before carrying out such work.

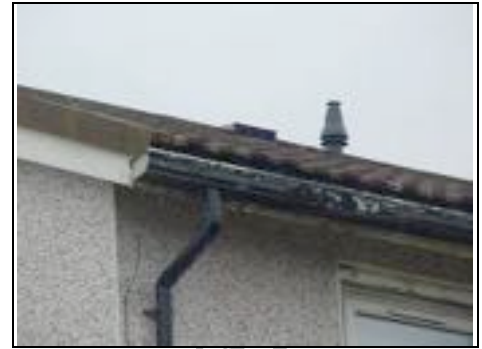
From what we could see the gutters and downpipes looked in reasonable condition however you can never be too careful on this type of property.

Gutters and downpipes

ACTION REQUIRED: We would recommend that the gutters and downpipes are checked and cleared of any debris and also inspect to ensure that the joints to the gutters and downpipes are not leaking and that they fall towards the downpipes and are watertight.

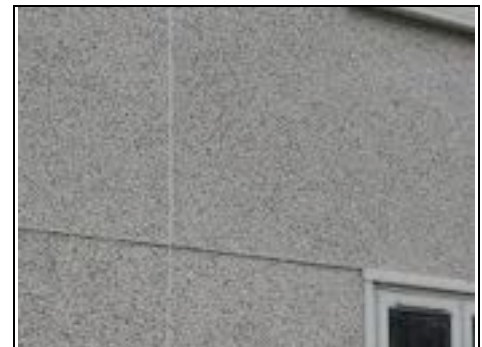
The walls have a pebbledash overcladding finish. We have inspected the walls and found no significant areas of cracking. We specifically looked at:

Movement joints within the panel construction that have been added

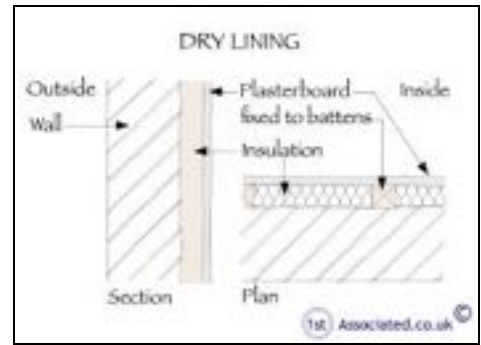
We noted cracking between the wall and ceiling structure and to the perimeter wall which is dry lined to the front right hand bedroom. This, we believe, may relate to differential movement and thermal expansion caused by the relatively poor air movement in the property.

Dry lining

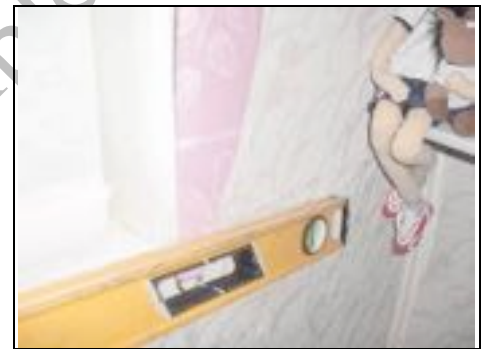
Crack in boarding

ACTION REQUIRED: Improve moisture removal and air movement in the property and add large humidity controlled extract fans venting to outside air in the bathroom and kitchen. In the kitchen we appreciate you have had a newly installed extract fan, this is a modern smaller variety and is not, from what we can see, automatic or moisture controlled.

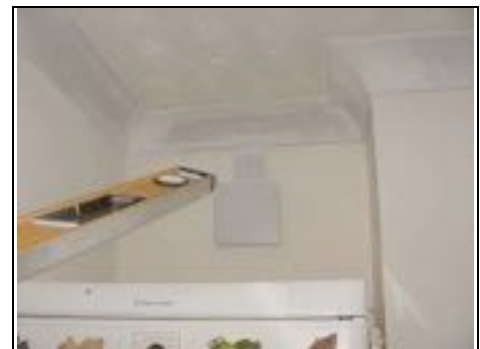
Extract in kitchen

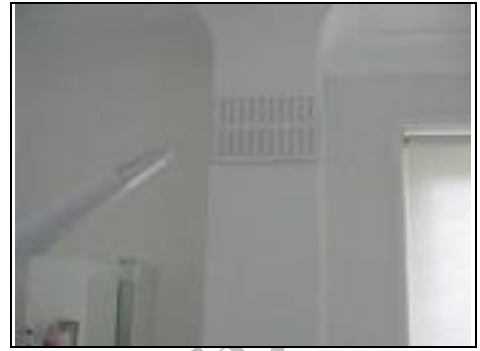
As the property currently stands there is a likelihood of condensation in this type of property. Surface condensation is the type of condensation that we can see which relates to things such as steaming up of the mirror in the bathroom but it is the interstitial condensation that needs to be reduced. This is why we would recommend large humidity controlled extract fans are added.

Vent in bathroom

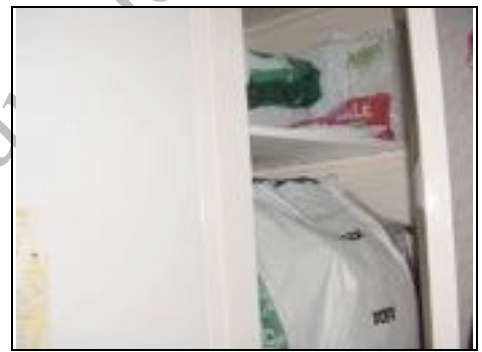
No visible signs of black mould within unventilated cupboard

ACTION REQUIRED: Add large humidity controlled extract fans to the kitchen, bathroom and humidity creating areas.

ANTICIPATED COST: We would anticipate costs between £150 - £250 per extract fan depending upon the wiring required. Please obtain quotations.

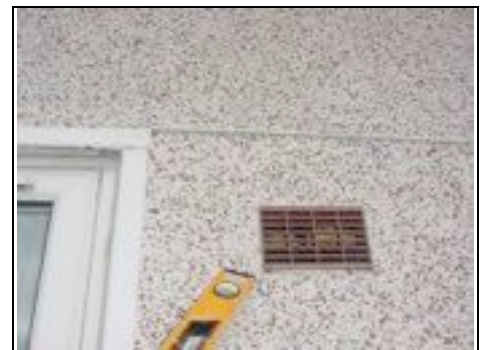
We also note there are high level vents in some of the rooms. If the large humidity controlled extract fans do not successfully remove the moisture then we would recommend these are opened up.

Old vents to rooms that are now blocked

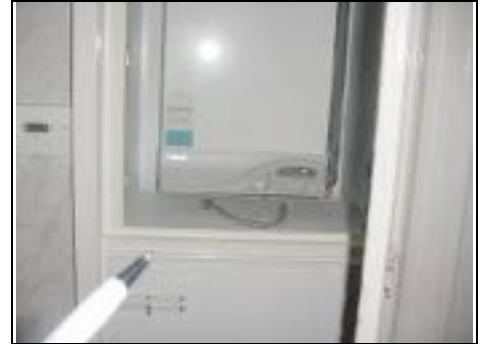
Boiler in front right bedroom

ACTION REQUIRED: We would look at relocating this to the kitchen area or possibly into the roof although we would prefer the kitchen area as the boiler could help cause condensation if it is positioned in the roof.

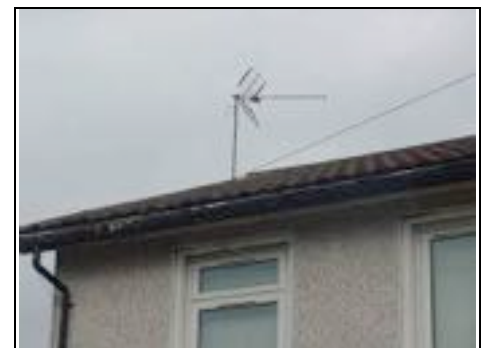
Roof difficult to view but we are advised they have been replaced by the council

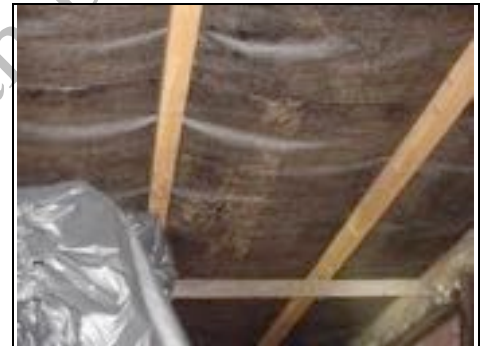
When we inspected the loft space we found a Hessian base Bitumen membrane. This type of membrane has been used since the 1960s. We generally found it to be in average condition, with damage in some areas which is what we typically find.

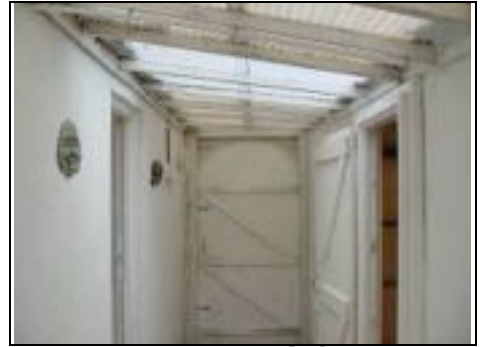
The lean-to has a polycarbonate roof. Generally we find that these leak. As you live in the property you are probably more aware of this than we are from a one off inspection. We would also say that they can also get condensation where you have such things as washing machines and kitchens nearby.

Lean to

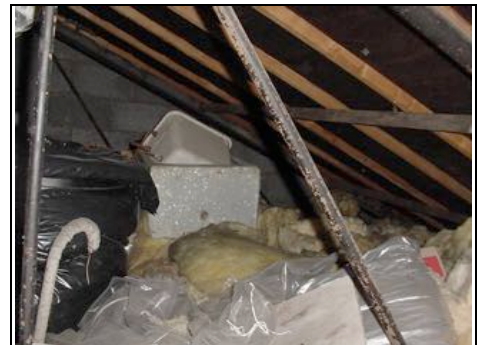
Plastic water tank

We would always recommend that water tanks be drained down and cleared of any debris etc. (we have seen dead birds and other unmentionable things in these tanks). As you are often cleaning your teeth with this water it is best that it is as clean as possible!

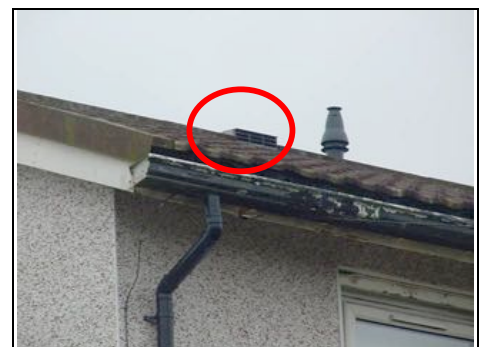
Vent to roof

We would recommend the roof is vented by the adding of additional roof vents and a vented soffit board (when the fascias and soffits are replaced).

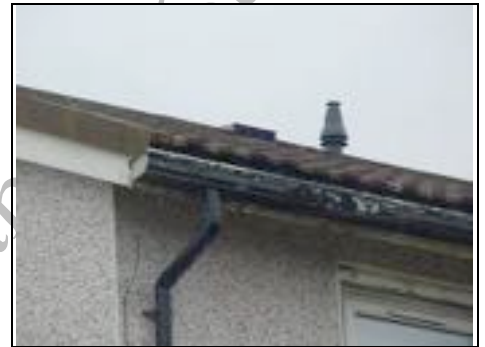
There may be some minor leaks but most people would be happy to live with these providing repairs are carried out within the next six to twelve months.

Metal gutter and plastic downpipe

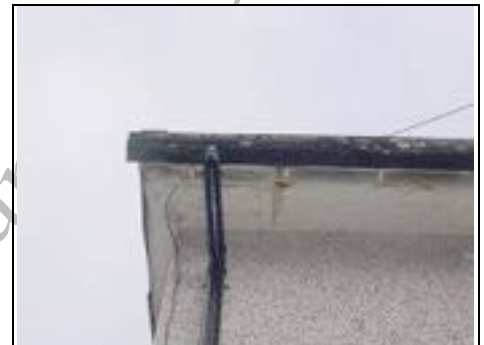
Fascias and soffits unvented

ACTION REQUIRED: We would recommend that the fascias and soffits are removed and replaced with vented fascias and soffits. Note the fascias and soffits could be asbestos so you do need to carry out an asbestos survey first.

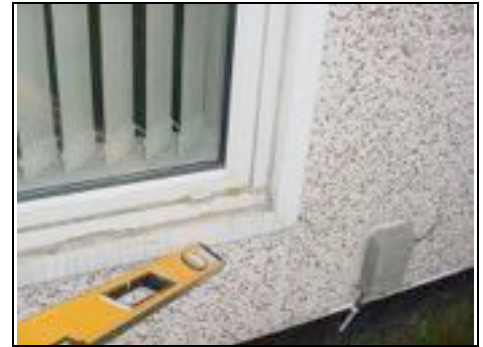
The property has plastic double glazed windows set within a frame, which forms a drip detail. There are no sills to some of the windows therefore pattern staining can occur around the windows without sills.

No sill to front window

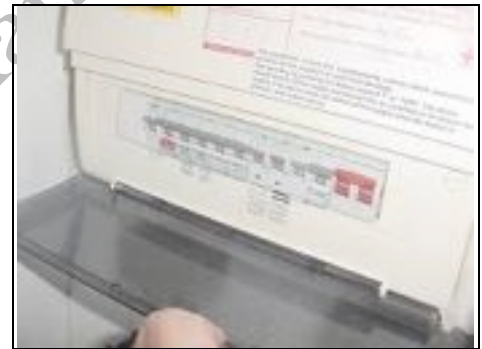
The electric fuses and consumer units were located under the stairs. We are advised that the property was re-wired around 2010/2011. We are always concerned when we are advised a property has been re-wired as often they are not re-wired, but only the fuse board and the socket points replaced.

Fuse Board

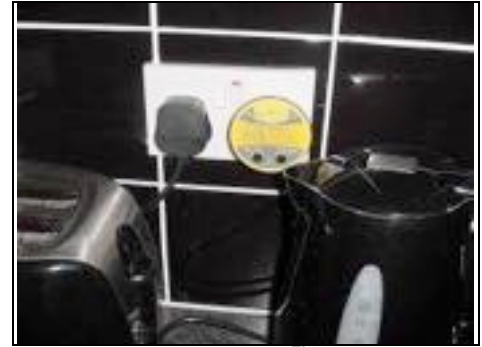
We carried out an earth test in the kitchen area to the socket point that is normally used for the kettle, this proved satisfactory.

Earth test

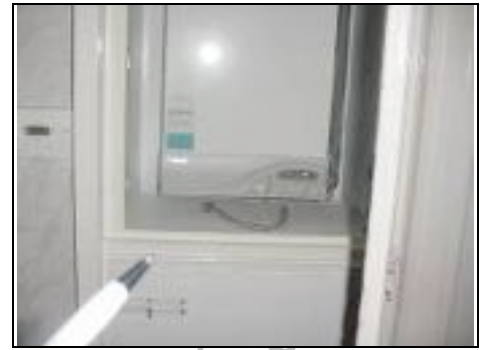
Our limited inspection of the hot water and central heating system revealed no evidence to suggest any serious defects but we would nevertheless recommend that the system be tested and overhauled before exchange of contracts and that a regular maintenance contract be placed with an approved heating engineer.

Boiler in front right bedroom

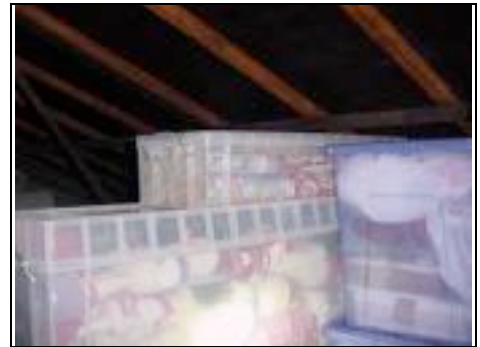
Stored items in roof
