# Non Traditional Example Residential Building Survey

NON TRADITIONAL CONSTRUCTION STRUCTURAL FRAME HOUSE

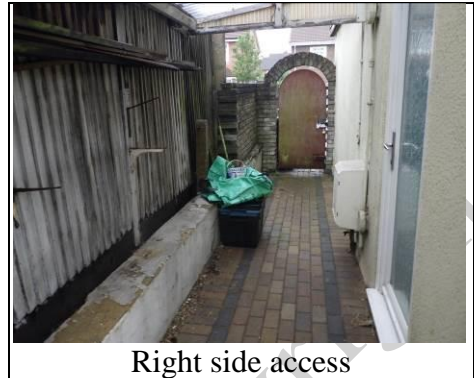
Right side access

The front garden is given over for parking. There is an access from the front of the property to the rear on the right hand side, which is partially/poorly covered (generally in a dilapidated condition – see our later comments).

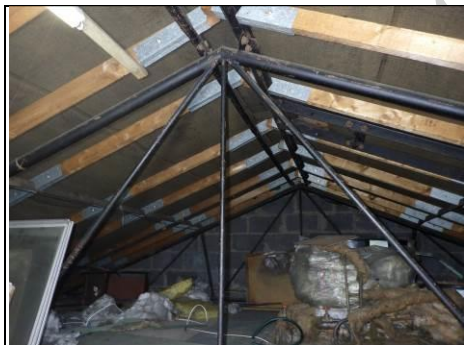
Where we can see the metal frame structure is within the roof. This has rusted slightly above average which we think is probably due in part to the humidity in the kitchen and bathroom rising.

Tubular metal structure in roof

Ideally, the metal work in the roof space needs to be rubbed back, prepared, repaired and redecorated with a red oxide paint or equivalent rust stopping paint. This needs to be carried out during the cooler/winter months of the year.

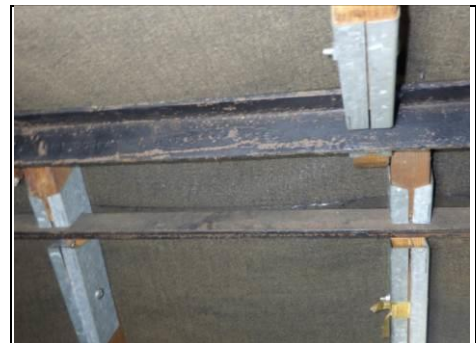
Rusting to some of the angle irons

**ACTION REQUIRED:** Reduce the humidity and condensation in the property by adding large good quality humidity controlled extract fans to reduce the humidity (see our later comments).

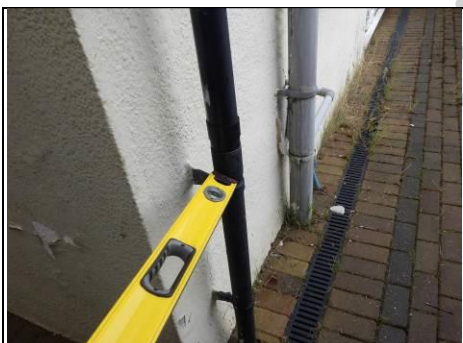
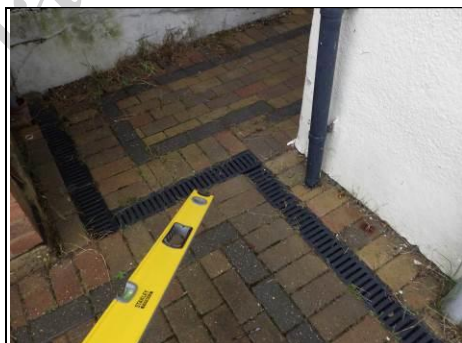
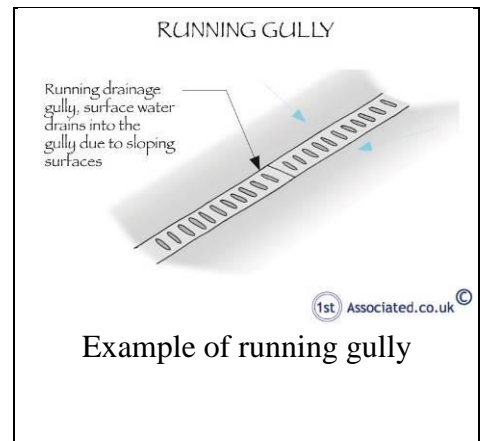
Unfortunately, as this is a metal frame building it can cause damage and deterioration to the metal frame of the structure, particularly as the concrete raft acts as blotting paper, drawing dampness in.

There is already a running gully to the rear of the property. Whilst these running gullies are better than not having anything, however by their very nature they tend to be quite shallow and can block easily.

**ACTION REQUIRED:** Due to this building being on a sloping site and water likely to be causing problems to the rear, we recommend opening up the walls to one metre squared in three areas to see the condition of the metal frame. In this particular case at least one of the areas, depending upon what was found, would be to the rear of the property. The benefits of opening up the structure is several reasons:

If this is not possible then you have to assume a worst case scenario and although you have running gullies to the rear of the property we would in addition put preventative measures in place by adding a land drain or a French drain, with a perforated pipe that discharges into a soak-away or one of the two manholes to the rear (subject to permission).

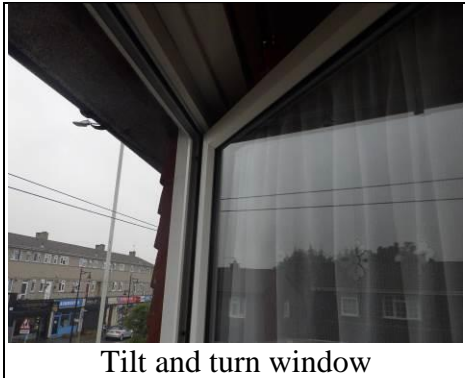
Tilt and turn window

The windows do not have any trickle vents which will add to the humidity in the property.

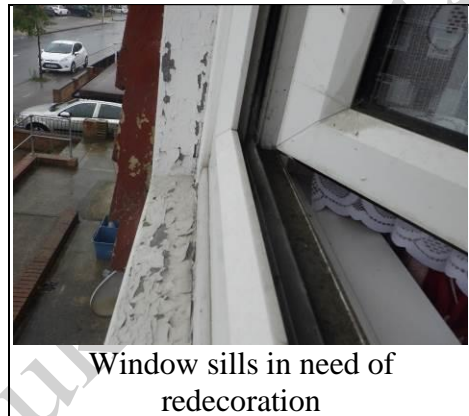
Window sills in need of redecoration

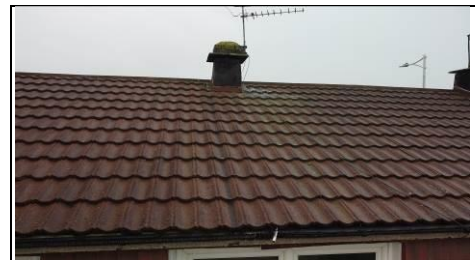
As mentioned originally the roof would have been formed with asbestos, we can now see it has been replaced with a pressed metal roof.

Pressed metal roof  
Aerial view

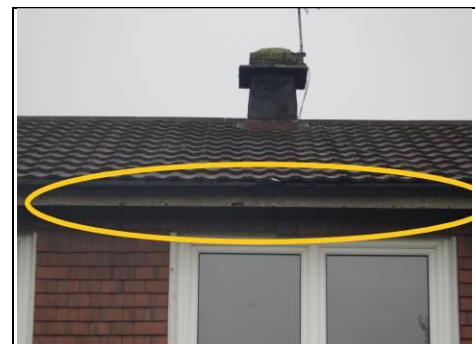
Often other elements were formed in asbestos, such as the fascias and soffits and the vents. We are not certain; this needs to be investigated and other areas.

Fascias and soffits

**ACTION REQUIRED:** We recommend you have an Asbestos Report confirming if there is any asbestos in the property remaining. This will also be valuable when you come to sell the property in the future as of course it will ensure you do not have any health risks from asbestos.

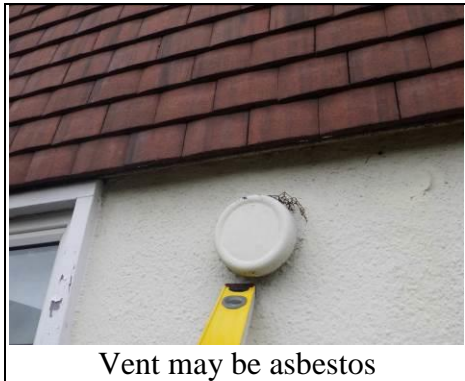
Vent may be asbestos

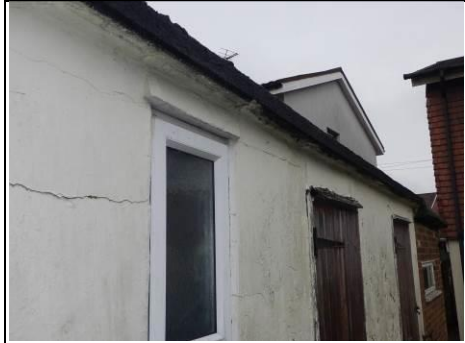
Most of the outbuildings structures are formed with reinforced concrete. To the roof of these the tar has weathered which will lead to water getting into the concrete roofs and concrete wall structures, which in turn can lead to the reinforcement within them deteriorating, causing the concrete to spall, flake and deteriorate.

Cracking to outbuilding walls

**ACTION REQUIRED:** We believe the roofs will need re-tarring. Then the building as a whole will need redecorating.

**ANTICIPATED COST:** In the region of £250 - £500 for re-tarring the concrete roof, not including any concrete repairs. To redecorate the outbuildings £250 - £500 and fill the cracks with a suitable mastic; please obtain quotations before you legally commit to purchase the property.

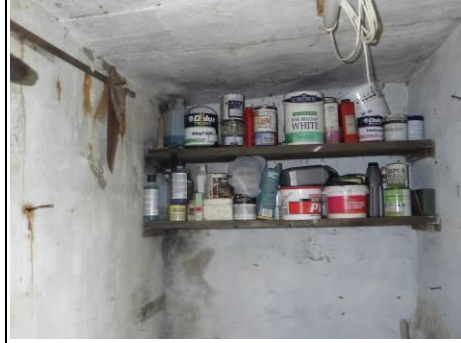
Dampness internally

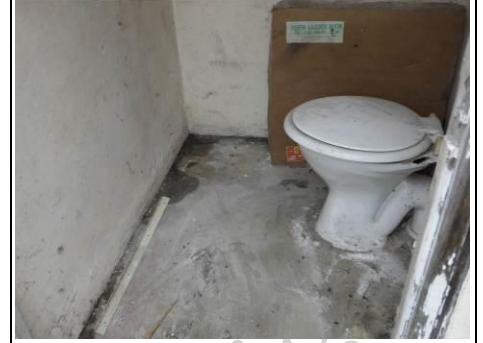
Dampness around toilet

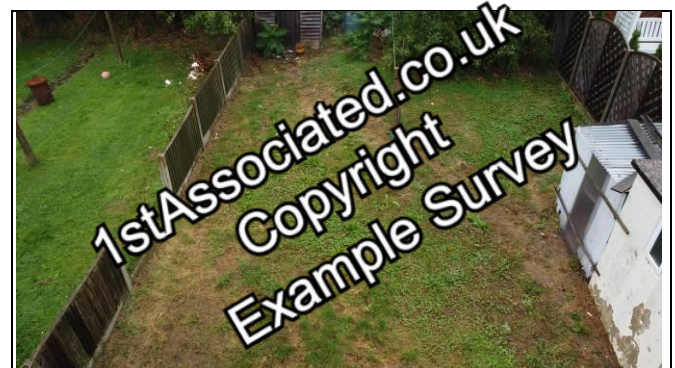
Rear garden with missing fence panel to left side  
~ Aerial View ~

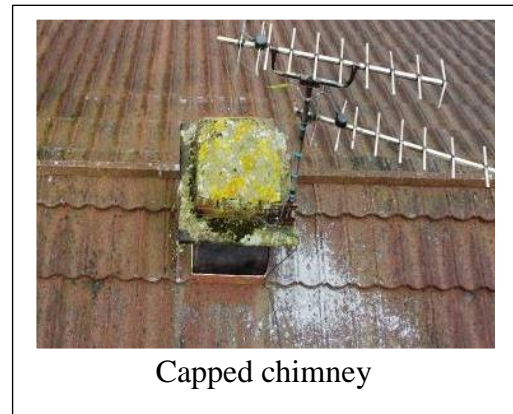
This chimney is metal, finished with a metal flashing and has been capped. From what we could see from ground level it is covered in moss and looked in slightly below average condition considering its age, type and style.

We noted an aerial attached to the chimney which we are not keen on as it can destabilise the chimney.

Capped chimney

**ACTION REQUIRED:** Periodic inspection. We think there may be some dampness that will get down around the chimney. You need to go into the roof and check from time to time.

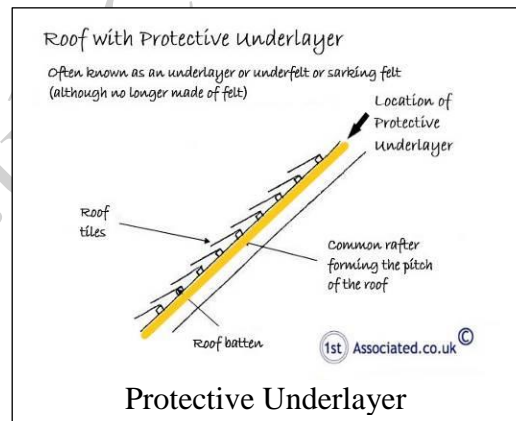
When we inspected the loft space, we found a Hessian based bitumen membrane. This type of membrane has been used since the 1960s. We generally found it to be in average condition with damage in some areas which is what we typically find.

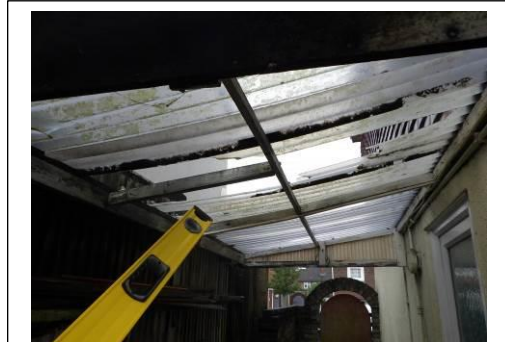
This roof to the right hand side is corrugated plastic. We would comment it is in a below average/dilapidated condition.

Deteriorating corrugated plastic roof to right side

**ACTION REQUIRED:** Please see our comments in the Executive Summary.

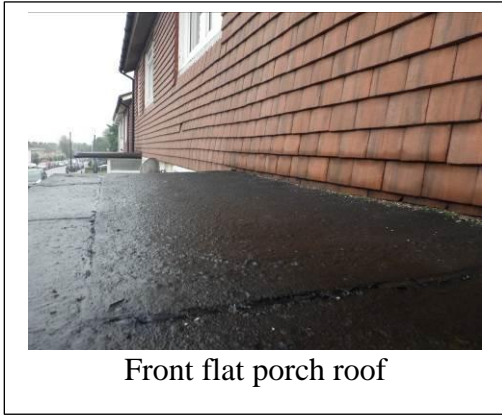
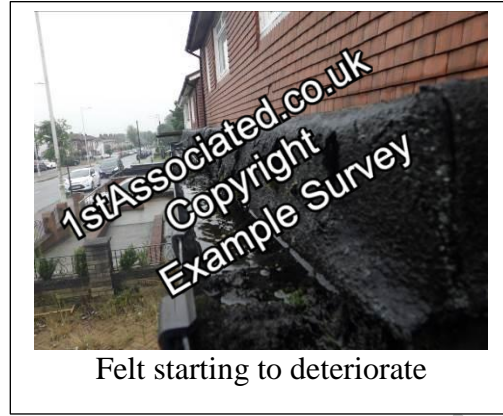
The flat roof is located to the front right and is covered with mineral felt. We would comment it is in below average condition for its age, type and style, with the felt starting to deteriorate.

**ACTION REQUIRED:** We recommend replacing with a good quality felt. We would always recommend that lead flashings are used.

**ANTICIPATED COST:** A few hundred pounds to £500. Please obtain quotations before you legally commit to purchase the property.

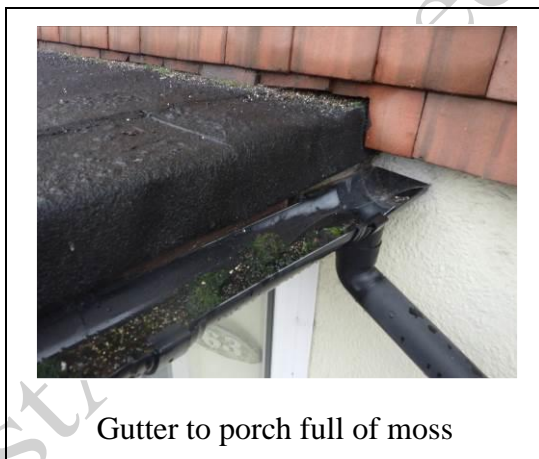
Gutter to porch full of moss

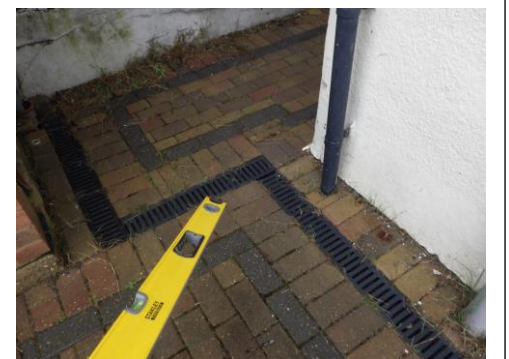
The downpipes feed directly into the ground so if there is a blockage then the drain would have to be opened up. This is a practice we are not particularly keen on; we would much prefer a gully.

Front right downpipe feeds directly into ground

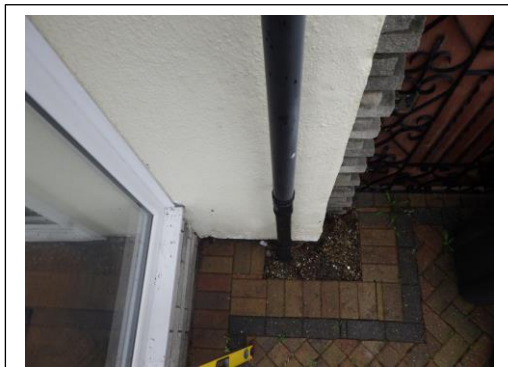
Rear right downpipe feeds directly into ground

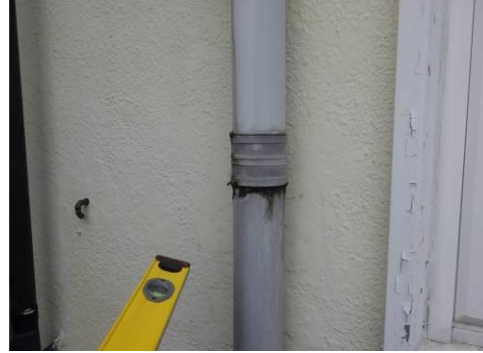
Soil and vent pipe leaking slightly

**ACTION REQUIRED:** Add some form of protection between the flue and the soil and vent pipe to stop it damaging it. We also noted the soil and vent pipe was various different colours of plastic. It may be that it is an older style plastic which does get affected by sunlight. You need to monitor/check the soil and vent pipe from time to time.

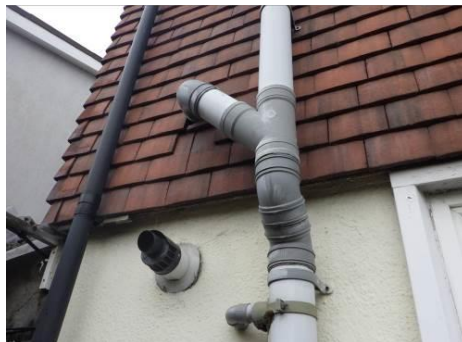
Soil and vent pipe close to flue

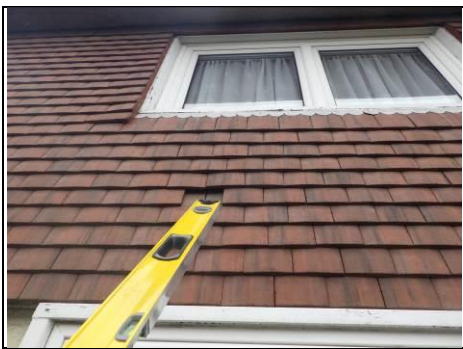
It is generally in average condition, but we did note a missing tile or two to the front.

Missing tile to front

**ACTION REQUIRED:** Replace missing tiles.

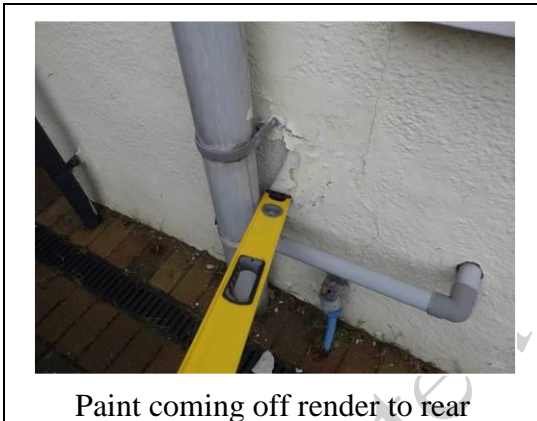
We have carried out a tap test (literally hitting the render with the back of a hammer). We found it to be in below average condition for its age, type and style, with deterioration and paint peeling.

Paint coming off render to rear

**ACTION REQUIRED:** We recommend you repair, prepare and redecorate in the summer/warmer months of 20XX.

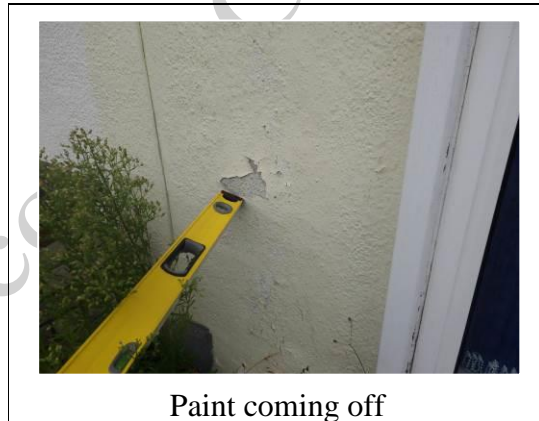
Paint coming off

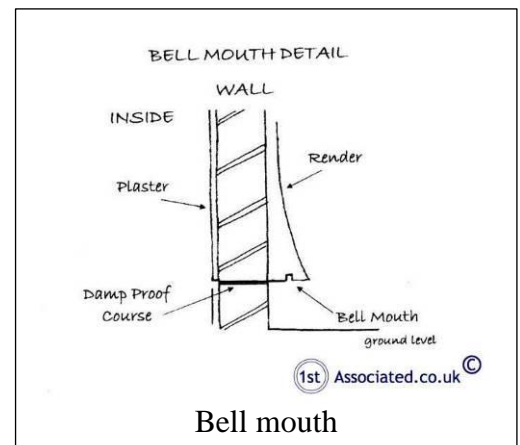
To the base of the render there was a small drip detail however we would prefer a larger drip detail.

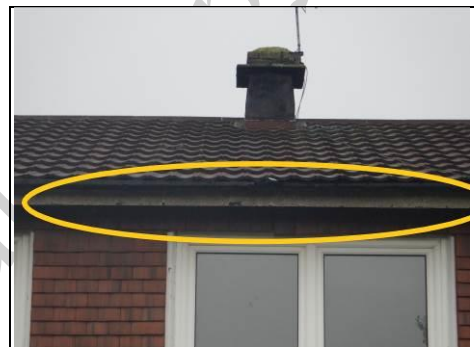
We believe the fascias and soffits may be asbestos.

Fascias and soffits

**ACTION REQUIRED:** We would always recommend any asbestos is removed from a property as it can not only be dangerous, it can affect the value of the property.

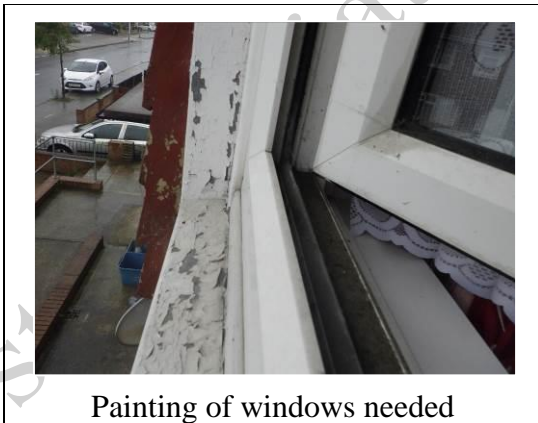
The property has double glazed tilt and turn windows in a metal frame without trickle vents. The windows are in below average condition, with redecoration of the metal surrounds required.

Painting of windows needed

**ACTION REQUIRED:** Redecorate. We recommend you add trickle vents.

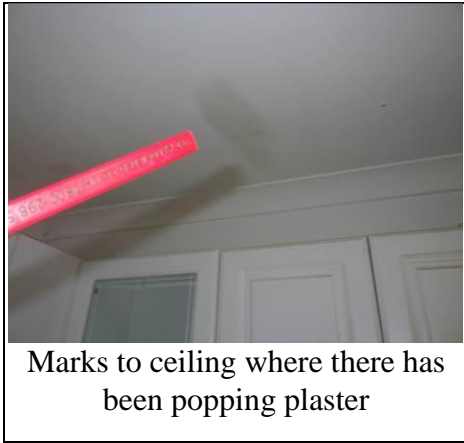
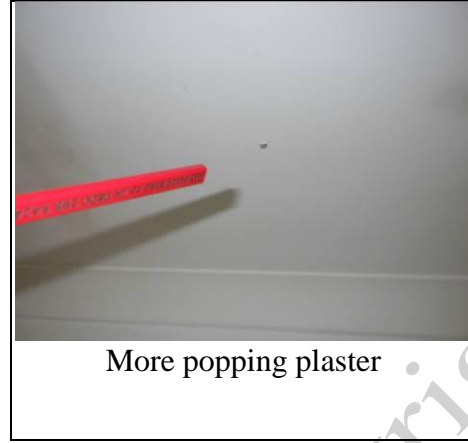
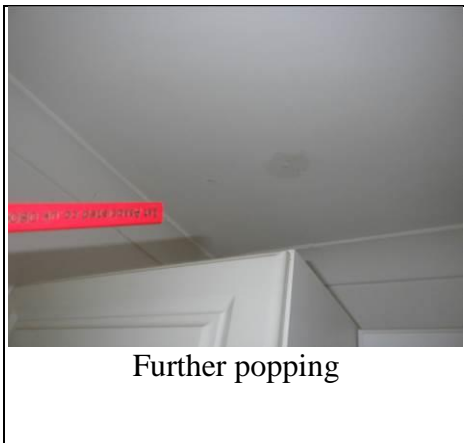
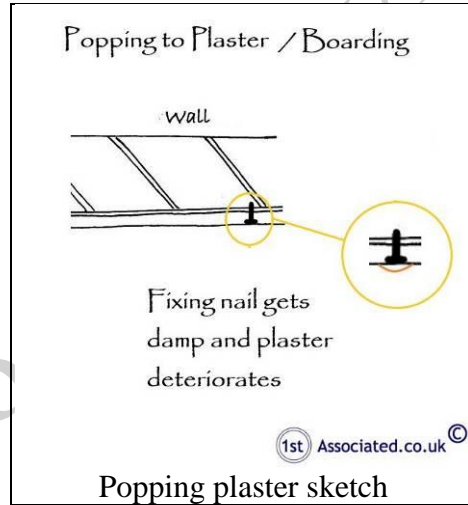
We noted popping of the plaster to several of the ceilings, for example the kitchen area. As we discussed, it could have been from water getting through from the bathroom above however it could also be from condensation and humidity.

**ACTION REQUIRED:** Please see our comments in the Executive Summary.

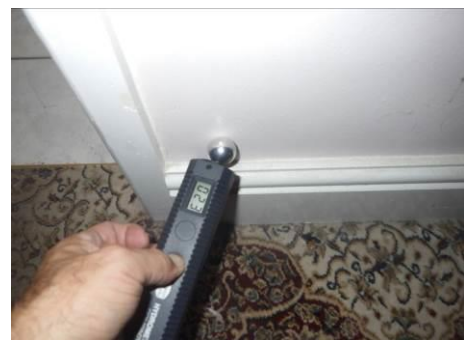
A random visual inspection and tests with a moisture meter have been taken to the perimeter walls. In this particular case, we were unable to obtain readings due to the dry lining.

Low rising damp readings due to dry lined walls

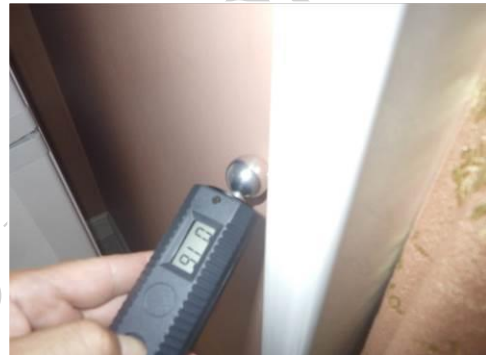
We used a resistance meter on the external walls. In this case, we were unable to obtain readings due to the dry lining.

Unable to obtain lateral damp readings due to dry lining

**ACTION REQUIRED:** You need to open up the walls.

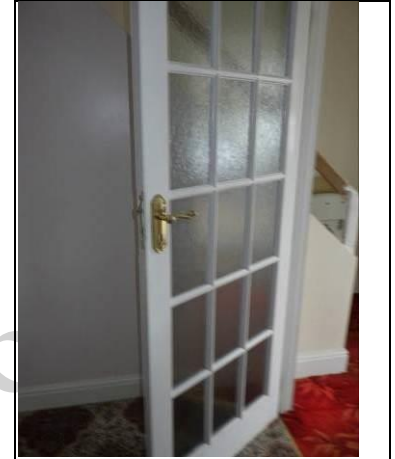
The property has a mixture of timber doors and a glazed door. We cannot see a British standard safety kite mark on the glazed doors and we therefore assume that this glass is not safety glass therefore it can shatter. We would recommend changing the glass to safety glass.

Glazed door

**ACTION REQUIRED:** Replace glass with safety glass.

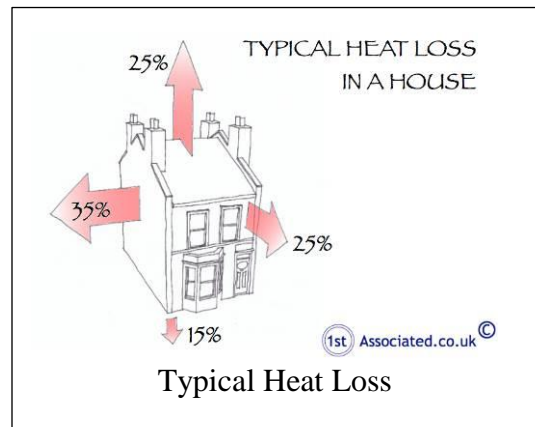
Some roof insulation was present although not to current Building Regulations requirements of 300mm. In this instance there is between 200mm to 300mm and no insulation in some areas.

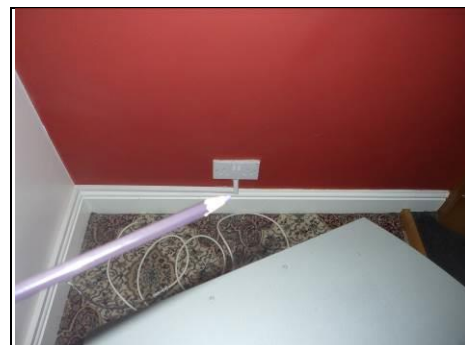
Some surface wiring should be boxed in

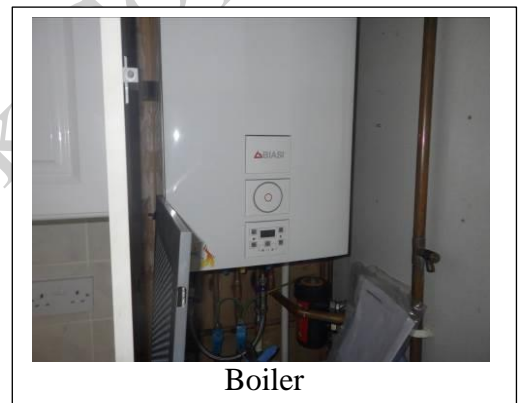
The wall mounted Biasi boiler was located in the kitchen. This is a make of boiler we rarely come across so it may be difficult to obtain replacement parts. In our vendor's questionnaire we were advised it was last serviced in 20XX.

Our limited inspection of the hot water and central heating system revealed no evidence to suggest any serious defects but we would nevertheless recommend that the system be tested and overhauled before exchange of contracts and that a regular maintenance contract be placed with an approved heating engineer.

**ACTION REQUIRED:** Please see our comments in the Executive Summary.

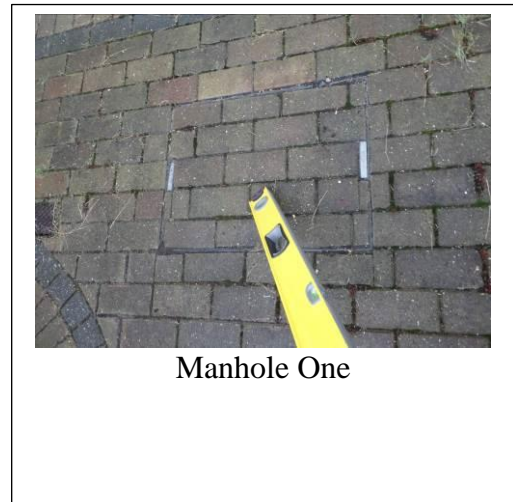
We were unable to lift the cover therefore are unable to comment.

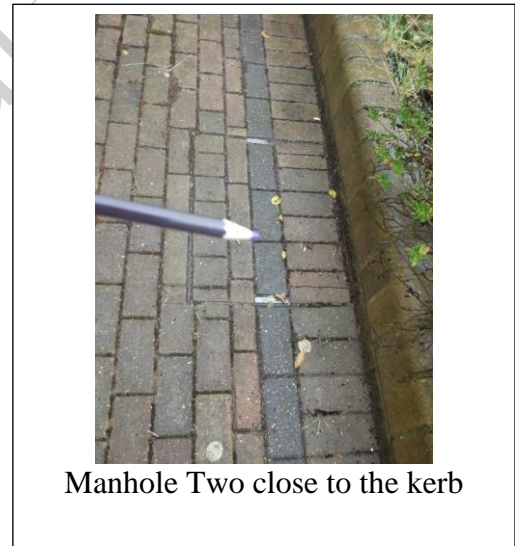
**Inspection Chamber/ Manhole Two - located to the front right**

Again we were unable to lift the cover therefore are unable to comment.

**ACTION REQUIRED:** We recommend a closed circuit TV camera report of the drains to check their condition.

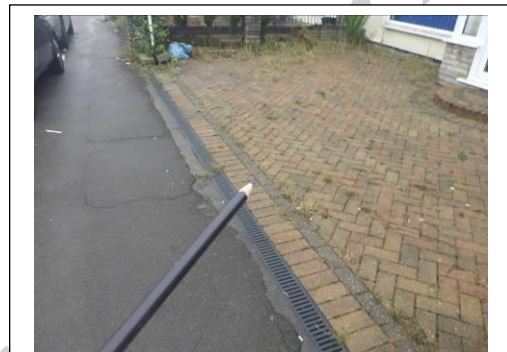
Front garden paved for off road parking, with a running gully

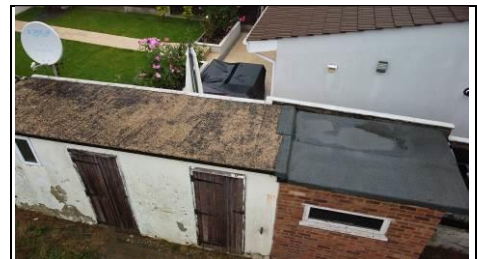
The tar on the roof has weathered causing water to get in. We noted cracking to the walls of the concrete outbuildings and dampness internally.

Concrete outbuildings and brick outbuilding (which we did not enter)

**ACTION REQUIRED:** Please see our comments in the Executive Summary. We would recommend nothing valuable is stored in the outbuildings.

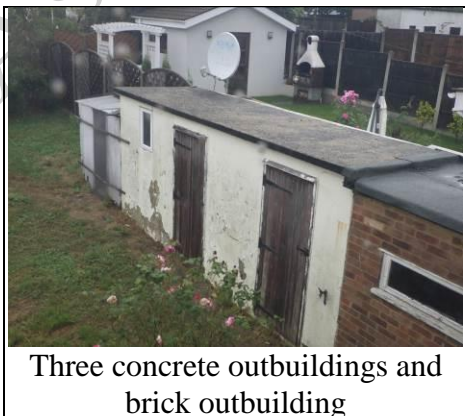
Three concrete outbuildings and brick outbuilding

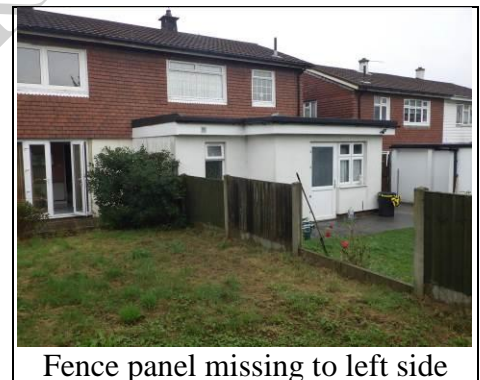
In this case we noted a fence panel missing to the rear left fence, typically this would be your responsibility but this needs to be checked by your solicitor.

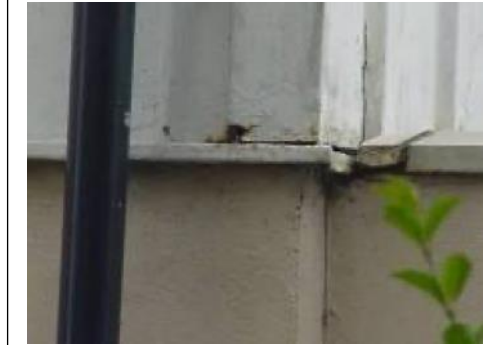
Rusting to profile metal cladding

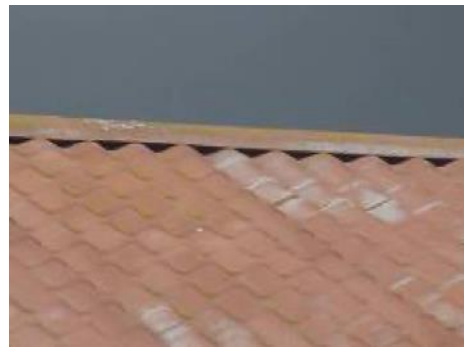
Weathering effect to roof

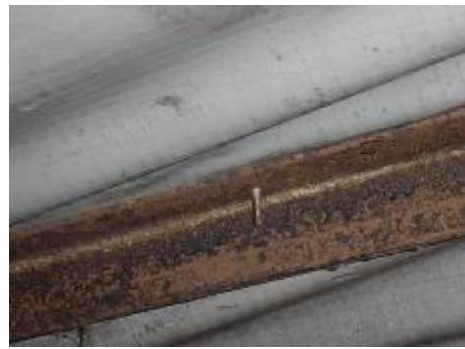
Example of rusting that we have seen in the roof of a metal framed building

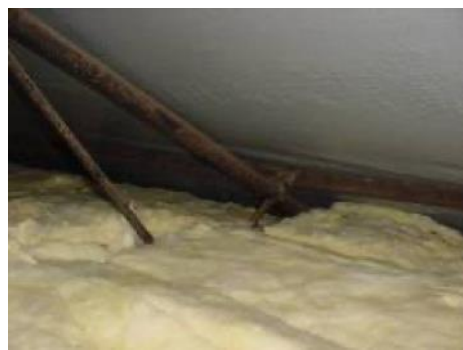
Example of over insulation of a metal framed property which causes condensation

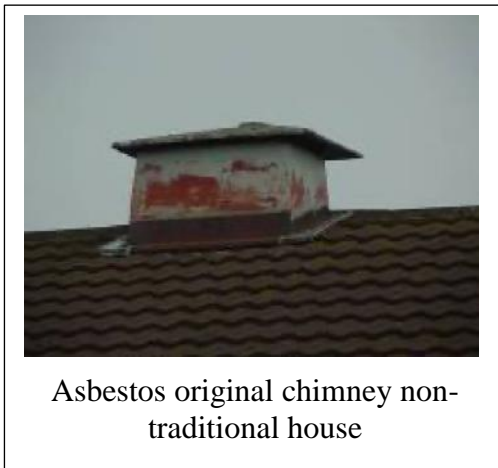
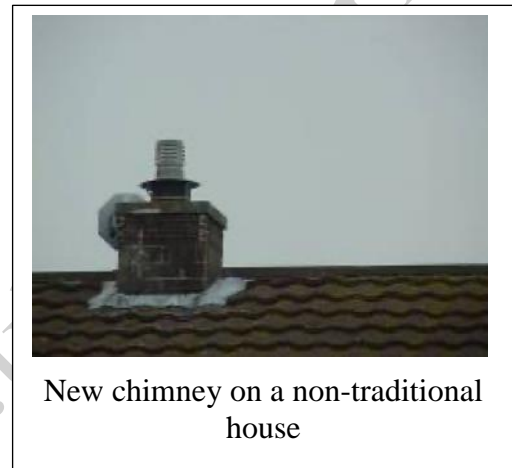
### Chimneys

Asbestos was a very popular material (yes really) when non-traditional houses were being built

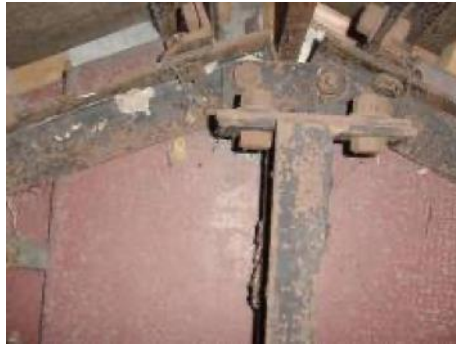
Rusting to a lightweight metal frame or damage or deterioration to the metal frame of a non-traditional house

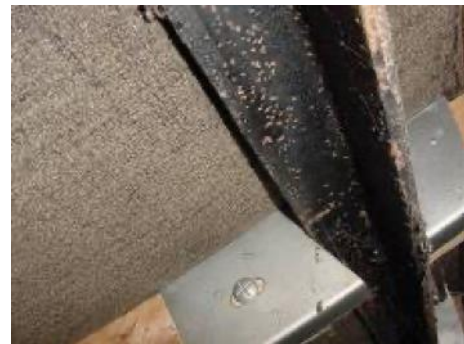
Some fixings replacements/repairs to a non-traditional house

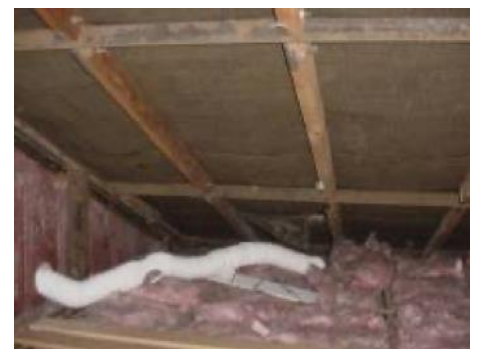
It is very common these days to have a shower/bathroom with an extract system. Does that extract system discharge into the roof or does it discharge out of the building? If it discharges into the roof then there can be problems with rusting and corroding of metal and dampness to timber.

Extract vent to outside often discharges into roof which is essential that they do not in this type of roof

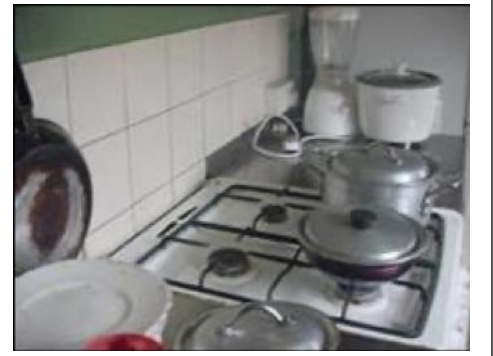
Cooking produces steam and requires ventilation
