## Residential Building Survey

NON TRADITIONAL CONSTRUCTION  
STRUCTURAL FRAME HOUSE

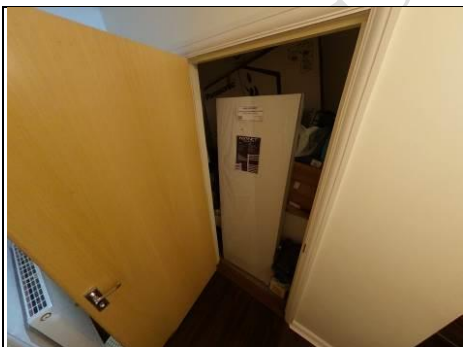
WC left full of stored items

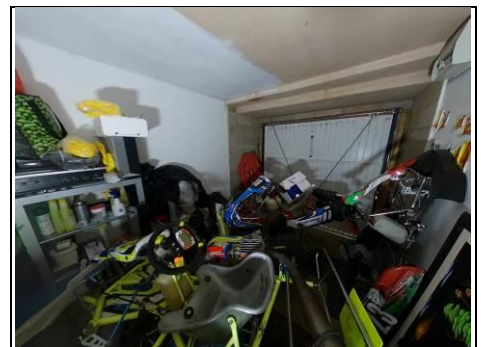
Garage full of stored items

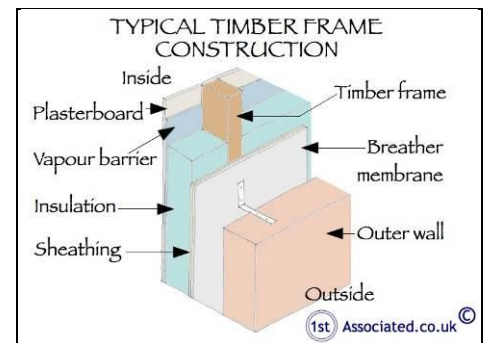
We noted efflorescence to the brickwork in many areas which is a salt coating. This is a fairly common factor in timber frame buildings.

Efflorescence is the white salt found on brickwork/stonework. It is a natural phenomenon which is where the minerals in water as they dry out come to the surface of stone or brick and leave a white crystallised powder, almost flour like. On a red brick it can stand out considerably, almost appearing bright white on a lighter white or yellow brick it can almost disappear.

This is caused by the walls never drying out. This, we believe, is a combination of external weather factors and the internal environment of humidity created inside such as showers, baths, cooking, breathing, etc as to the appearance of salts. This is a personal opinion, we have never seen any technical information on it, we have seen efflorescence regularly on timber frame buildings brick walls.

Timber frame

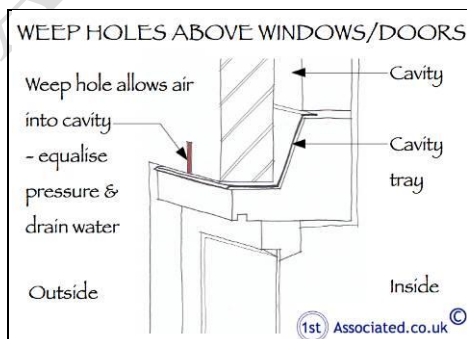
The weep holes are an example of how the designers tried to remove the moisture from within the structure.

Weep hole

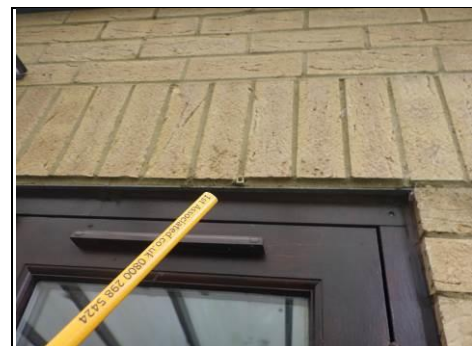
Weep hole above window

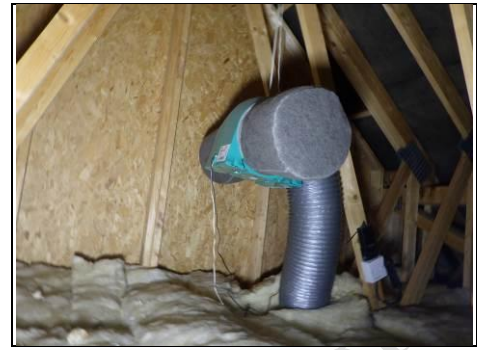
Within the roof we have identified a positive pressure fan. These are used where there are condensation problems and black mould problems. The aim of them is to create an airflow within the property. It draws air from within the roof space, sometimes it warms it up or changes its temperature and then pushes the air with the positive air pressure around the building. Nevertheless, we think there have been problems with black mould in this property.

Positive pressure fan in roof space

**ACTION REQUIRED:** You need to speak to the Housing Association or whoever has the shared ownership with this building to ask them to provide a detailed record of problems in relation to condensation, black mould, etc. in the property.

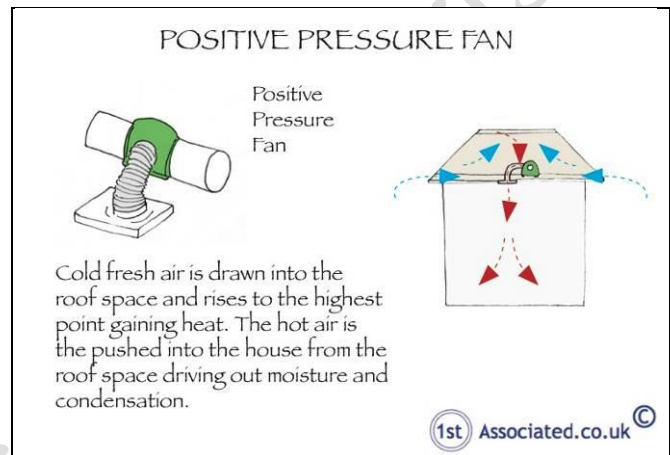
Positive pressure fan

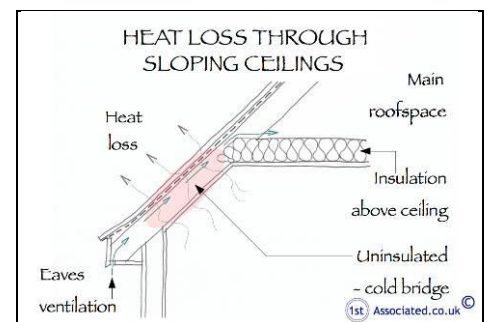
The bedroom ceilings are formed partly within the roof therefore during hotter weather you will get some heat gain unless they are very well insulated and equally in the colder weather you will get heat loss.

Heat loss through sloping ceiling

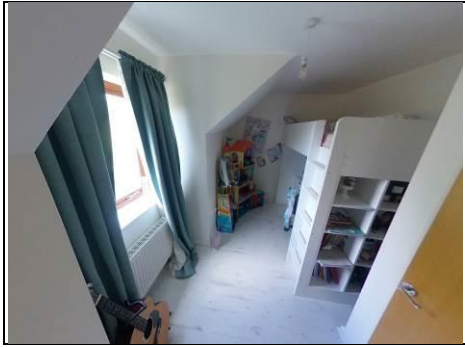
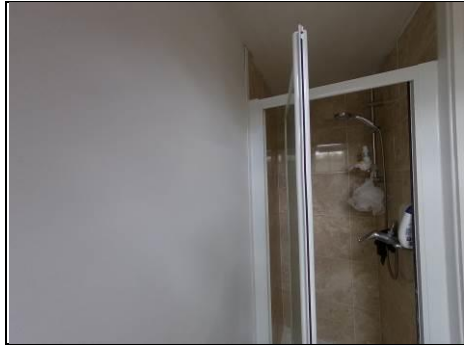
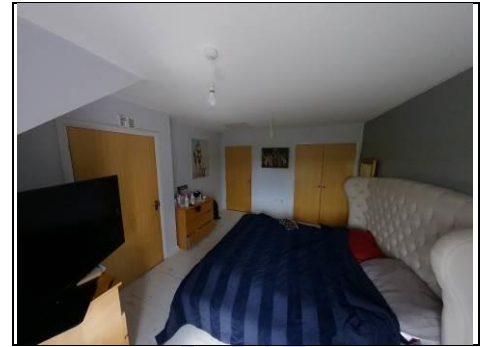
Rear bedroom sloping ceiling

Front en-suite shower room sloping ceiling

Front bedroom sloping ceiling

We believe there are problems with ventilation and black mould particularly around the en-suite shower room and the bedroom.

**ACTION REQUIRED:** We would recommend adding a large humidity controlled extract fan in the shower room. By large extract fans we mean 150mm. Unfortunately, this is quite a difficult job and will need some sort of air vent externally.

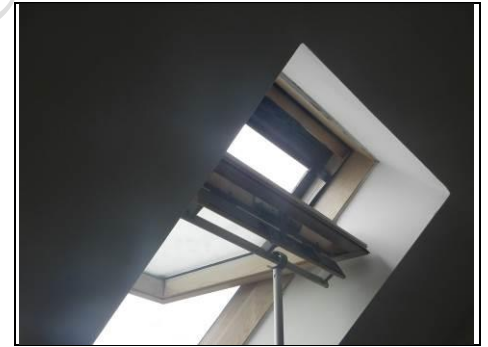
En-suite roof window open at time of survey

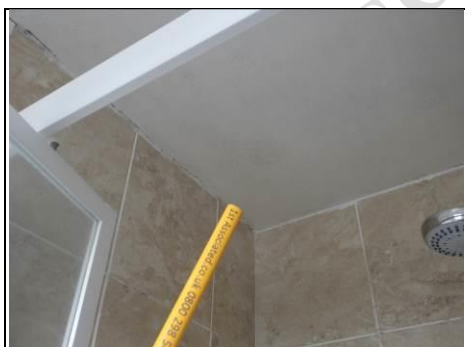
Black mould in shower unit

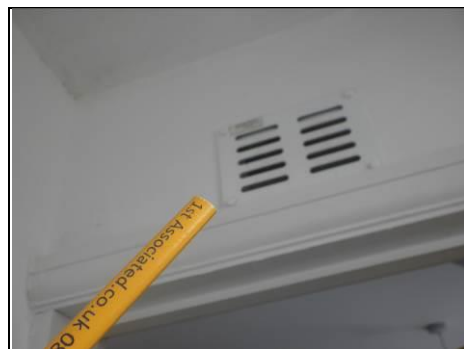
Vent above en-suite door

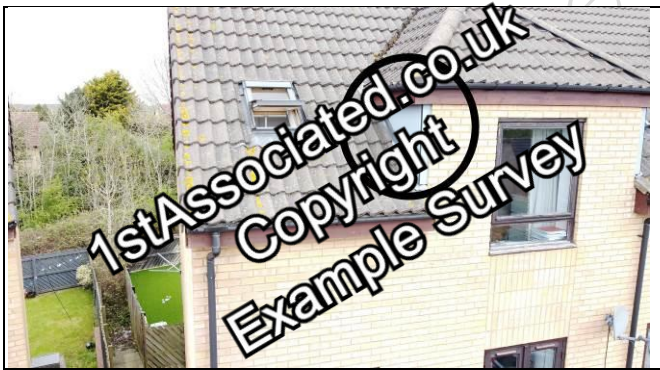
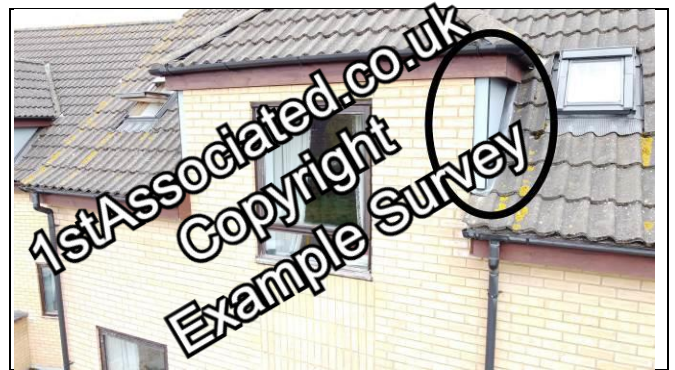
We believe that black mould will be problematic in this area due to the design of the building which is very difficult to resolve. Externally we can see the dormer roof has what we would term a lightweight construction timber frame and cold bridging will occur in these areas which in turn leads to black mould.

Lightweight dormer  
~ Aerial View - 360 Photo ~

Timber frame to side of dormer  
~ Aerial View - 360 Photo ~

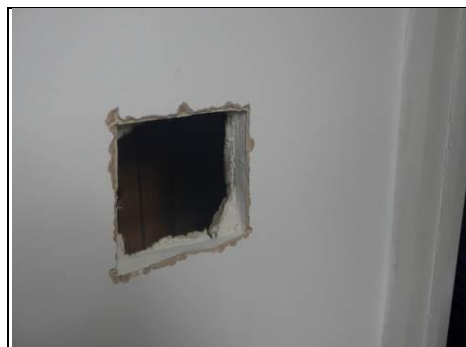
There looks to be some work taking place in the shower room; you need to enquire as to what this is.

Hole in en-suite wall

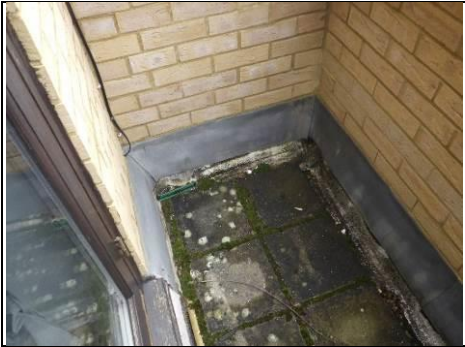
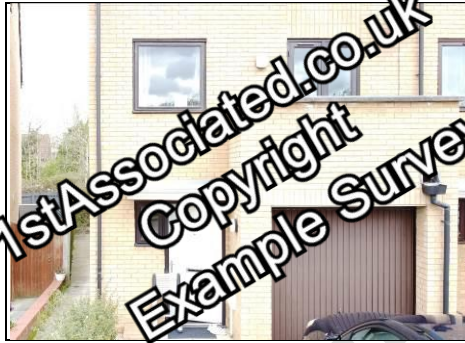
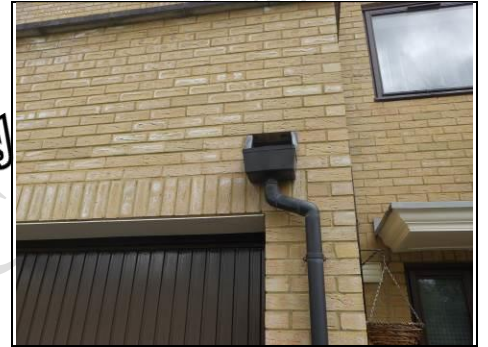
We could see dampness on the balcony. There is an awkward detail where the balcony tries to drain into the hopperhead which does not appear to have a sufficient fall and has led to the balcony becoming covered in moss.

The balcony is directly over the garage which we did not have proper access to therefore we would not be surprised if dampness is coming into the garage.

Dampness to balcony

Balcony over garage

Hopperhead to balcony

**ACTION REQUIRED:** Investigate further when the garage has had stored items removed and is able to be viewed.

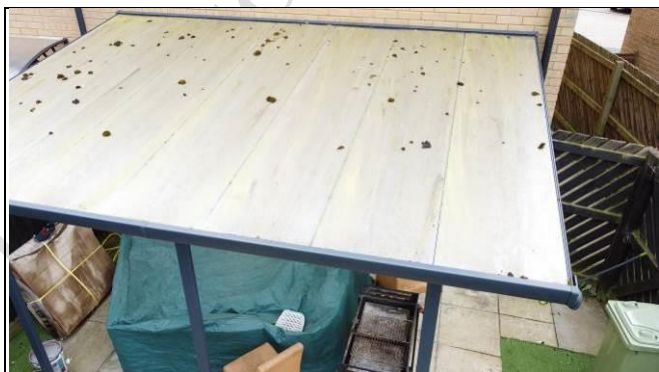
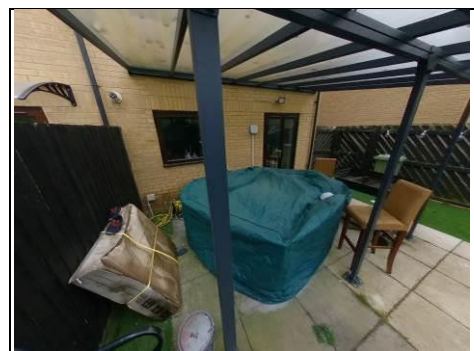
To the rear patio there is a metal frame with a plastic canopy. It needs to be checked whether this needs planning permission or not.

Rear canopy  
~ Aerial View - 360 Photo ~

Rear covered paved area

**ACTION REQUIRED:** Your legal advisor to check and confirm.

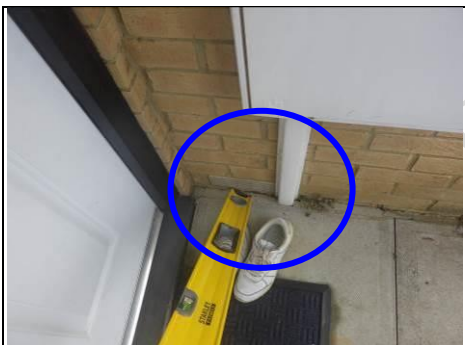
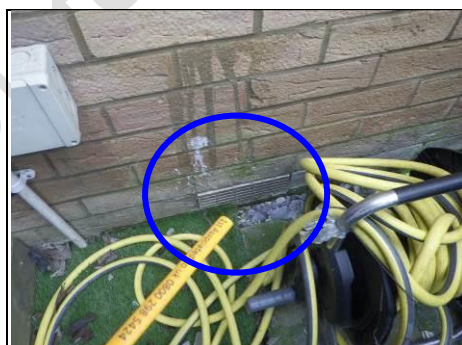
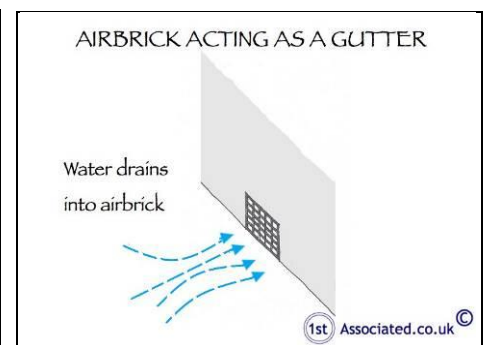
The floor needs an airflow underneath it and unfortunately the airbricks which should ventilate the floor unfortunately are too low and are acting as gutters. We can see moss around the rear airbrick.

Front air brick low

Rear airbrick acting as gutter

Airbrick acts as gutter

**ACTION REQUIRED:** Protect airbricks and ensure that no water gets into the property. Also, ideally we would recommend the floors are opened up. You need to speak to whoever has the shared ownership of the property and see if they will open up the floors or if there is a known about problem.

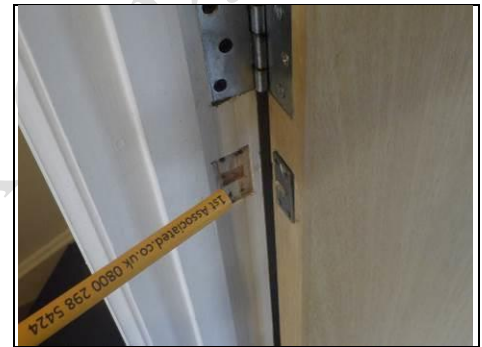
Throughout the property we noted various fire doors have had the central door closer removed (often known by its generic name of Perco).

Door closer removed

**ACTION REQUIRED:** Re-install all of the fire doors. We would normally expect to see an intumescent strip around the doors to indicate that they have a fire rating and they seal when they are heated.

**ANTICIPATED COST:** £1,000 - £2,000 depending upon whether the existing doors are fire doors and can be repaired or replaced; ask the owners/shared ownership. Please obtain quotations before you legally commit to purchase the property.

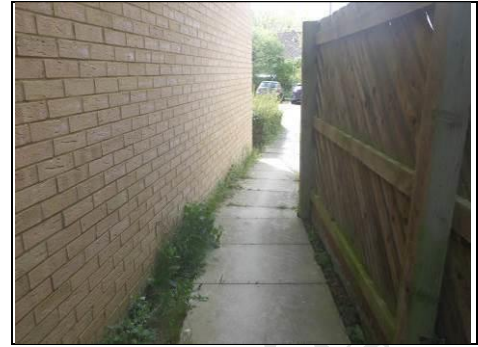
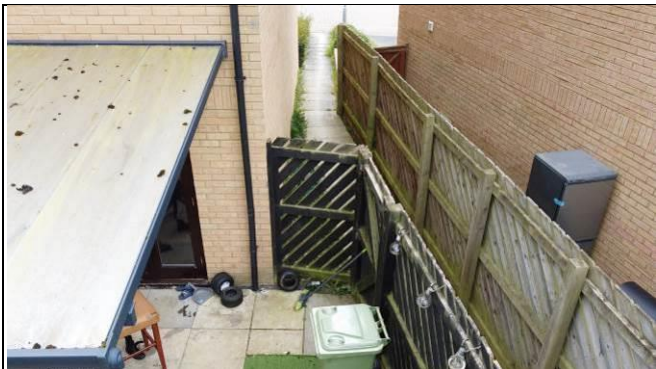
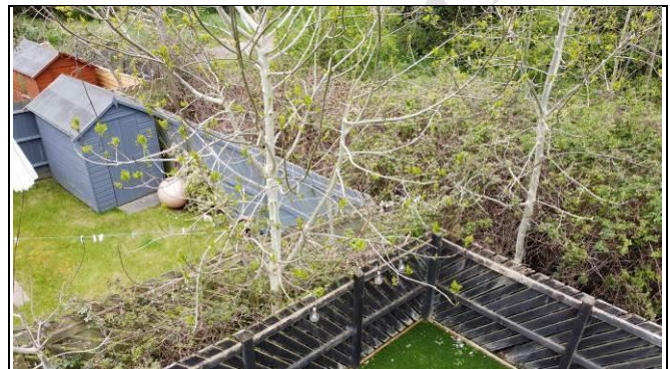
There is a shared access on the left side of the building which leads to the gardens but then continues where it is overgrown. We were wondering whether this is a right of way or not.

Path

Shared left path  
~ Aerial View - 360 Photo ~

Access path and trees  
~ Aerial View - 360 Photo ~

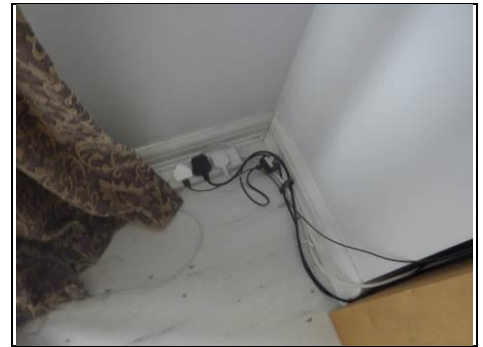
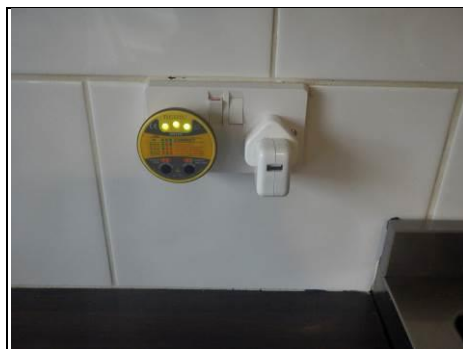
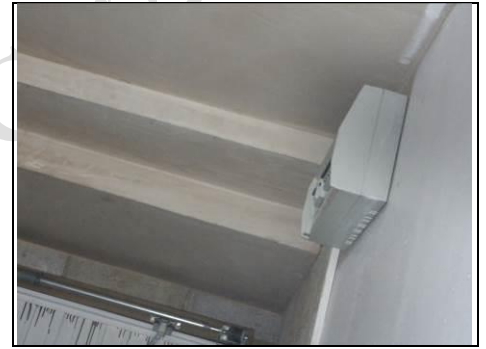
The electrics tripped when we carried out our usual earth test. We also noted the need for extra socket points.

Extension lead

Earth test passed second and third time

Fuse board in garage

The Institution of Engineering and Technology (IET) recommend a test and report when properties change hands, to be carried out by an NICEIC registered and approved electrical contractor or equivalent.

- 1) £250 - £500 for test and report
- 2) £250 - £500 for a new fuse board
- 3) In the region of £100 - £200 per additional socket point
- 4) Plus any further work recommended

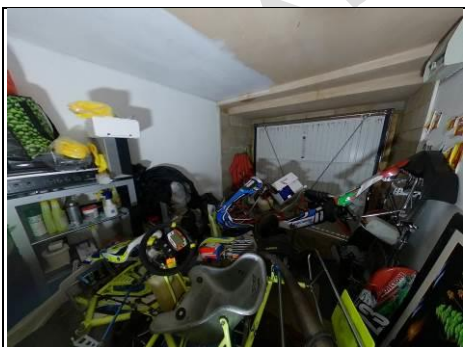
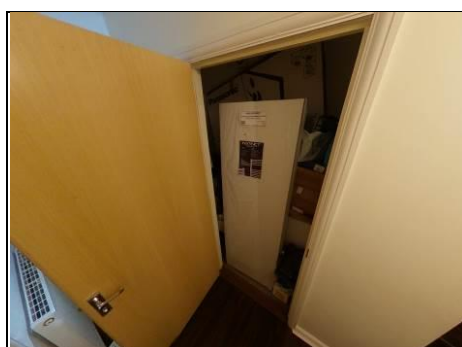
There were a lot of stored items which restricted our view, for example we were unable to get in the garage properly or the WC. There looks to be an older/original fuse board and we noted some lightbulbs were missing meaning that we had to use torchlight to view some areas.

Stored items in garage

WC left full of stored items

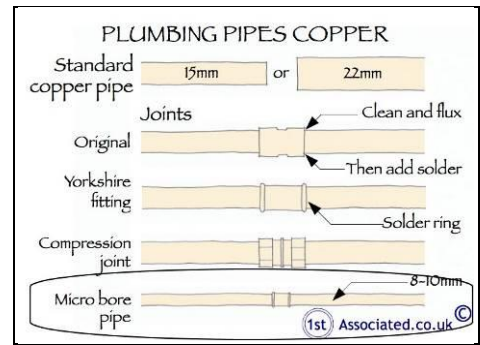
Microbore pipes

**ACTION REQUIRED:** We recommend a power flush from time to time to ensure they are working satisfactorily. You need to be aware that we generally do not feel they work as well as a traditional system.

**ANTICIPATED COST:** Budget to replace boiler in the region of £2,000 - £3,000; please obtain quotations before you legally commit to purchase the property.

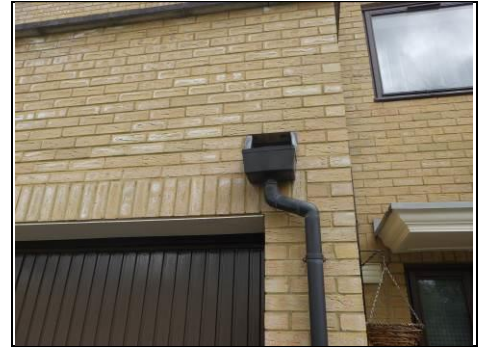
There are some relatively poor details here such as drainage from the balcony area. This type of property is relatively modern (i.e., less than one hundred years old) but nevertheless still requires ongoing maintenance and repair. A budget for such work must be allowed to ensure it is maintained in a good condition. This will prevent undue and unnecessary deterioration.

Hopperhead to balcony

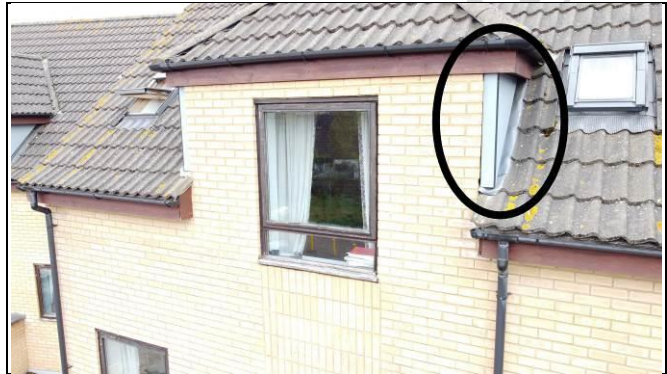
Front dormer timber frame  
~ Aerial View - 360 Photo ~

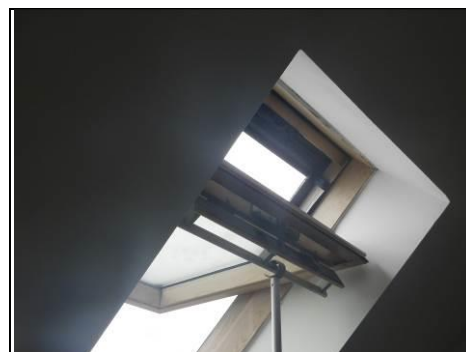
The property has a purpose made roof window. In this instance we would comment that it looked in reasonable condition.

It seems inevitable with roof windows that they will sooner or later leak. If this doesn't occur then they seem prone to condensation. Keep a cloth handy!

Roof window in en-suite

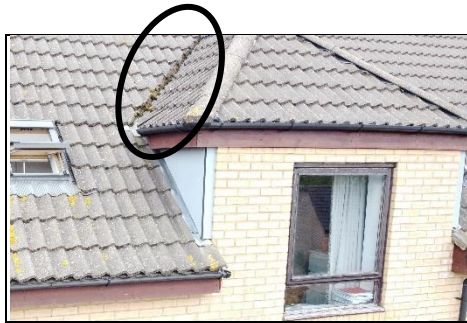
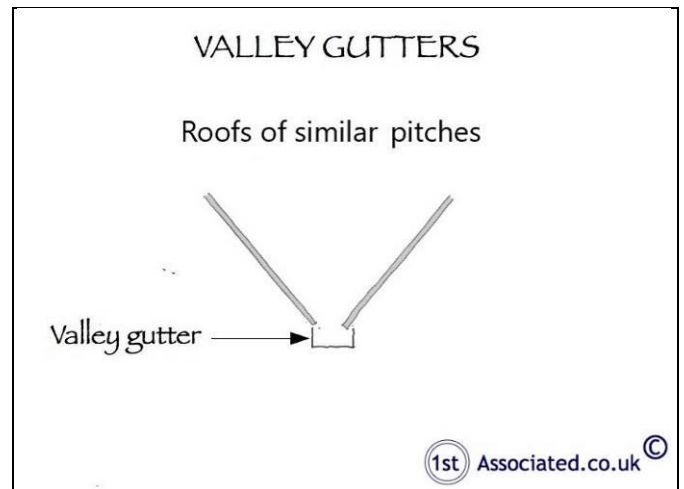
This property has valley gutters which we could not see properly which are generally a problematic area.

Valley gutter

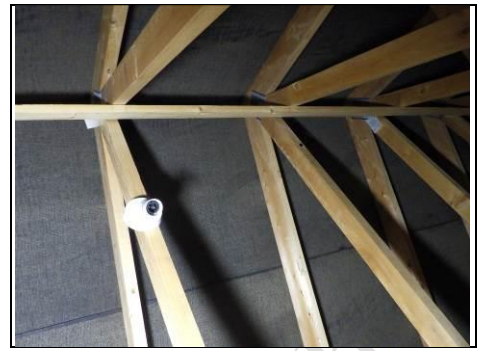
When we inspected the loft space we found a Hessian base Bitumen membrane. This type of membrane has been used since the 1960's. We generally found it to be in average condition, with damage in some areas which is what we typically find.

This photo shows the common rafters (the ones that form the pitch of the roof) and the dark area between is the underlayer.

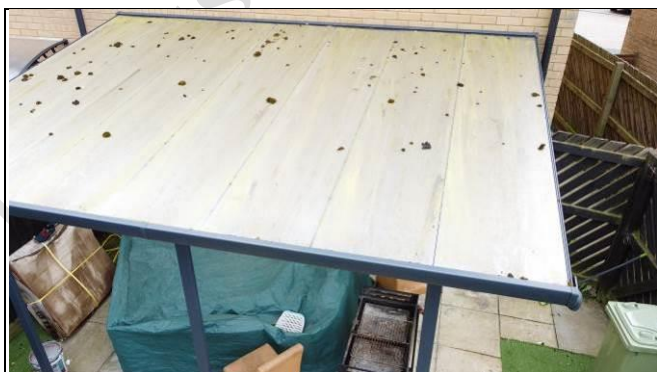
To the rear patio there is a metal frame with a plastic canopy. Your legal advisor to check and confirm this has planning permission.

Rear canopy  
~ Aerial View - 360 Photo ~

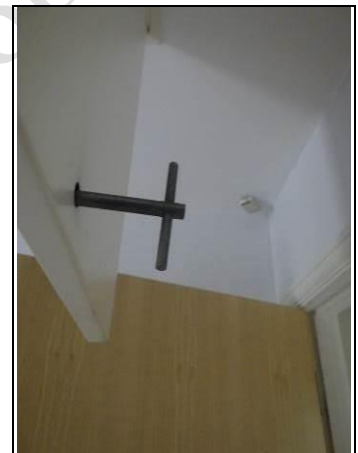
The main roof is accessed via the loft hatch located on the landing. A key is required to get into the roof. The owners advised they have lost their key – you need to ensure they get a replacement key.

Key for loft hatch

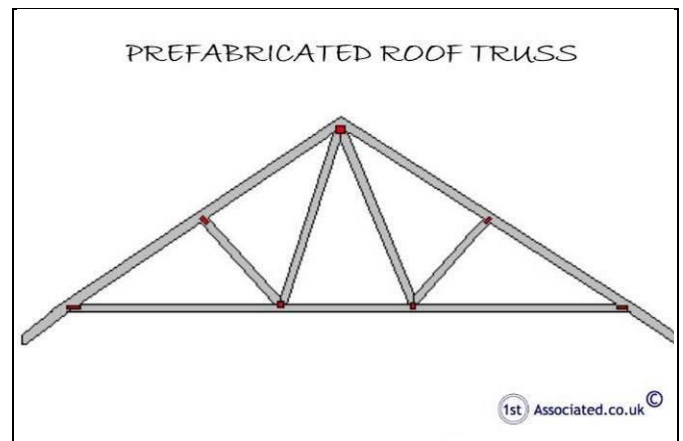
The property has a pre-fabricated trussed roof rafter. These are made in a factory and transported to site and then lifted into place. Without the manufacturers calculations and installation details we cannot comment categorically on the roof.

Pre-fabricated roof truss

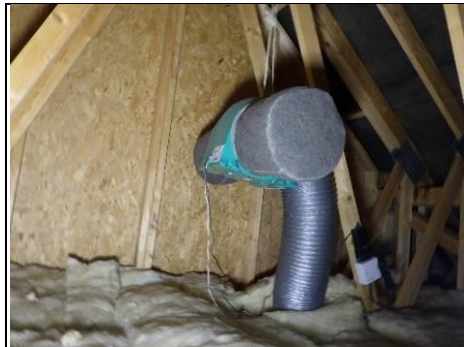
The left gable end is plywood and the right gable which is also the party wall has a plastic sheet. This should be fire resistant however we cannot confirm.

Left gable plywood with positive pressure extract fan

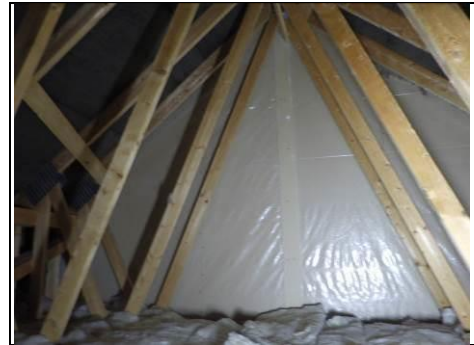
Plastic sheet to right gable

**ACTION REQUIRED:** Your legal advisor to check and confirm that it is a fire resistant party wall and that fire cannot be spread from one property to another.

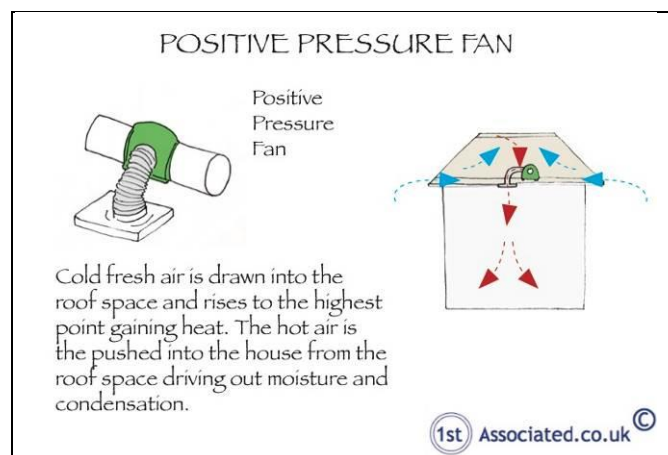
Within the roof space we could see a positive pressure extract fan/air movement unit which are normally introduced where there is black mould.

Positive pressure fan

**ACTION REQUIRED:**  
Please see our comments in the Executive Summary.

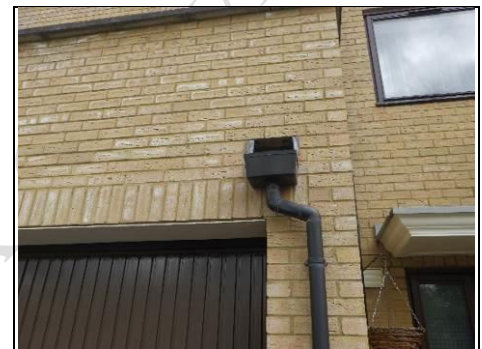
Balcony hopperhead

There is an awkward detail where the balcony tries to drain into the hopperhead which does not appear to have sufficient fall and has led to the balcony becoming covered in moss.

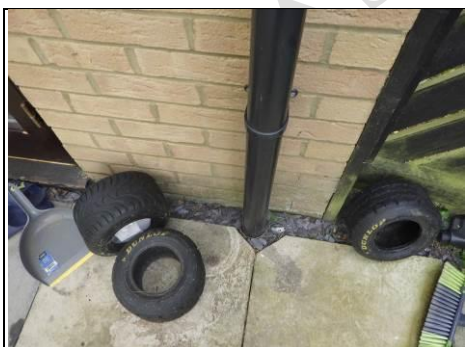
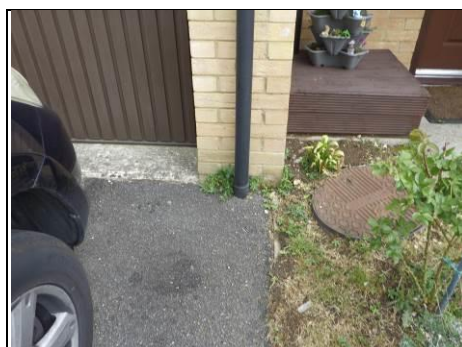
The downpipes feed directly into the ground. This is a practice we are not particularly keen on as we cannot be certain where they go, so if there is a blockage then the drain would have to be opened up. We would much prefer a gully.

Downpipes feed directly into ground rear left corner

Downpipe into ground right corner of garage

We also recommend that the gutters and downpipes are cleaned out, the joints are checked and the alignment checked to ensure that the gutters fall towards the downpipes.

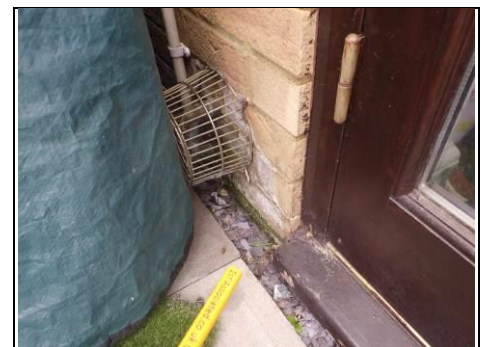
Please see our earlier comments regarding airbricks acting as gutters and moss to the base of the property.

Moss to rear base

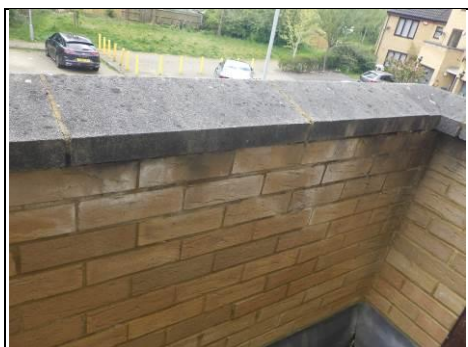
The balcony wall looks to be damp. This may be due to the coping stone not having sufficient drip detail.

Balcony wall damp

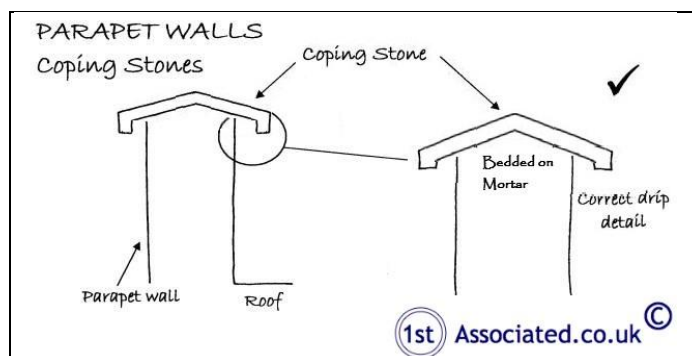
Parapet wall coping stone

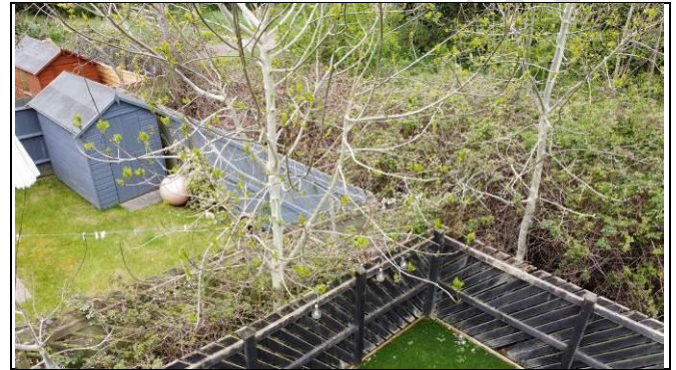
There are trees outside what we would term as influencing distance however they do need maintenance.

Trees to rear  
~ Aerial View - 360 Photo ~

**ACTION REQUIRED:** You need to establish who owns the trees.

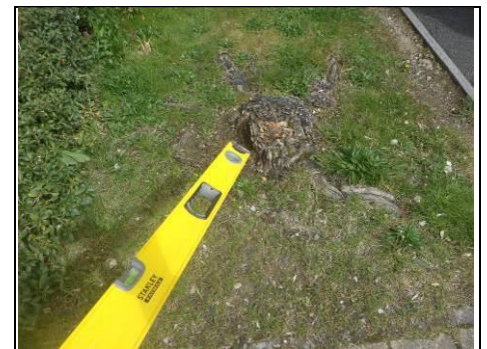
There looks to have been a substantial tree cut down to the front.

Tree cut down

**ACTION REQUIRED:** You need to find out further information regarding this. We would be happy to comment further or you could instruct an arboriculturalist (not a tree surgeon).

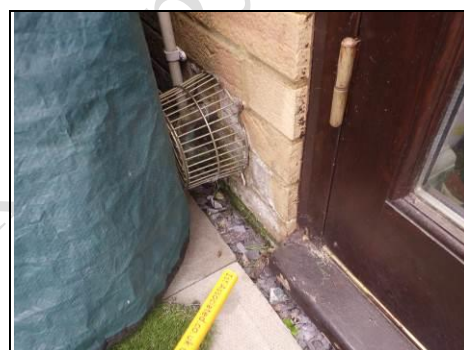
There was no damp proof course visible however we noted a change of levels around the building which can result in the damp proof course being bridged. There was moss to the base of the property at the time of our survey.

Moss to rear base

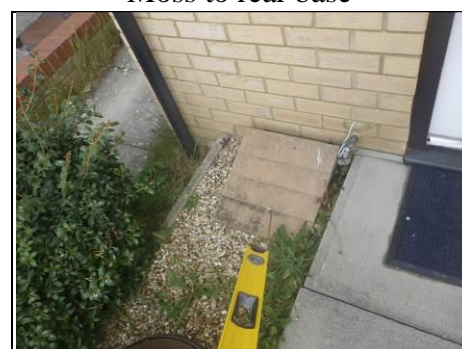
Change in levels

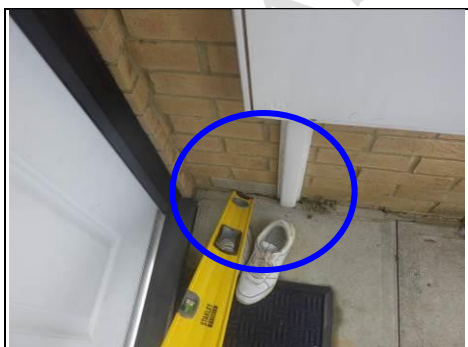
The floor needs an airflow underneath it and unfortunately the airbricks which should ventilate the floor are so low they are acting as gutters.

Front air brick low

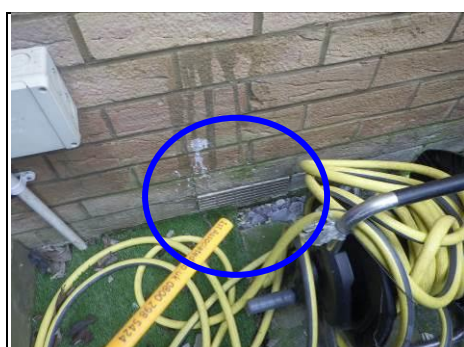
Rear airbrick acting as gutter

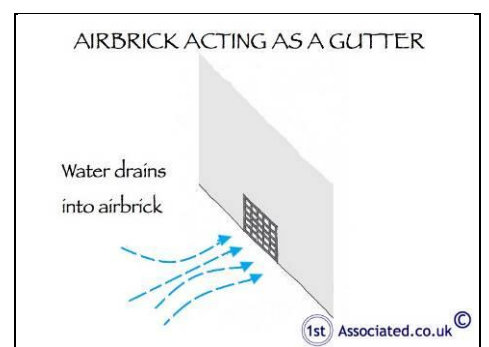
Airbrick acts as gutter

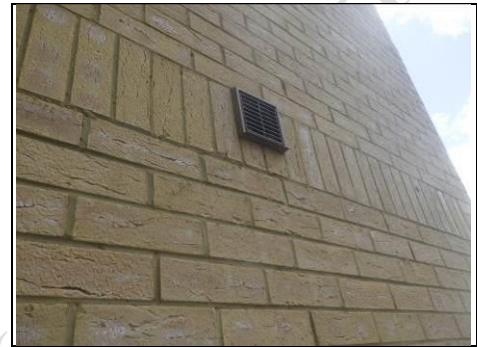
We could see an extract vent from the WC however we could not view this area due to the mass of stored items.

Extract vent from WC

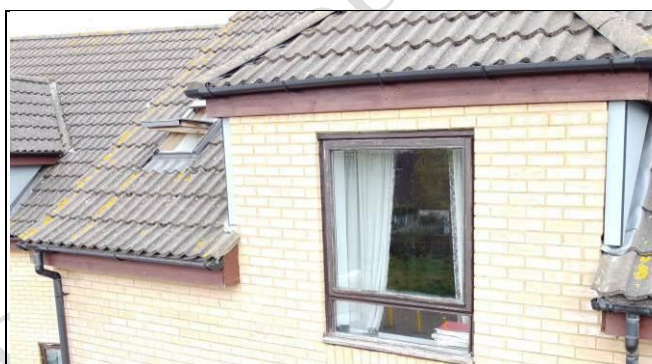
The fascias and soffits are timber. They are stained and we would comment they are in weathered condition for their age, type and style.

Fascias and soffits  
~ Aerial View - 360 Photo ~

We recommend redecoration when the windows are redecorated which we would

recommend is as soon as possible in the warmer months. Make sure gutters and downpipes are watertight before carrying out any work on fascias and soffits. As this is a shared ownership we do not know who is responsible for the fascias and soffits and the windows.

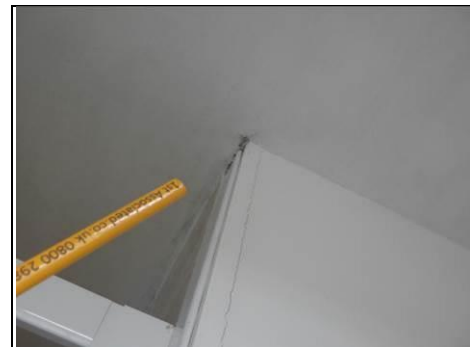
Black mould in en-suite

**ACTION REQUIRED:** We would recommend large humidity controlled extract fans be added to kitchens, bathrooms and any rooms where you intend to dry clothes.

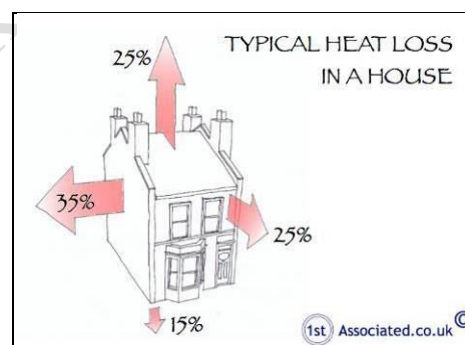
Some roof insulation was present although not to current Building Regulations requirements of 300mm. In this instance there is 200-300mm.

Typical heat loss

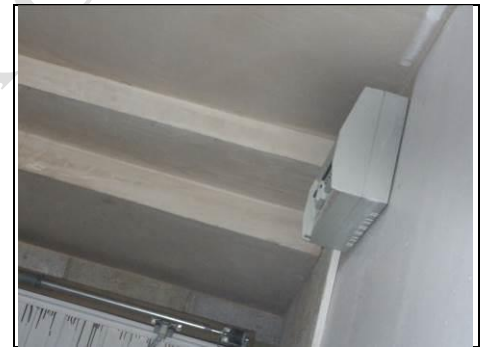
The electric fuses and consumer units were located in the garage, we were unable to have a close inspection due to the stored items in the garage particularly go-carts.

Fuse board in garage

**ACTION REQUIRED:** We recommend a new fuse board with a fire resistant metal case and would

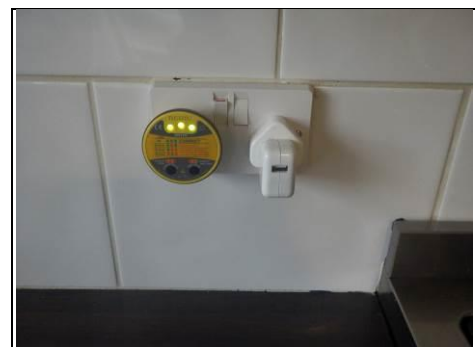
Earth test passed second and third time

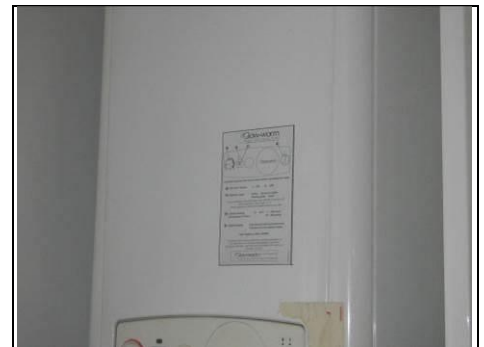
There is a Glow worm boiler located in the kitchen. This looks to be an older boiler and you should budget to replace.

Our limited inspection of the hot water and central heating system revealed no evidence to suggest any serious defects but we would nevertheless recommend that the system be tested and overhauled before exchange of contracts and that a regular maintenance contract be placed with an approved heating engineer.

**ACTION REQUIRED:** We recommend that you test the heating.

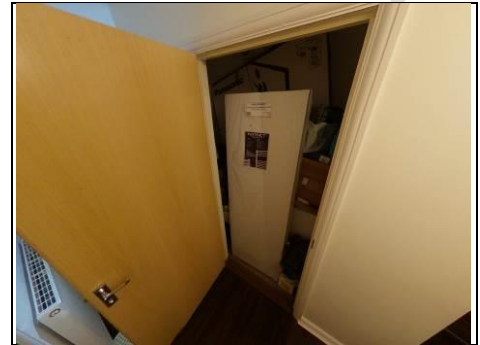
We were unable to access the cloakroom due to the mass of stored items.

WC left full of stored items

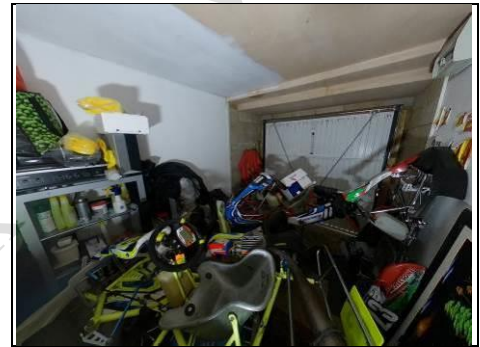
The property has a garage on the right side which was full of stored items at the time of our inspection particularly go-karts.

Garage full of stored items

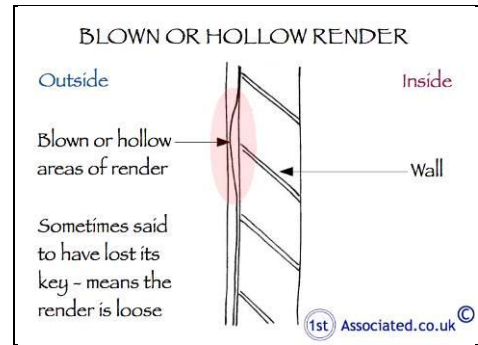
Render with lost key

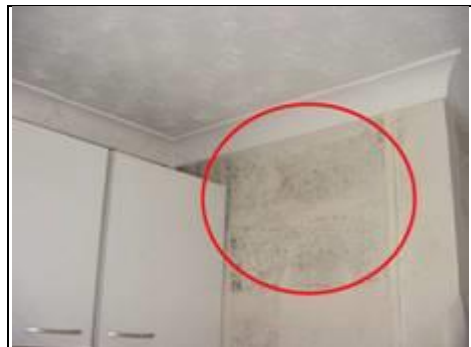
Black mould

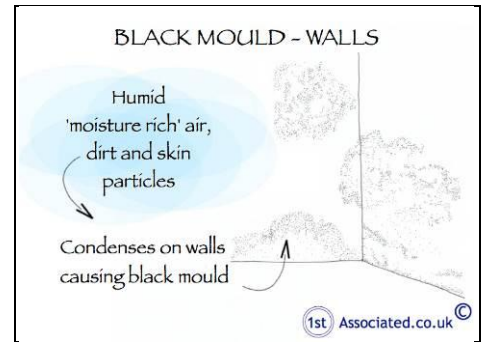
Condensation and black mould

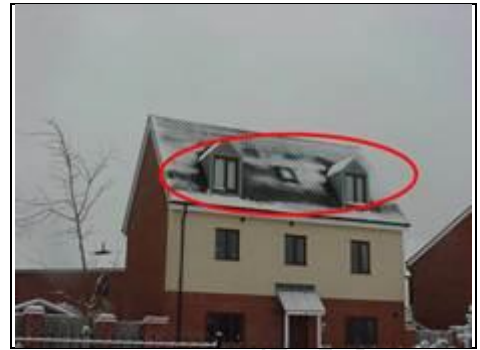
Heat loss via poorly insulated roof

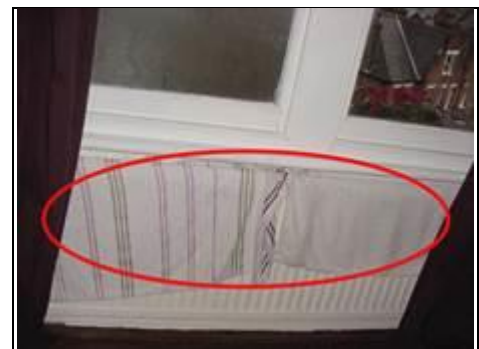
Drying clothes on a radiator can cause condensation

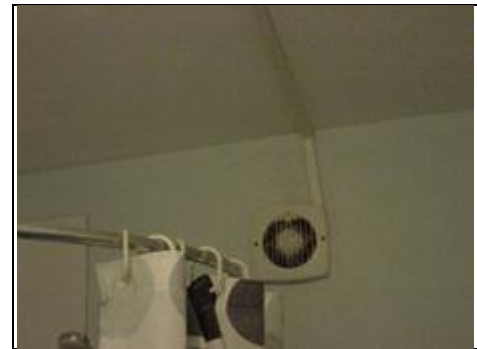
Small extract fan needs to be improved

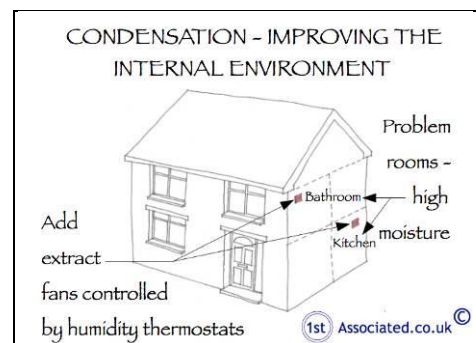
Condensation

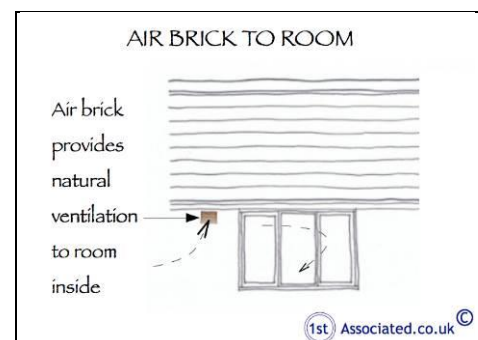
Air brick may not ventilate room enough

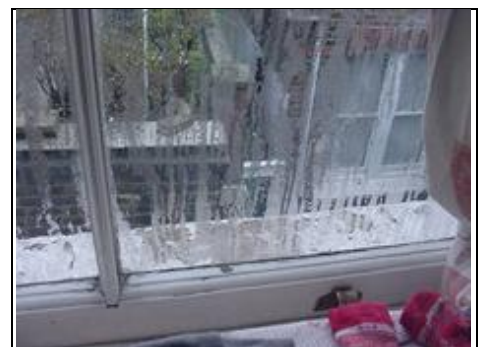
Condensation on window
