Non Traditional Example Residential Building Survey

INTRODUCTION

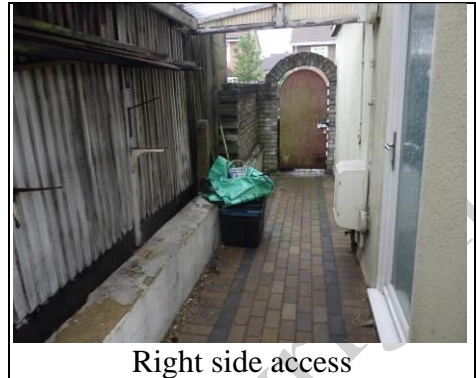
Right side access

The front garden is given over for parking. There is an access from the front of the property to the rear on the right hand side, which is partially/poorly covered (generally in a dilapidated condition – see our later comments).

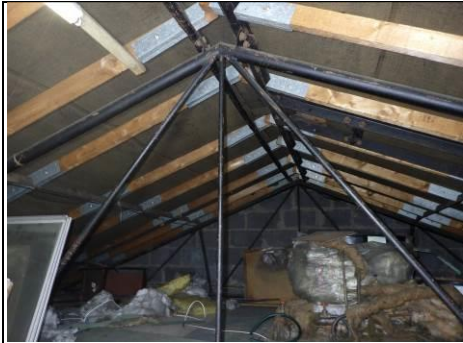
Where we can see the metal frame structure is within the roof. This has rusted slightly above average which we think is probably due in part to the humidity in the kitchen and bathroom rising.

Tubular metal structure in roof

ACTION REQUIRED: Reduce the humidity and condensation in the property by adding large good quality humidity controlled extract fans to reduce the humidity (see our later comments).

Ideally, the metal work in the roof space needs to be rubbed back, prepared, repaired and redecorated with a red oxide paint or equivalent rust stopping paint. This needs to be carried out during the cooler/winter months of the year.

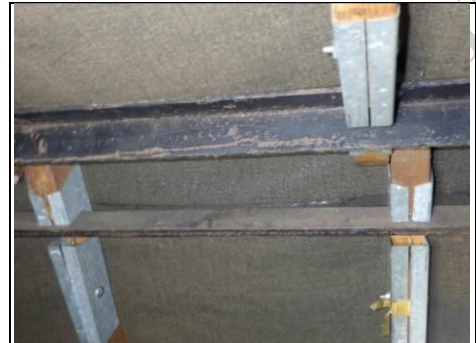
Rusting to some of the angle irons

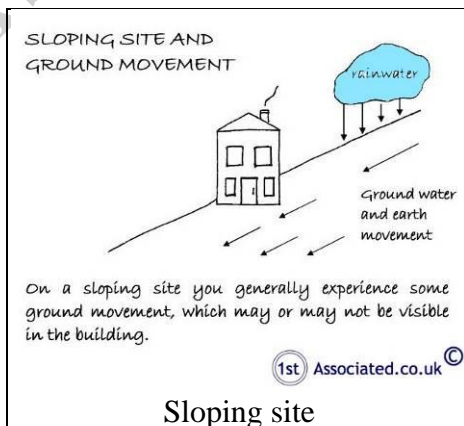
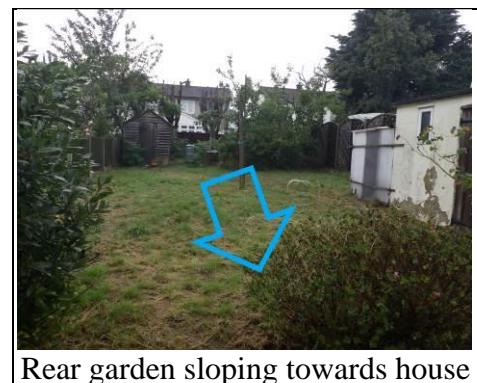
4.0) Sloping garden to rear

We can see that whoever has lived in the house has tried to resolve the problem of the slope by adding a running gully to the rear. However, having said that, there is still vegetation growing against the base of the building.

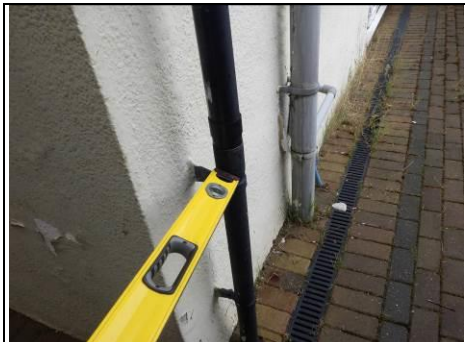
There is already a running gully to the rear of the property. Whilst these running gullies are better than not having anything, however by their very nature they tend to be quite shallow and can block easily.

Running gully to rear

ACTION REQUIRED: Due to this building being on a sloping site and water likely to be causing problems to the rear, we recommend opening up the walls to one metre squared in three areas to see the condition of the metal frame. In this particular case at least one of the areas, depending upon what was found, would be to the rear of the property. The benefits of opening up the structure is several reasons:

If this is not possible then you have to assume a worst case scenario and although you have running gullies to the rear of the property we would in addition put preventative measures in place by adding a land drain or a French drain, with a perforated pipe that discharges into a soak-away or one of the two manholes to the rear (subject to permission).

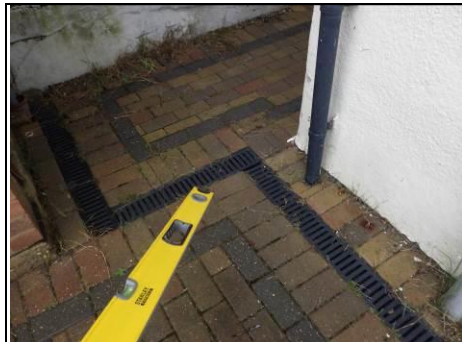
Running gully to rear right

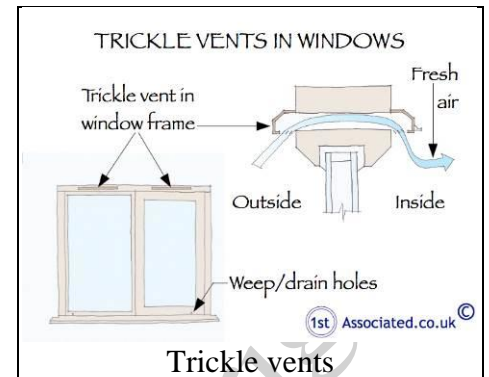
The windows do not have any trickle vents which will add to the humidity in the property.

ACTION REQUIRED: You do need to be very careful with this type of window.

Ideally you need to add trickle vents to the windows and you do need to find out whether it is possible to add trickle vents to this type of window before you legally commit to purchase this property by obtaining quotes.

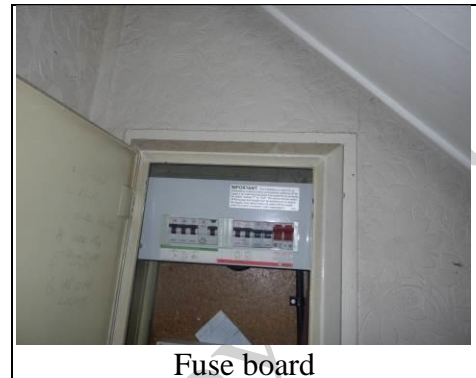
Fuse board

The electrics are located under the stairs. They are 1980's-2000's and better are now available.

ACTION REQUIRED: We recommend a new fuse board with a fire resisting metal case and would advise as the property is changing occupancy the Institution of Engineering and Technology (IET) recommend a test and report. Any recommendations from the report should be carried out by a NICEIC registered, or equivalent, approved electrical contractor or similarly approved.

ANTICIPATED COST: We would expect costs in the region of:

1. £250 - £500 for test and report
2. £250 - £500 for a new fuse board
3. In the region of £100 - £200 per additional socket point
4. Plus any further work recommended; allow the sum of £1,000

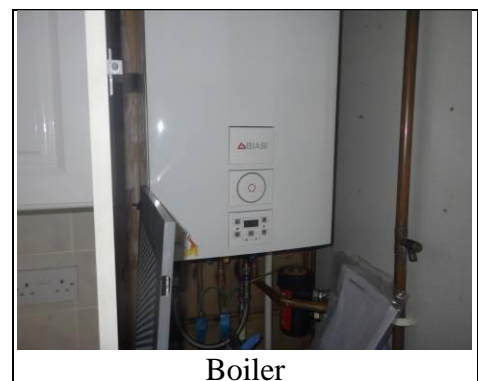
Boiler

Also, as it is a make of boiler we rarely come across it may be difficult to get parts.

ACTION REQUIRED: Your legal adviser to check and confirm who originally installed the boiler and whether it has been serviced.

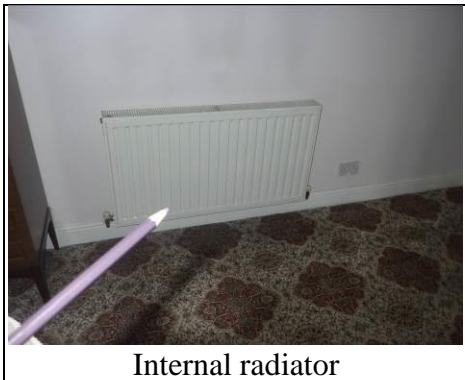
Many of the radiators are internal. We much prefer to see radiators positioned under windows for good air circulation.

ACTION REQUIRED: We recommend radiators are moved under windows where possible for better air movement, which will in turn will reduce humidity.

ANTICIPATED COST: A few hundred pounds per radiator moved; please obtain quotations before you legally commit to purchase.

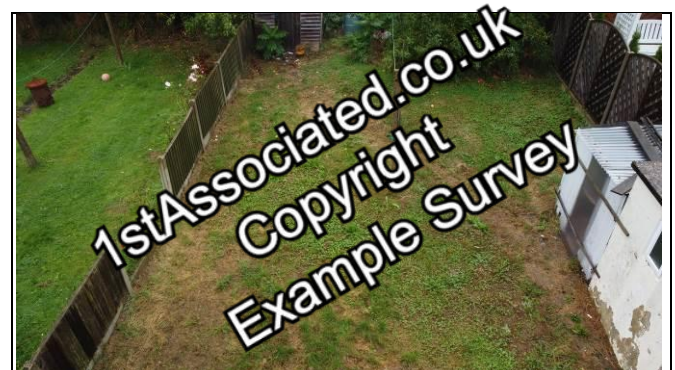
Rear garden with missing fence panel to left side
~ Aerial View ~

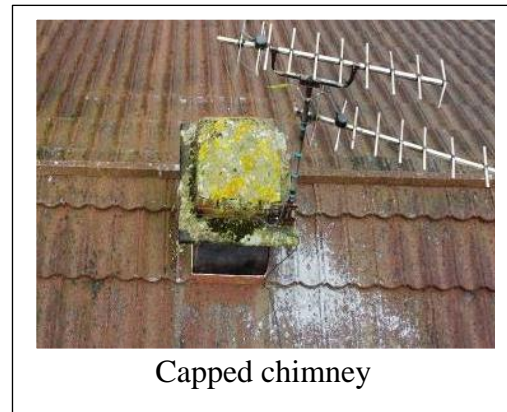
This chimney is metal, finished with a metal flashing and has been capped. From what we could see from ground level it is covered in moss and looked in slightly below average condition considering its age, type and style.

Capped chimney

ACTION REQUIRED: Periodic inspection. We think there may be some dampness that will get down around the chimney. You need to go into the roof and check from time to time.

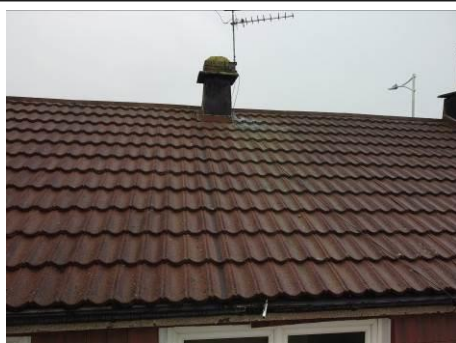
Main roof to front

The roof is pitched and clad with pressed metal tiles and, from ground level, this looks in average condition considering the roof's age, type and style. Originally this roof is likely to have been asbestos tiles.

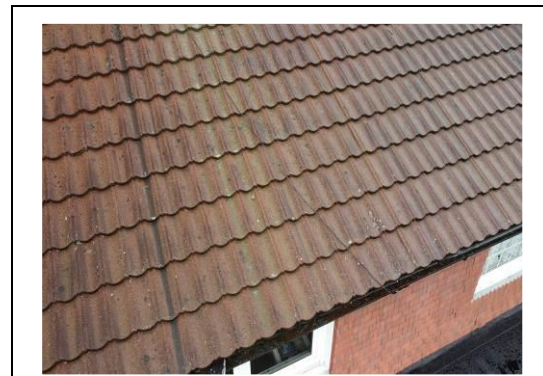
Pressed metal tiles to rear

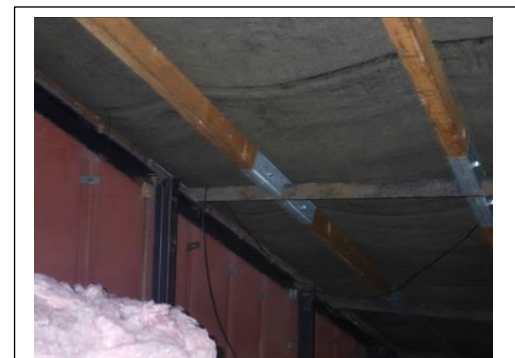
When we inspected the loft space, we found a Hessian based bitumen membrane. This type of membrane has been used since the 1960s. We generally found it to be in average condition with damage in some areas which is what we typically find.

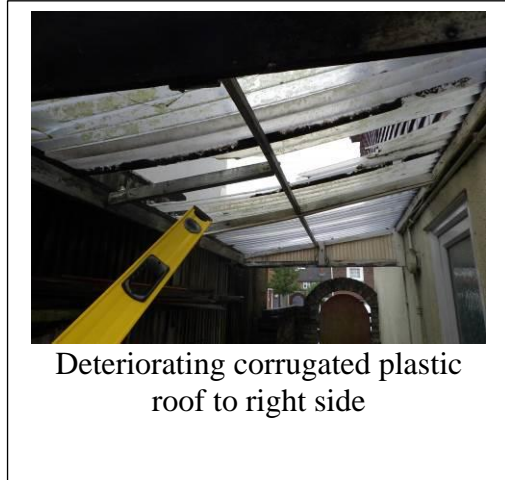
This roof to the right hand side is corrugated plastic. We would comment it is in a below average/dilapidated condition.

ACTION REQUIRED: Please see our comments in the Executive Summary.

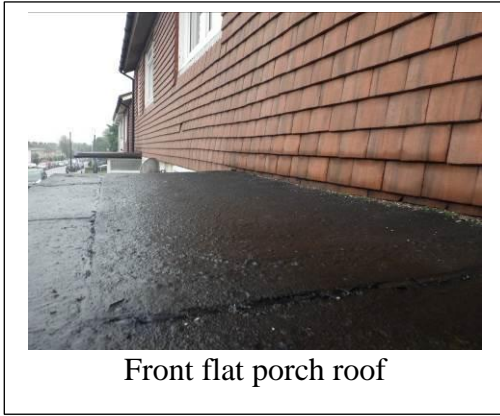
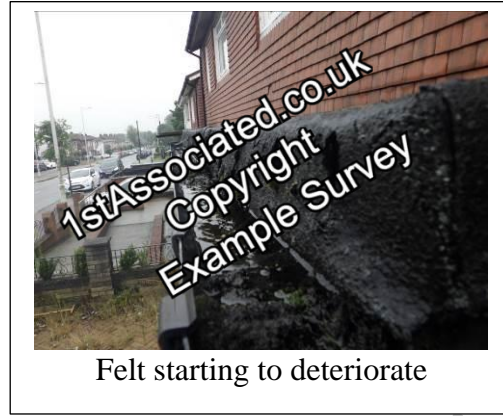
The flat roof is located to the front right and is covered with mineral felt. We would comment it is in below average condition for its age, type and style, with the felt starting to deteriorate.

ACTION REQUIRED: We recommend replacing with a good quality felt. We would always recommend that lead flashings are used.

ANTICIPATED COST: A few hundred pounds to £500. Please obtain quotations before you legally commit to purchase the property.

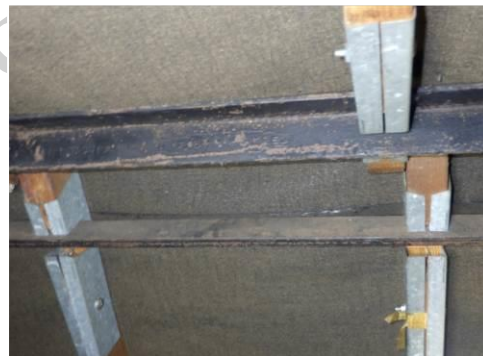
Rusting to some of the rolled steel angle

The only way to be one hundred percent certain is to have the roof cleared and checked. Please note our comments with regards to work required to remove rust, etc from the metal frame.

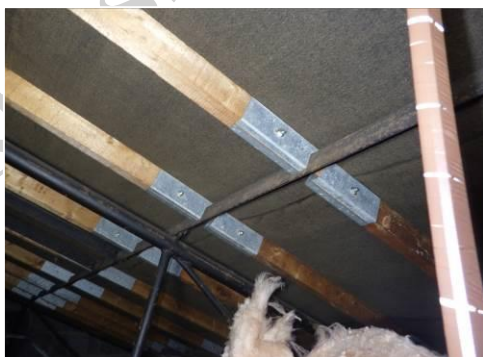
Common rafters with metal sections

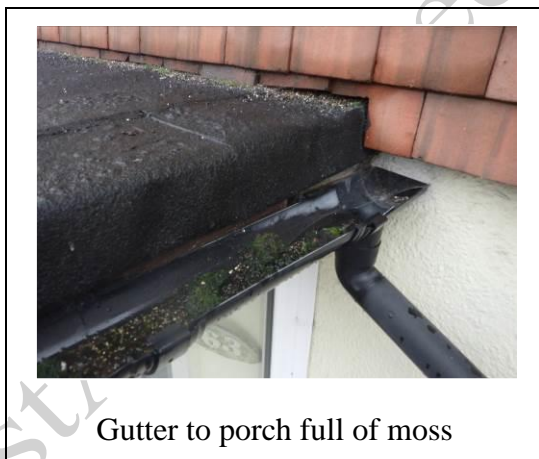
Gutter to porch full of moss

We also recommend that the gutters and downpipes are cleaned out, the joints are checked and the alignment checked to ensure that the gutters fall towards the downpipes.

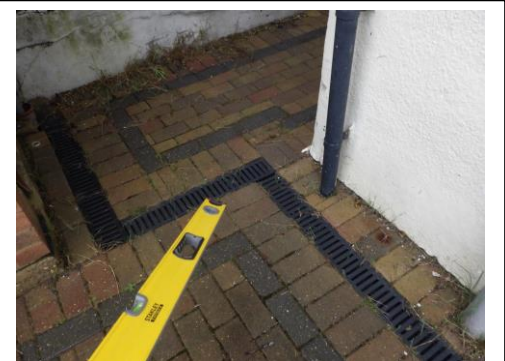
The downpipes feed directly into the ground so if there is a blockage then the drain would have to be opened up. This is a practice we are not particularly keen on; we would much prefer a gully.

Front right downpipe feeds directly into ground

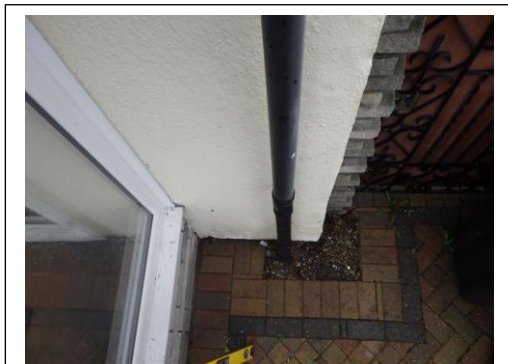
Rear right downpipe feeds directly into ground

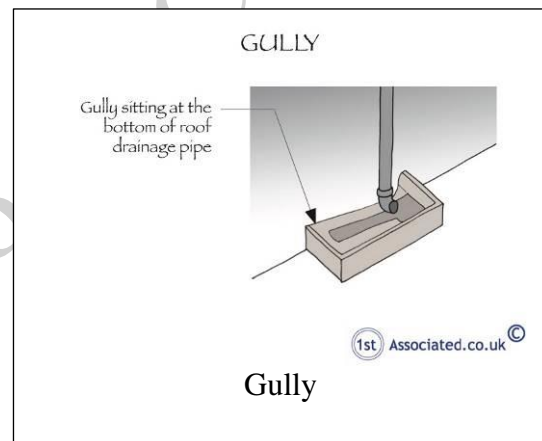
GULLY

Gully sitting at the bottom of roof drainage pipe

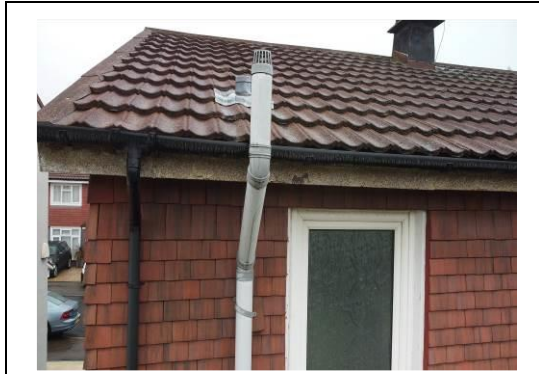
Relatively new plastic soil and vent pipe

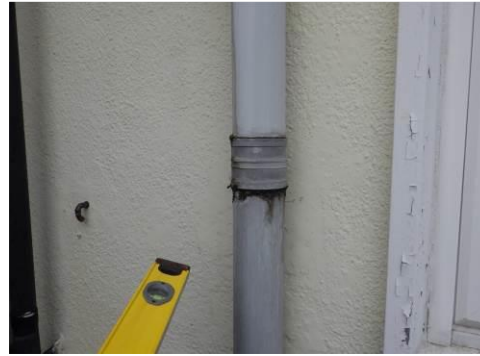
Soil and vent pipe leaking slightly

ACTION REQUIRED: Add some form of protection between the flue and the soil and vent pipe to stop it damaging it. We also noted the soil and vent pipe was various different colours of plastic. It may be that it is an older style plastic which does get affected by sunlight. You need to monitor/check the soil and vent pipe from time to time.

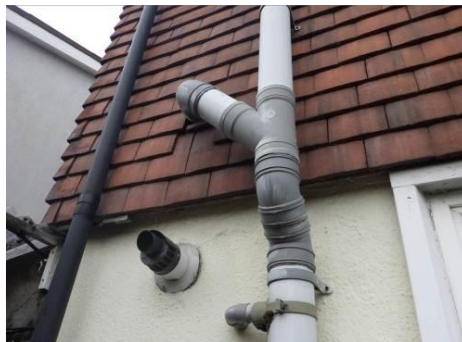
Soil and vent pipe close to flue

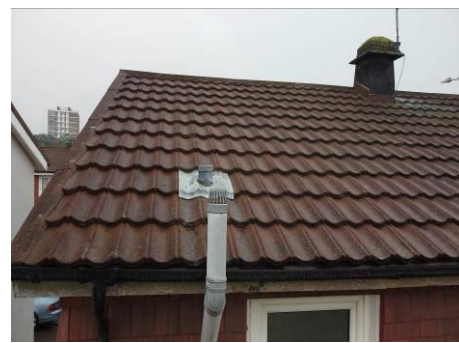
Old capped off soil and vent pipe to rear right

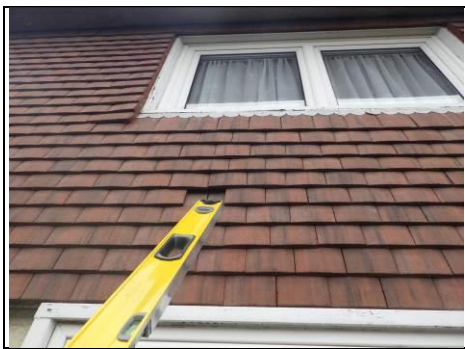
It is generally in average condition, but we did note a missing tile or two to the front.

Missing tile to front

ACTION REQUIRED: Replace missing tiles.

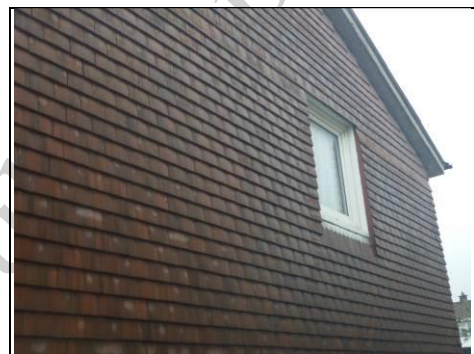
Vertical tiling to right gable

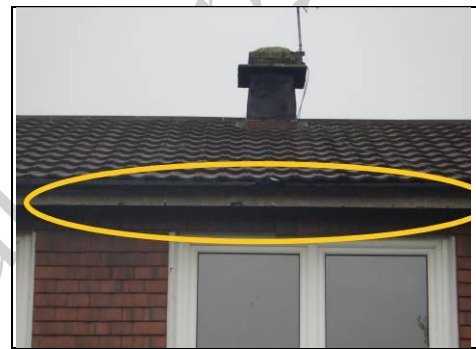
We believe the fascias and soffits may be asbestos.

Fascias and soffits

ACTION REQUIRED: We would always recommend any asbestos is removed from a property as it can not only be dangerous, it can affect the value of the property.

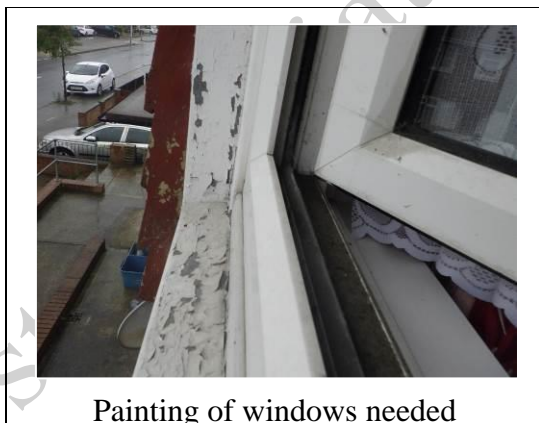
The property has double glazed tilt and turn windows in a metal frame without trickle vents. The windows are in below average condition, with redecoration of the metal surrounds required.

Painting of windows needed

ACTION REQUIRED: Redecorate. We recommend you add trickle vents.

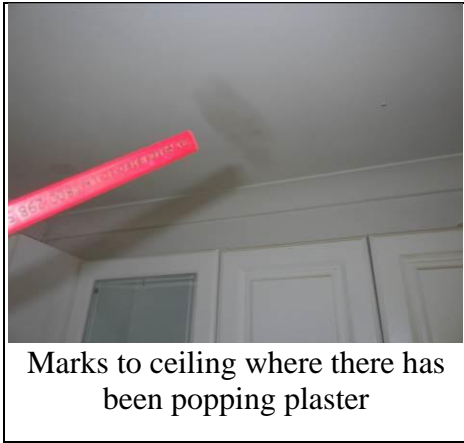
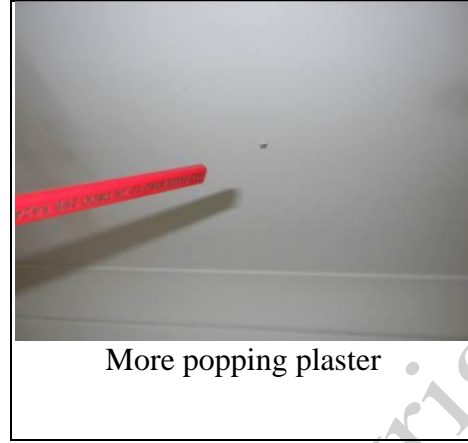
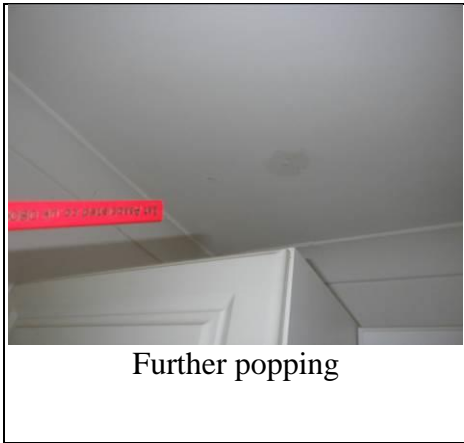
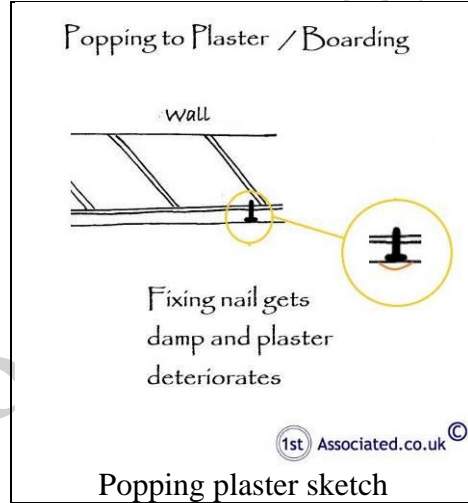
We noted popping of the plaster to several of the ceilings, for example the kitchen area. As we discussed, it could have been from water getting through from the bathroom above however it could also be from condensation and humidity.

ACTION REQUIRED: Please see our comments in the Executive Summary.

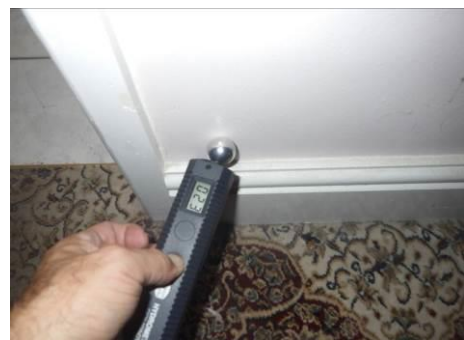
A random visual inspection and tests with a moisture meter have been taken to the perimeter walls. In this particular case, we were unable to obtain readings due to the dry lining.

Low rising damp readings due to dry lined walls

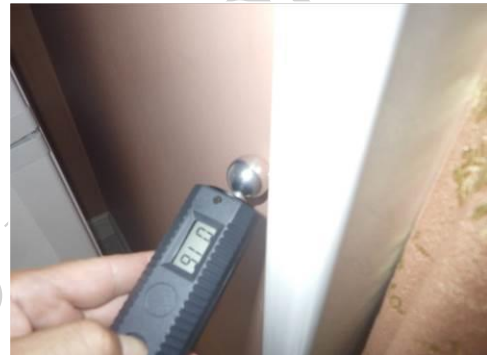
We used a resistance meter on the external walls. In this case, we were unable to obtain readings due to the dry lining.

Unable to obtain lateral damp readings due to dry lining

ACTION REQUIRED: You need to open up the walls.

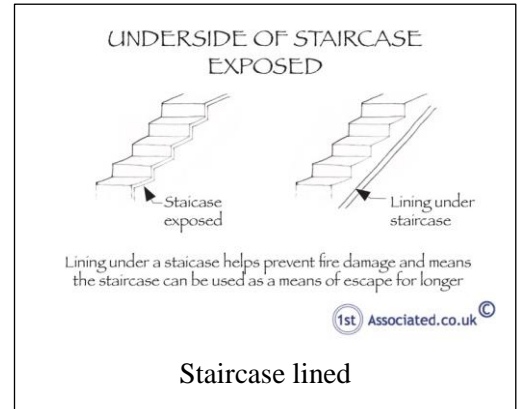
We were unable to examine the underside of the stair timbers due to it being lined where we could see it, which precluded our inspection, so we cannot comment further upon the stair structure. We can, however, say that the lining gives a resistance to the spread of fire if such circumstances were to occur.

Staircase lined

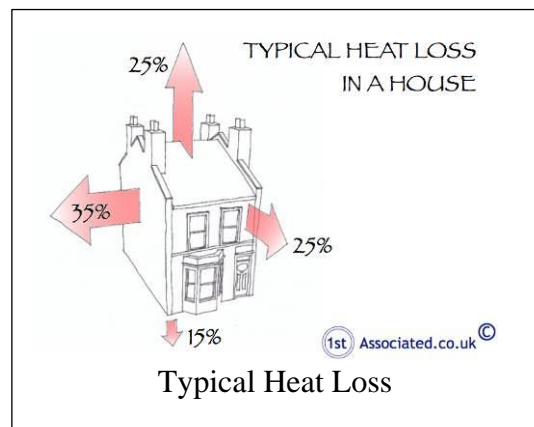
Some roof insulation was present although not to current Building Regulations requirements of 300mm. In this instance there is between 200mm to 300mm and no insulation in some areas.

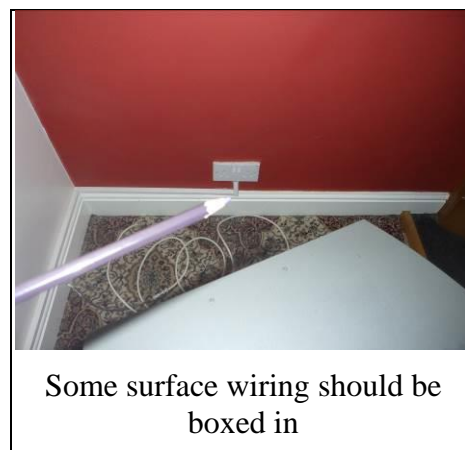
Some surface wiring should be boxed in

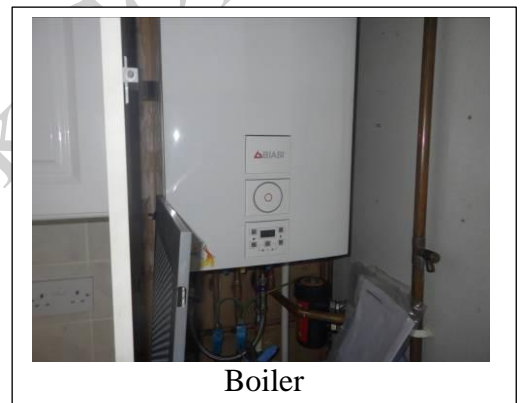
The wall mounted Biasi boiler was located in the kitchen. This is a make of boiler we rarely come across so it may be difficult to obtain replacement parts. In our vendor's questionnaire we were advised it was last serviced in 20XX.

Our limited inspection of the hot water and central heating system revealed no evidence to suggest any serious defects but we would nevertheless recommend that the system be tested and overhauled before exchange of contracts and that a regular maintenance contract be placed with an approved heating engineer.

ACTION REQUIRED: Please see our comments in the Executive Summary.

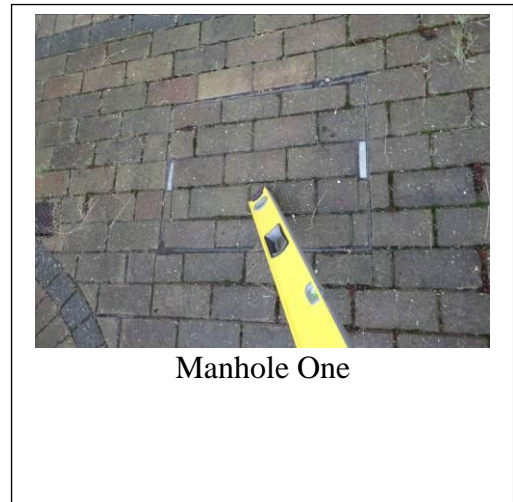
We were unable to lift the cover therefore are unable to comment.

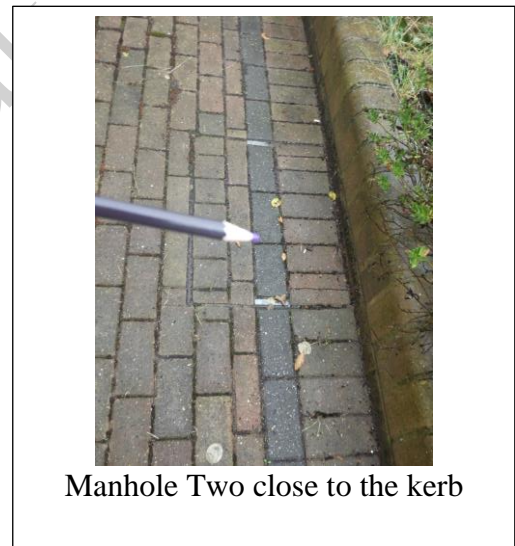
Inspection Chamber/ Manhole Two - located to the front right

Again we were unable to lift the cover therefore are unable to comment.

ACTION REQUIRED: We recommend a closed circuit TV camera report of the drains to check their condition.

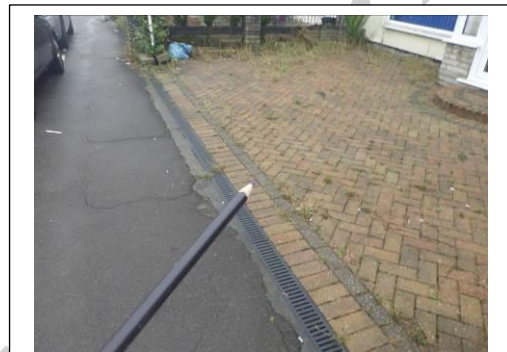
The front garden has been paved over for parking. There is a running gully. There is a slight slope to the front of the property.

Front garden paved for off road parking, with a running gully

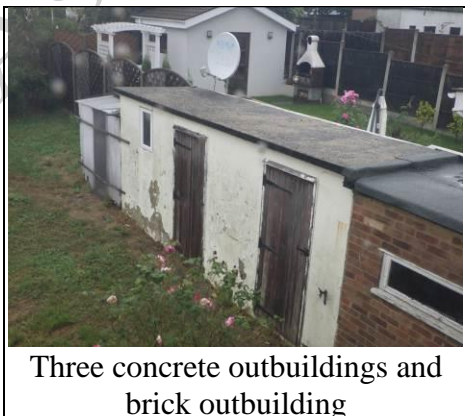
Three concrete outbuildings and brick outbuilding

ACTION REQUIRED: Please see our comments in the Executive Summary. We would recommend nothing valuable is stored in the outbuildings.

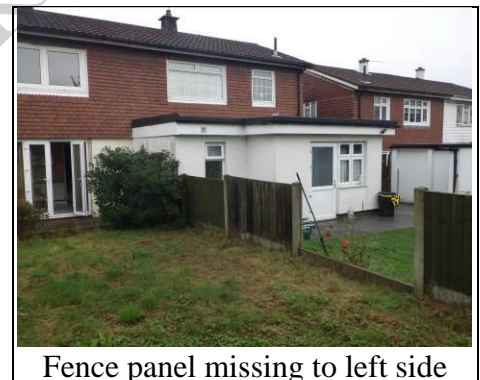
In this case we noted a fence panel missing to the rear left fence, typically this would be your responsibility but this needs to be checked by your solicitor.

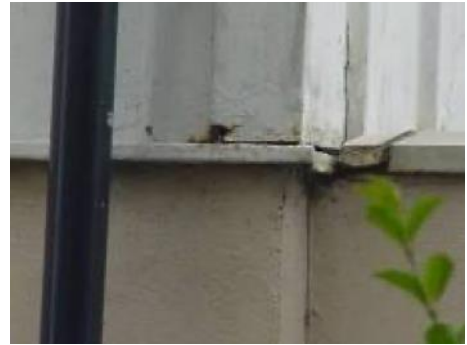
Rusting to profile metal cladding

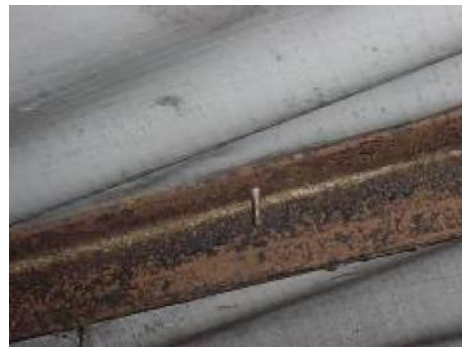
Example of rusting that we have seen in the roof of a metal framed building

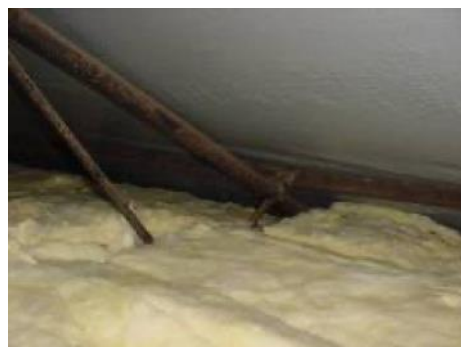
Example of over insulation of a metal framed property which causes condensation

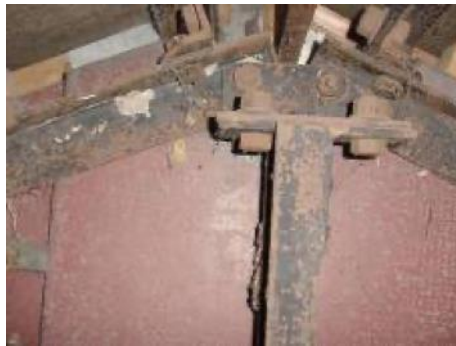
Rusting to a lightweight metal frame or damage or deterioration to the metal frame of a non-traditional house

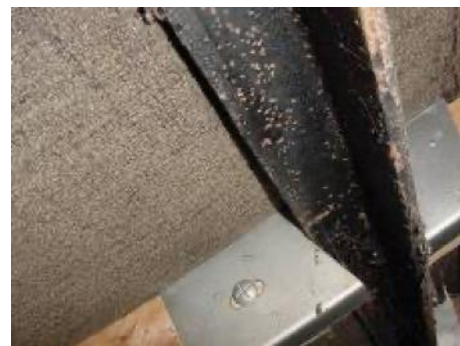
Some fixings replacements/repairs to a non-traditional house

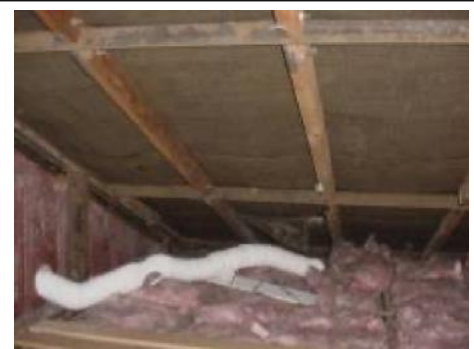
Extract vent to outside often discharges into roof which is essential that they do not in this type of roof

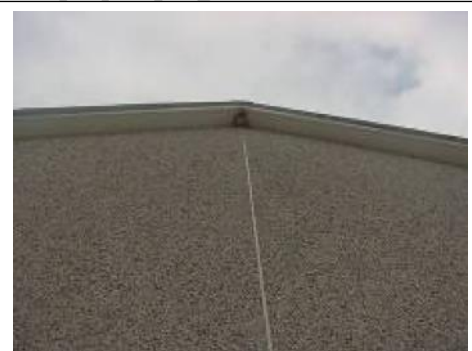
Jointing to a non-traditional house

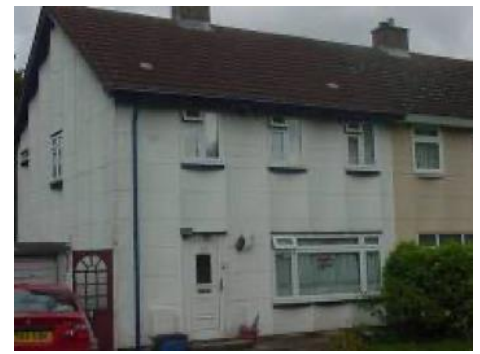
Non-Traditional house mainly
asbestos

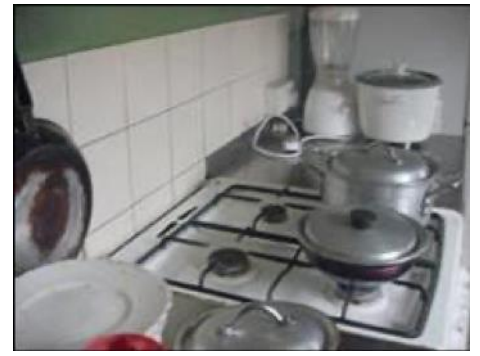
Cooking produces steam and requires ventilation
