Non Traditional Example Residential Building Survey

This is a modern timber frame property which were typically built in the 1980's till today (we have found sales going back to 2006 on Rightmove of nearby properties therefore we assume this is the approximate date of construction although they may have been built quite a bit earlier than this). If the age of the property interests you your Legal Advisor may be able to find out more information from the Deeds.

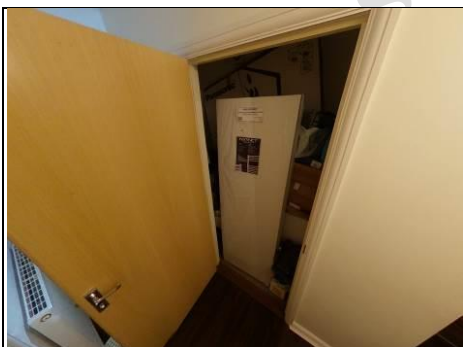
WC left full of stored items

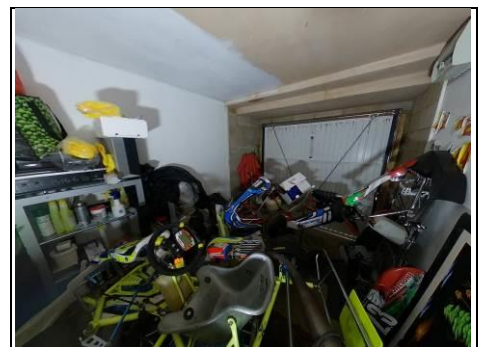
Garage full of stored items

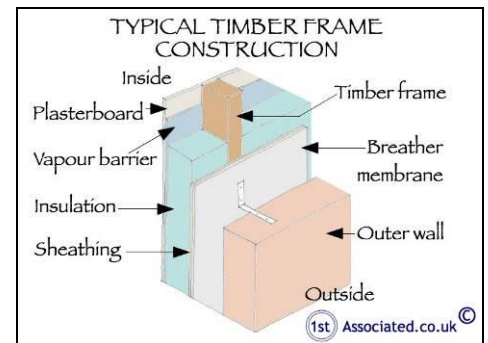
Timber frame

We noted efflorescence to the brickwork in many areas which is a salt coating. This is a fairly common factor in timber frame buildings.

This is caused by the walls never drying out. This, we believe, is a combination of external weather factors and the internal environment of humidity created inside such as showers, baths, cooking, breathing, etc as to the appearance of salts. This is a personal opinion, we have never seen any technical information on it, we have seen efflorescence regularly on timber frame buildings brick walls.

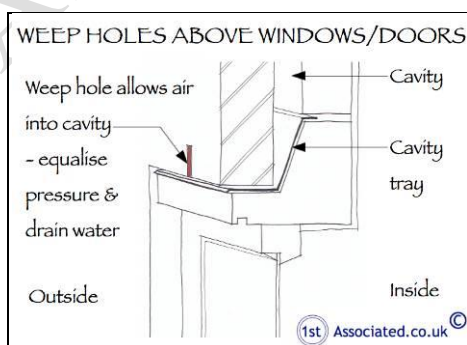
The weep holes are an example of how the designers tried to remove the moisture from within the structure.

Weep hole

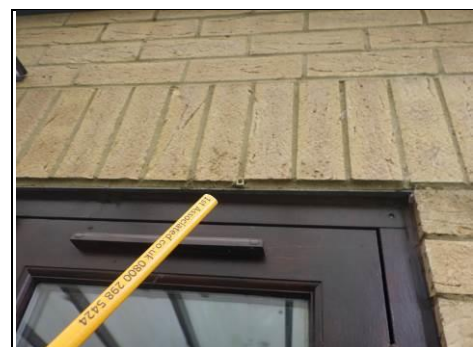
Weep hole above window

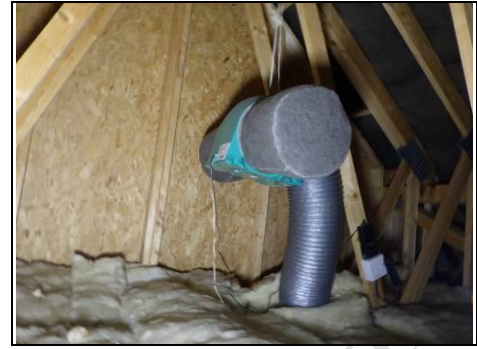
Within the roof we have identified a positive pressure fan. These are used where there are condensation problems and black mould problems. The aim of them is to create an airflow within the property. It draws air from within the roof space, sometimes it warms it up or changes its temperature and then pushes the air with the positive air pressure around the building. Nevertheless, we think there have been problems with black mould in this property.

Positive pressure fan in roof space

ACTION REQUIRED: You need to speak to the Housing Association or whoever has the shared ownership with this building to ask them to provide a detailed record of problems in relation to condensation, black mould, etc. in the property.

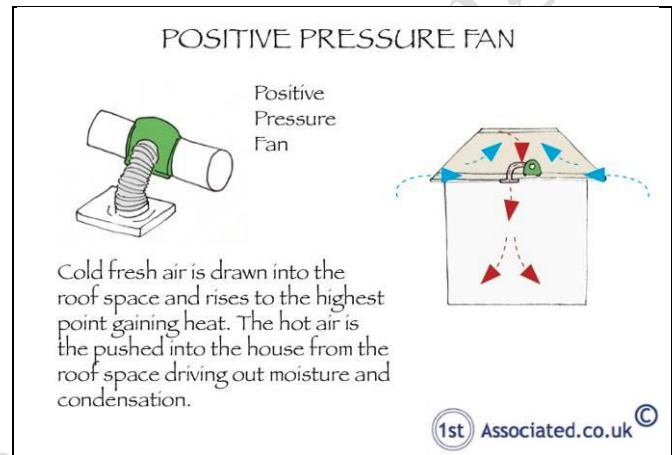
Positive pressure fan

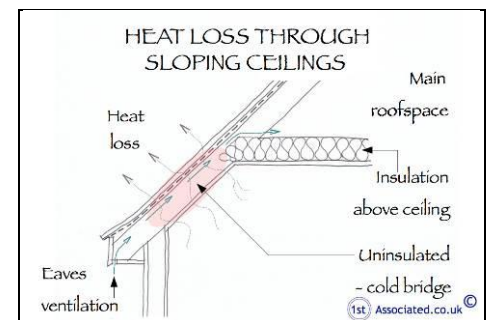
The bedroom ceilings are formed partly within the roof therefore during hotter weather you will get some heat gain unless they are very well insulated and equally in the colder weather you will get heat loss.

Heat loss through sloping ceiling

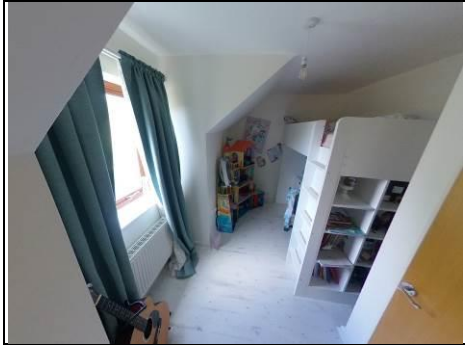
Rear bedroom sloping ceiling

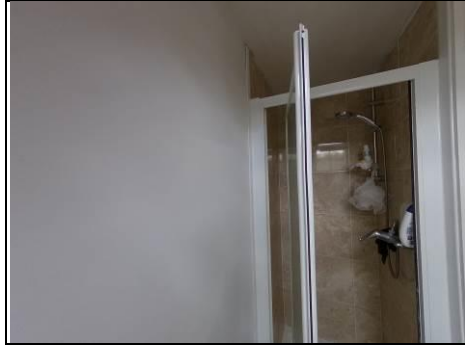
Front en-suite shower room sloping ceiling

We believe there are problems with ventilation and black mould particularly around the en-suite shower room and the bedroom.

ACTION REQUIRED: We would recommend adding a large humidity controlled extract fan in the shower room. By large extract fans we mean 150mm. Unfortunately, this is quite a difficult job and will need some sort of air vent externally.

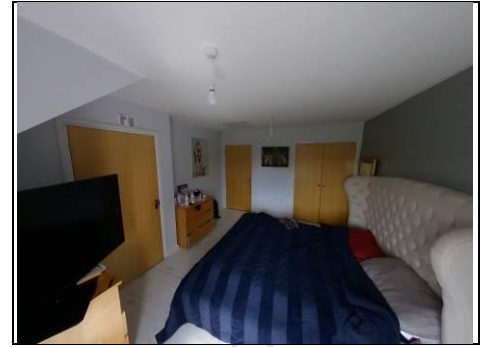
Front bedroom sloping ceiling

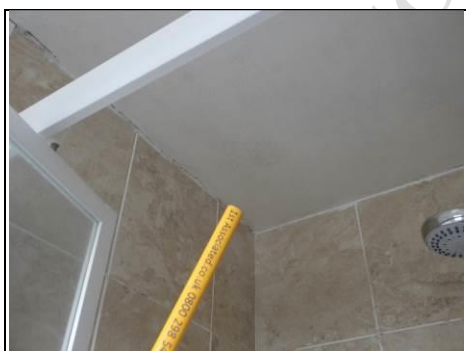
Black mould in shower unit

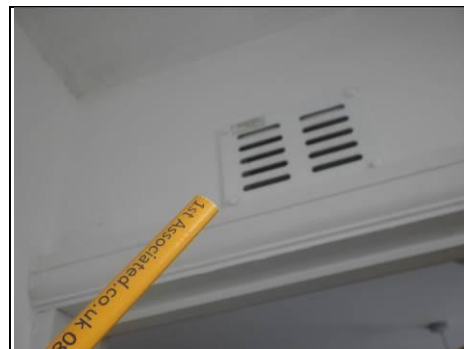
Vent above en-suite door

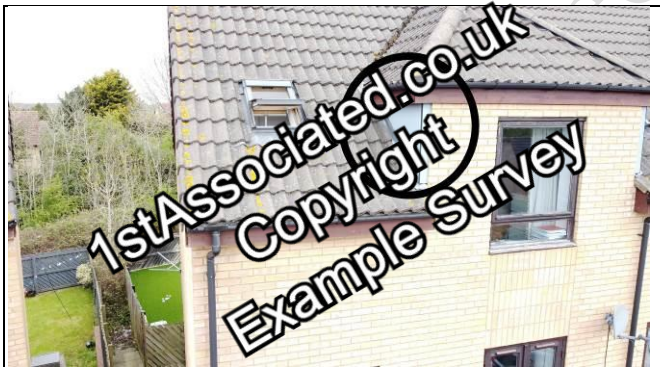
We believe that black mould will be problematic in this area due to the design of the building which is very difficult to resolve. Externally we can see the dormer roof has what we would term a lightweight construction timber frame and cold bridging will occur in these areas which in turn leads to black mould.

Lightweight dormer
~ Aerial View - 360 Photo ~

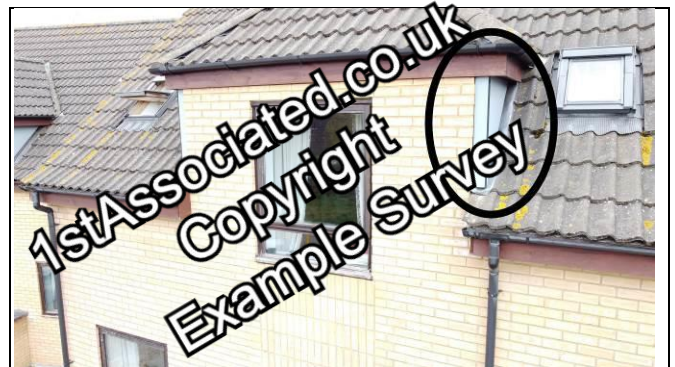
Timber frame to side of dormer
~ Aerial View - 360 Photo ~

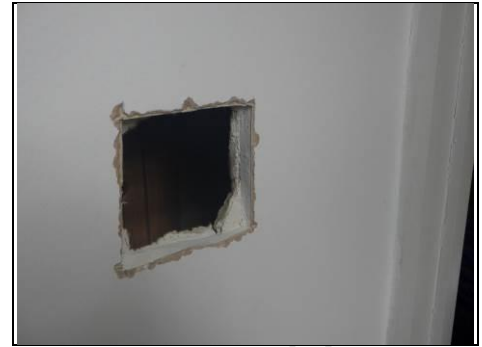
There looks to be some work taking place in the shower room; you need to enquire as to what this is.

Hole in en-suite wall

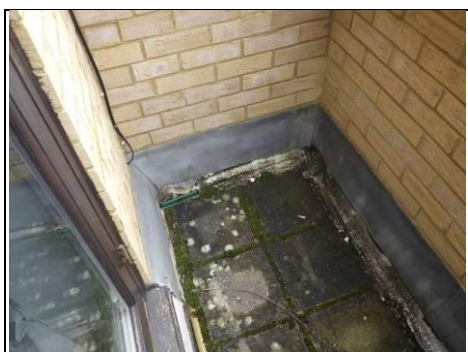
We could see dampness on the balcony. There is an awkward detail where the balcony tries to drain into the hopperhead which does not appear to have a sufficient fall and has led to the balcony becoming covered in moss.

Dampness to balcony

ACTION REQUIRED: Investigate further when the garage has had stored items removed and is able to be viewed.

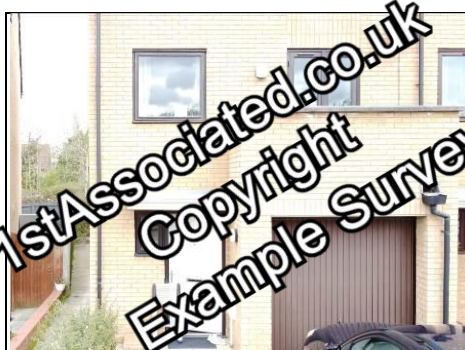
The balcony is directly over the garage which we did not have proper access to therefore we would not be surprised if dampness is coming into the garage.

Balcony over garage

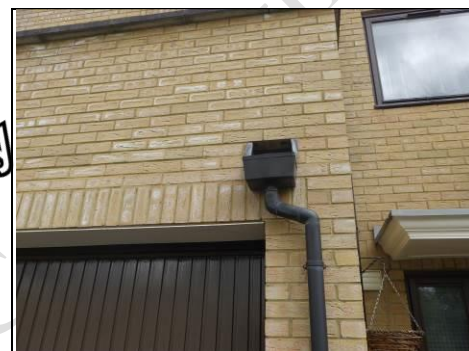
Hopperhead to balcony

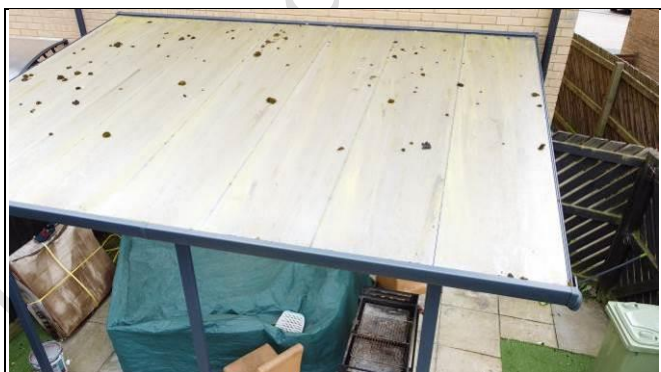
To the rear patio there is a metal frame with a plastic canopy. It needs to be checked whether this needs planning permission or not.

Rear canopy

ACTION REQUIRED: Your legal advisor to check and confirm.

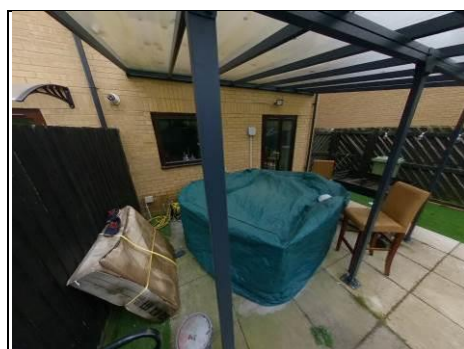
Rear covered paved area

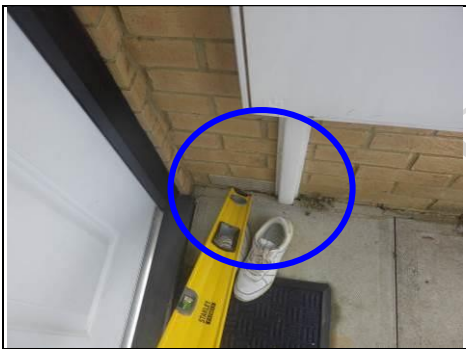
The floor needs an airflow underneath it and unfortunately the airbricks which should ventilate the floor unfortunately are too low and are acting as gutters. We can see moss around the rear airbrick.

Front air brick low

ACTION REQUIRED: Protect airbricks and ensure that no water gets into the property. Also, ideally we would recommend the floors are opened up. You need to speak to whoever has the shared ownership of the property and see if they will open up the floors or if there is a known about problem.

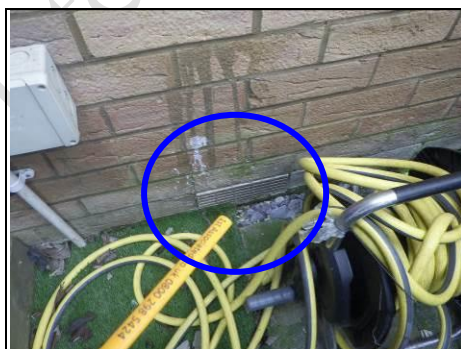
Rear airbrick acting as gutter

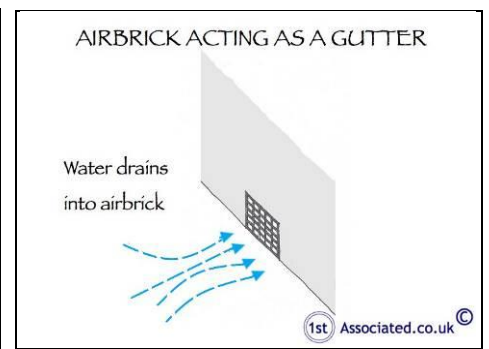
Airbrick acts as gutter

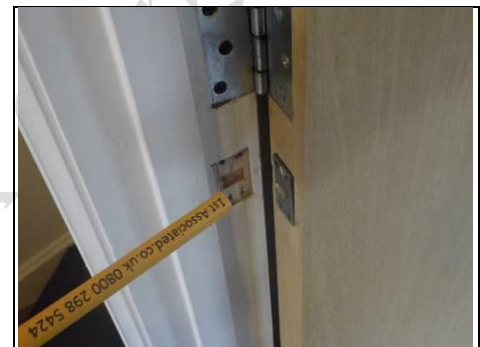
Throughout the property we noted various fire doors have had the central door closer removed (often known by its generic name of Perco).

Door closer removed

ACTION REQUIRED: Re-install all of the fire doors. We would normally expect to see an intumescent strip around the doors to indicate that they have a fire rating and they seal when they are heated.

ANTICIPATED COST: £1,000 - £2,000 depending upon whether the existing doors are fire doors and can be repaired or replaced; ask the owners/shared ownership. Please obtain quotations before you legally commit to purchase the property.

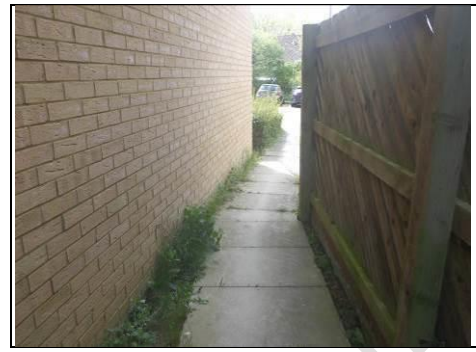
Path

There is a shared access on the left side of the building which leads to the gardens but then continues where it is overgrown. We were wondering whether this is a right of way or not.

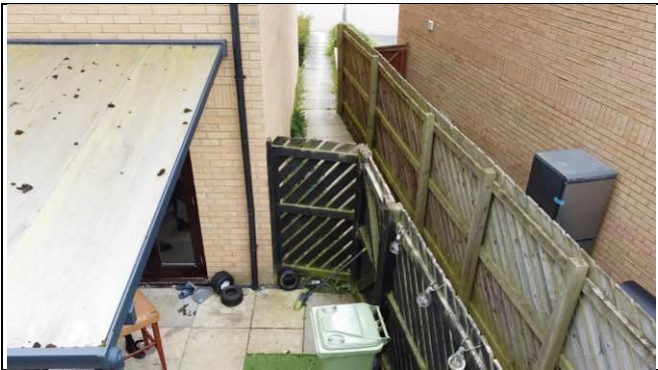
Shared left path
~ Aerial View - 360 Photo ~

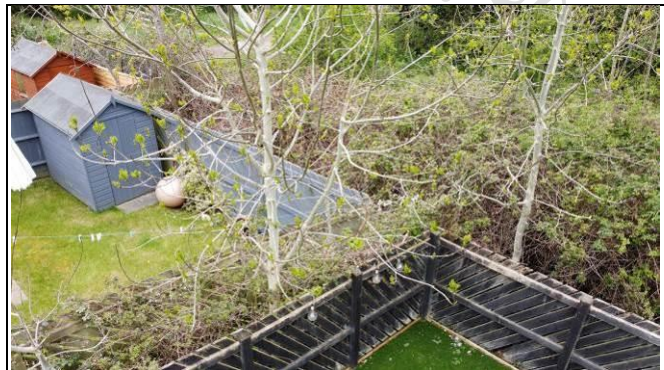
Access path and trees
~ Aerial View - 360 Photo ~

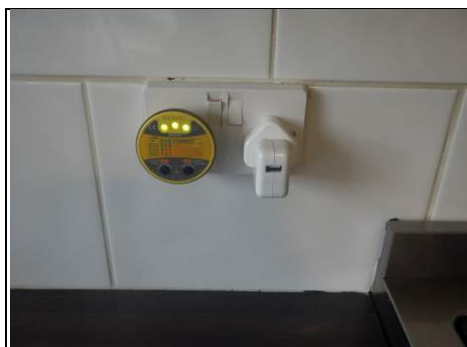
The electrics tripped when we carried out our usual earth test. We also noted the need for extra socket points.

Earth test passed second and third time

The Institution of Engineering and Technology (IET) recommend a test and report when properties change hands, to be carried out by an NICEIC registered and approved electrical contractor or equivalent.

- 1) £250 - £500 for test and report
- 2) £250 - £500 for a new fuse board
- 3) In the region of £100 - £200 per additional socket point
- 4) Plus any further work recommended

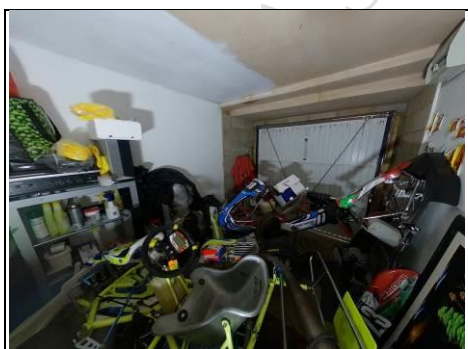
There were a lot of stored items which restricted our view, for example we were unable to get in the garage properly or the WC. There looks to be an older/original fuse board and we noted some lightbulbs were missing meaning that we had to use torchlight to view some areas.

Stored items in garage

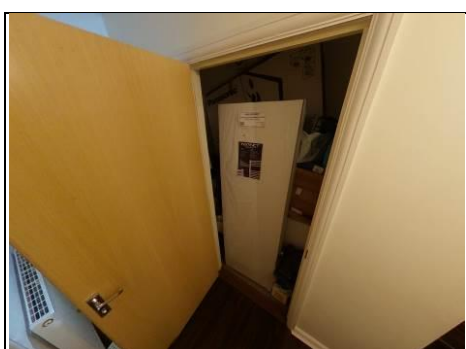
WC left full of stored items

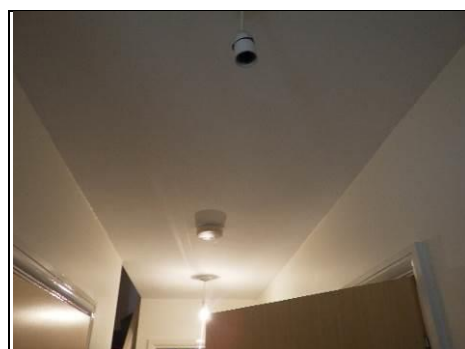
Lightbulbs missing

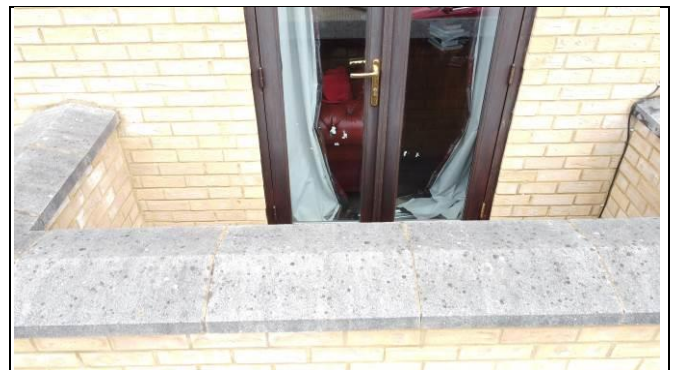
Balcony
~ Aerial View - 360 Photo ~

There are some relatively poor details here such as drainage from the balcony area. This type of property is relatively modern (i.e., less than one hundred years old) but nevertheless still requires ongoing maintenance and repair. A budget for such work must be allowed to ensure it is maintained in a good condition. This will prevent undue and unnecessary deterioration.

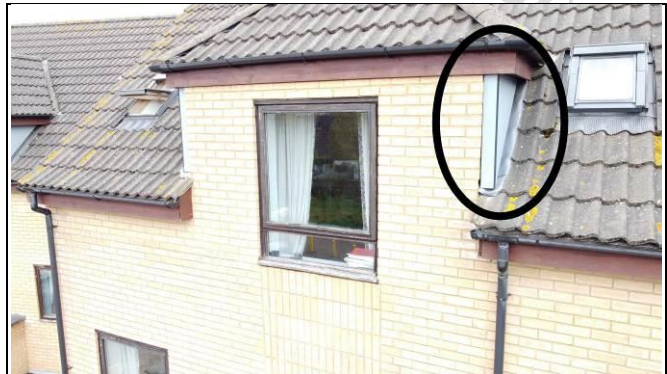
Front dormer timber frame
~ Aerial View - 360 Photo ~

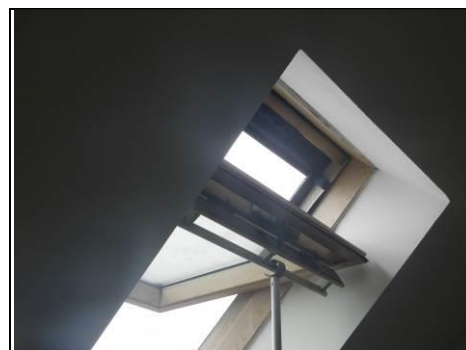
The property has a purpose made roof window. In this instance we would comment that it looked in reasonable condition.

It seems inevitable with roof windows that they will sooner or later leak. If this doesn't occur then they seem prone to condensation. Keep a cloth handy!

Roof window in en-suite

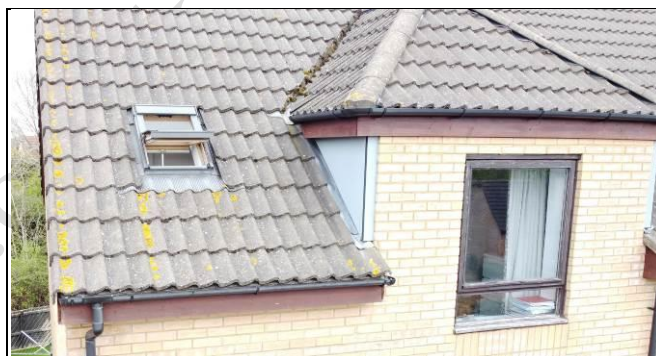
The main roof is pitched and clad with a concrete tile. From ground level, this looks in average condition considering the roof's age, type and style.

Concrete tiles
~ Aerial View - 360 Photo ~

There is some slight moss on the roof. The moss can hold water against the tiles and cause them to have accelerated deterioration. We recommend removing moss with a soft brush, we do not recommend high pressure cleaning or chemicals are used on the roof tiles as they can damage the tiles.

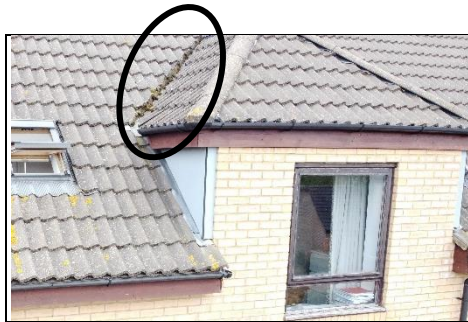
This property has valley gutters which we could not see properly which are generally a problematic area.

Valley gutter

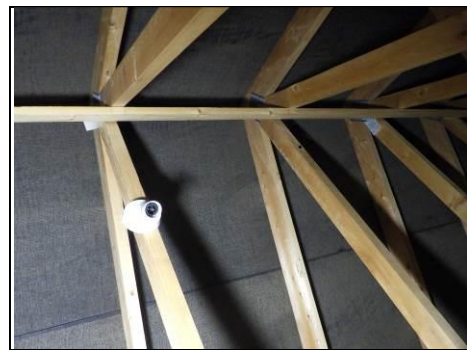
When we inspected the loft space we found a Hessian base Bitumen membrane. This type of membrane has been used since the 1960's. We generally found it to be in average condition, with damage in some areas which is what we typically find.

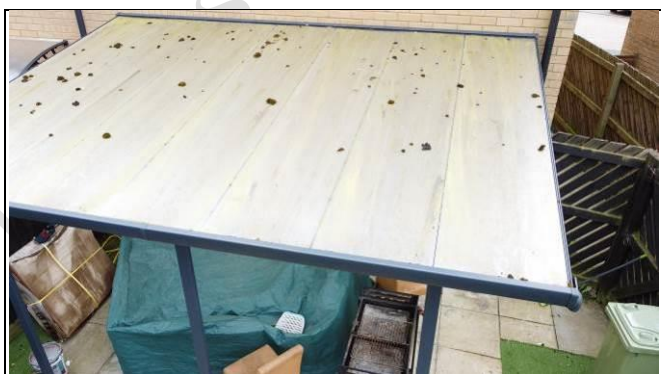
To the rear patio there is a metal frame with a plastic canopy. Your legal advisor to check and confirm this has planning permission.

Rear canopy

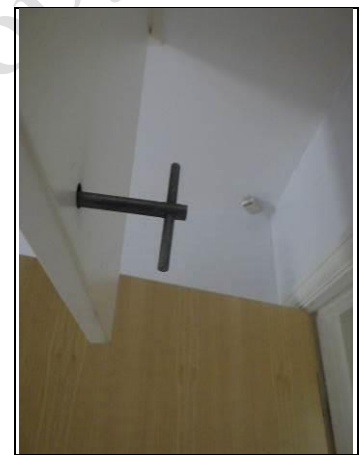
The main roof is accessed via the loft hatch located on the landing. A key is required to get into the roof. The owners advised they have lost their key – you need to ensure they get a replacement key.

Key for loft hatch

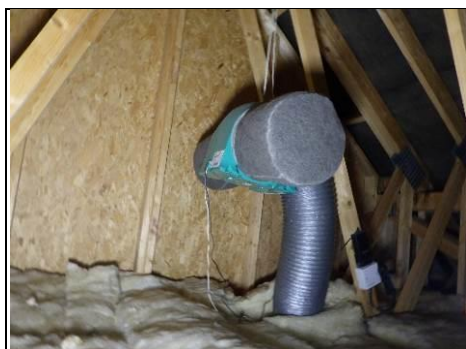
The left gable end is plywood and the right gable which is also the party wall has a plastic sheet. This should be fire resistant however we cannot confirm.

Left gable plywood with positive pressure extract fan

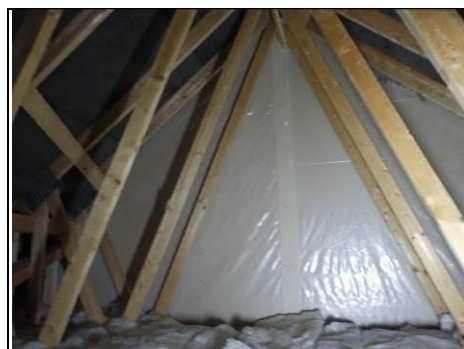
Plastic sheet to right gable

ACTION REQUIRED: Your legal advisor to check and confirm that it is a fire resistant party wall and that fire cannot be spread from one property to another.

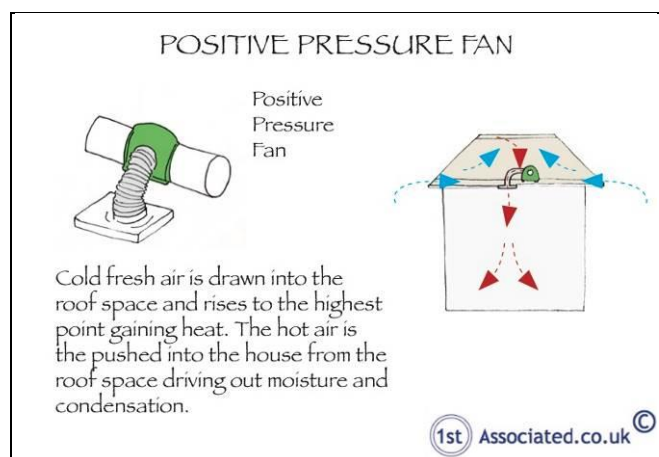
Within the roof space we could see a positive pressure extract fan/air movement unit which are normally introduced where there is black mould.

Positive pressure fan

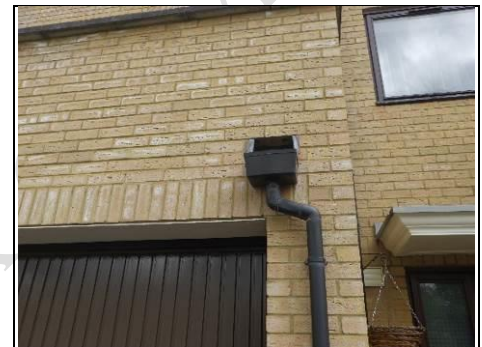
Balcony hopperhead

There is an awkward detail where the balcony tries to drain into the hopperhead which does not appear to have sufficient fall and has led to the balcony becoming covered in moss.

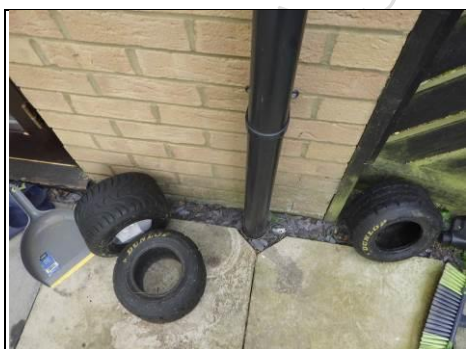
The downpipes feed directly into the ground. This is a practice we are not particularly keen on as we cannot be certain where they go, so if there is a blockage then the drain would have to be opened up. We would much prefer a gully.

Downpipes feed directly into ground rear left corner

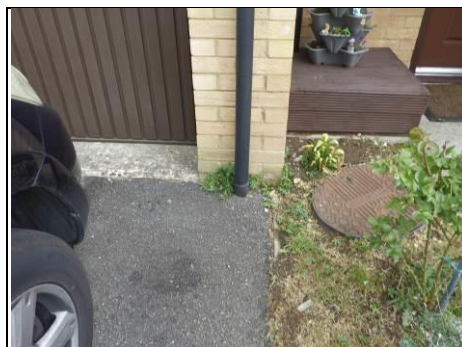
Downpipe into ground right corner of garage

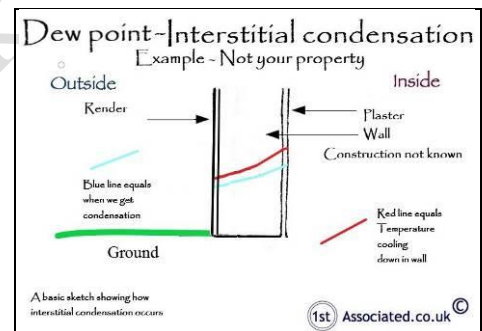
We have come across problems with interstitial condensation in this era of property. Again, without opening up the structure it is difficult to confirm. This problem needs to be raised with the existing owners.

Interstitial condensation

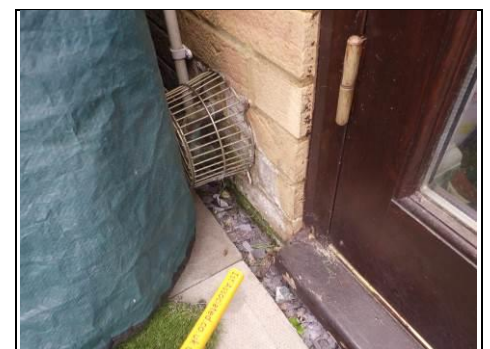
Please see our earlier comments regarding airbricks acting as gutters and moss to the base of the property.

Moss to rear base

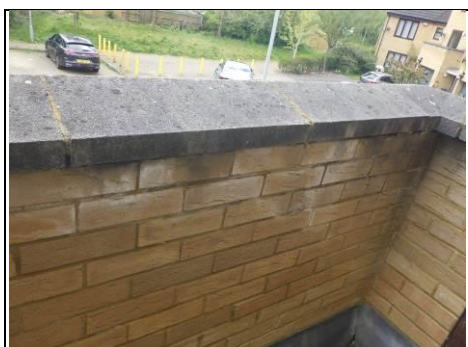
The balcony wall looks to be damp. This may be due to the coping stone not having sufficient drip detail.

Balcony wall damp

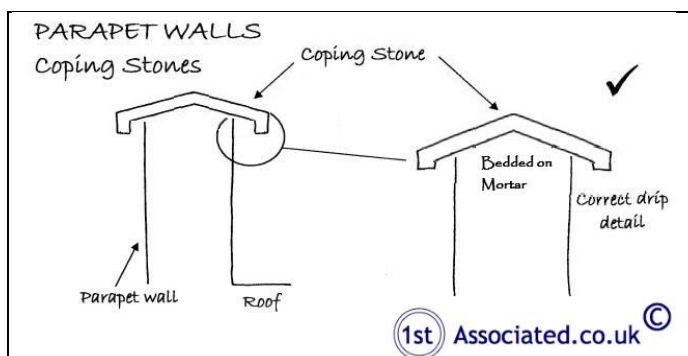
Parapet wall coping stone

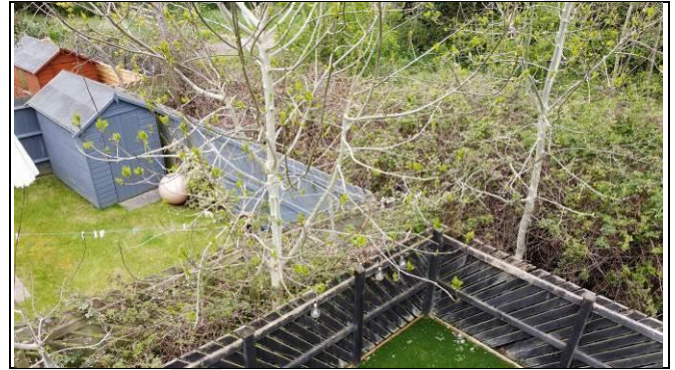
There are trees outside what we would term as influencing distance however they do need maintenance.

Trees to rear
~ Aerial View - 360 Photo ~

ACTION REQUIRED: You need to establish who owns the trees.

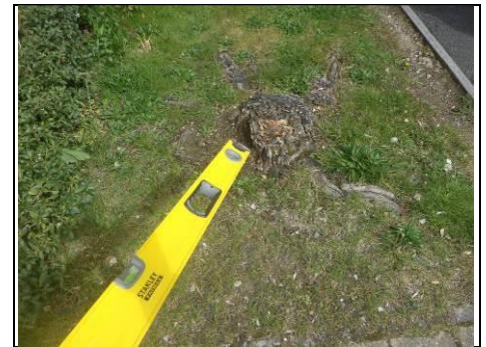
There looks to have been a substantial tree cut down to the front.

Tree cut down

ACTION REQUIRED: You need to find out further information regarding this. We would be happy to comment further or you could instruct an arboriculturalist (not a tree surgeon).

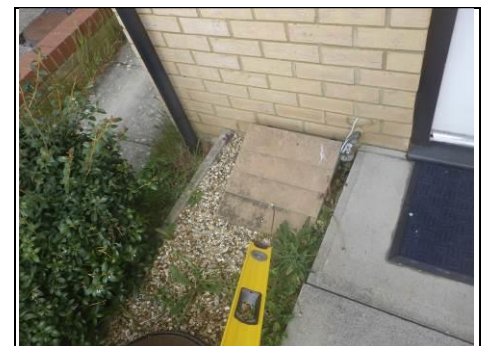
There was no damp proof course visible however we noted a change of levels around the building which can result in the damp proof course being bridged. There was moss to the base of the property at the time of our survey.

Change in levels

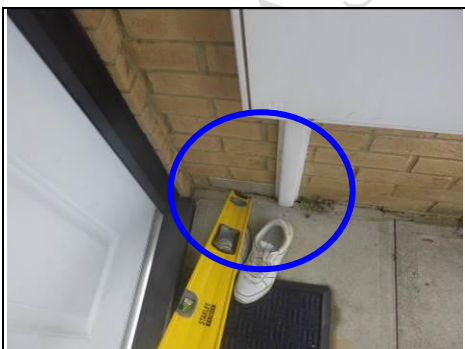
The floor needs an airflow underneath it and unfortunately the airbricks which should ventilate the floor are so low they are acting as gutters.

Front air brick low

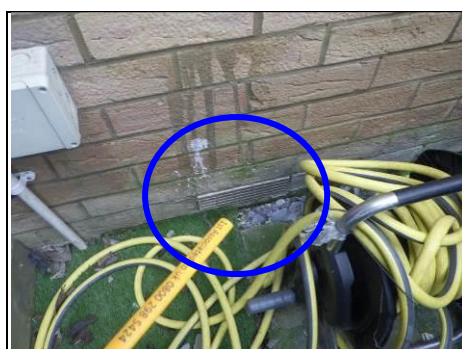
Rear airbrick acting as gutter

The property has a suspended floor, we do not know whether this is concrete or timber as we have not opened it up. We can see airbricks at each end of the property that are acting as gutters.

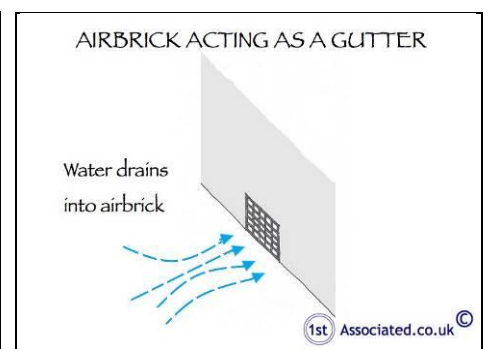
Airbrick acts as gutter

We have not visually seen any signs of significant wet rot during the course of our inspection. Wet rot could occur to the windows and fascias and soffits if it isn't redecorated. Also, if it is a suspended timber floor this could be deteriorating due to the airbricks acting as gutters.

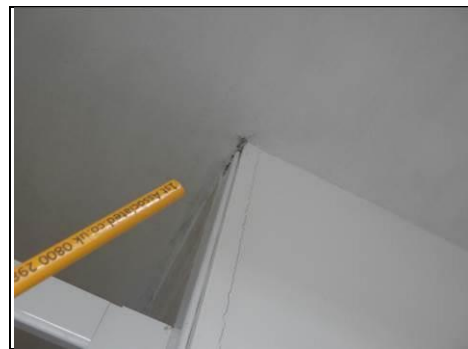
Black mould in en-suite

ACTION REQUIRED: We would recommend large humidity controlled extract fans be added to kitchens, bathrooms and any rooms where you intend to dry clothes.

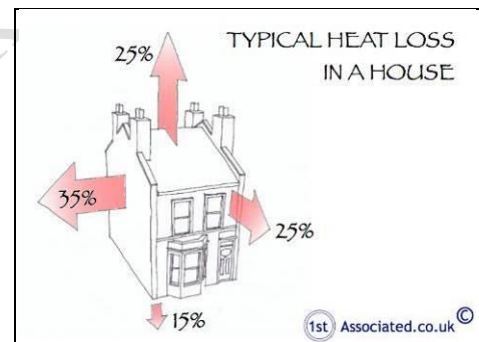
Some roof insulation was present although not to current Building Regulations requirements of 300mm. In this instance there is 200-300mm.

Typical heat loss

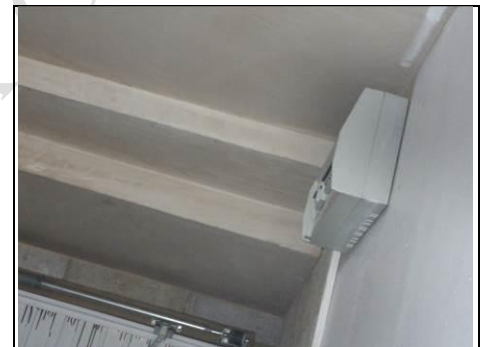
The electric fuses and consumer units were located in the garage, we were unable to have a close inspection due to the stored items in the garage particularly go-carts.

Fuse board in garage

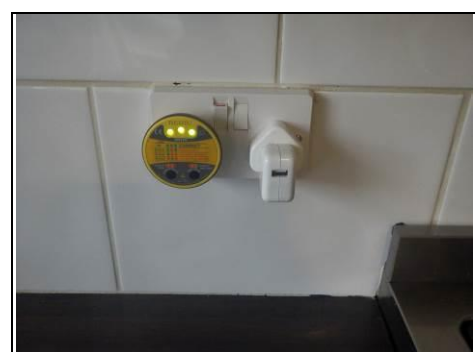
We found the kitchen in average condition, subject to some wear and tear as one would expect. Please note our comments with regards to the electric earth test failing on our first test in the kitchen socket.

Earth test passed second and third time

ACTION REQUIRED: We recommend a new fuse board with a fire resistant metal case and would advise as the property is changing occupancy the Institution of

Engineering and Technology (IET) recommend a test and report. Any recommendations from the report should be carried out by a NICEIC registered, or equivalent, approved electrical contractor or similarly approved.

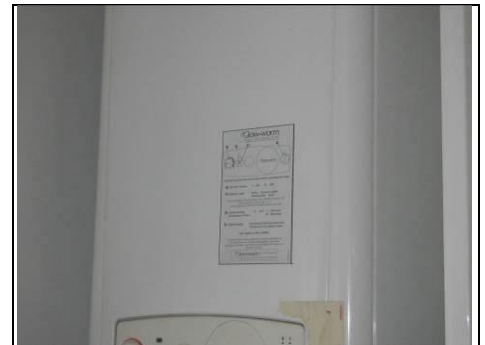
There is a Glow worm boiler located in the kitchen. This looks to be an older boiler and you should budget to replace.

Glow worm boiler

Our limited inspection of the hot water and central heating system revealed no evidence to suggest any serious defects but we would nevertheless recommend that the system be tested and overhauled before exchange of contracts and that a regular maintenance contract be placed with an approved heating engineer.

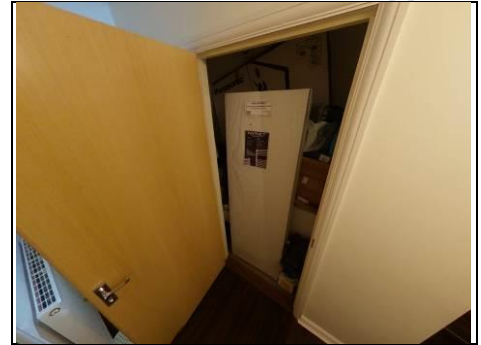
We were unable to access the cloakroom due to the mass of stored items.

WC left full of stored items

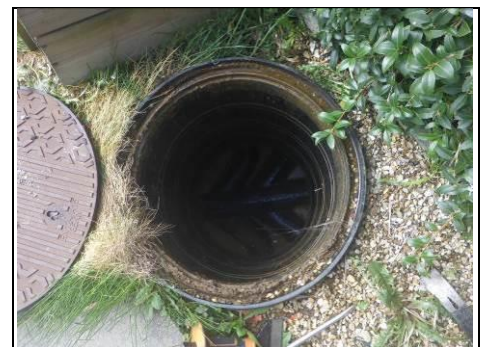
We duly lifted the cover and found it to be clear at the time of our inspection.

From what we could see it is plastic built.

Front manhole

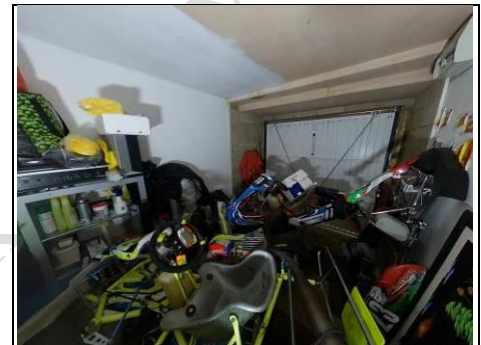
The property has a garage on the right side which was full of stored items at the time of our inspection particularly go-karts.

Garage full of stored items
