# Non Traditional Example Residential Building Survey

NON TRADITIONAL CONSTRUCTION STRUCTURAL FRAME HOUSE

## BISF FRAME

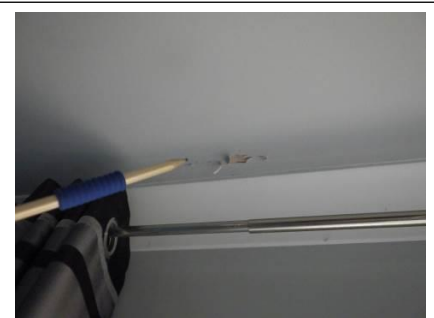
Dampness or condensation in main bedroom

**ACTION REQUIRED:** We would recommend large good quality humidity controlled extract fans are added to the kitchen, the bathroom and any areas that are used for drying clothes internally during winter months (we would assume that clothes will be dried externally during the warmer months). By large extract fans we mean 150mm.

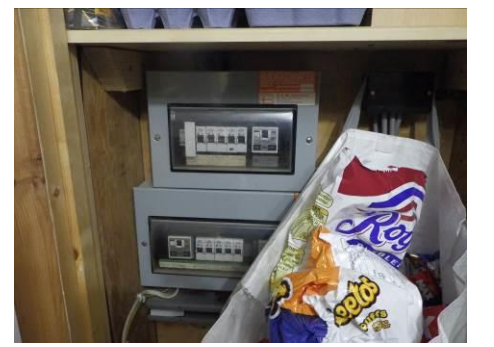
The fuse board is dated and the electricians failed our earth test. We also noted that some of the light sockets were loose.

1980's-2000 fuse board in kitchen

**ACTION REQUIRED:** We recommend a new fuse board with a metal casing; modern standards require half hour to one hour fire resistant casing around a fuse board.

We recommend a test and report and as the property is changing occupancy an Institution of Engineering and Technology (IET) test and report and any recommendations should be carried out by a NICEIC registered, or equivalent, approved electrical contractor or similarly approved.

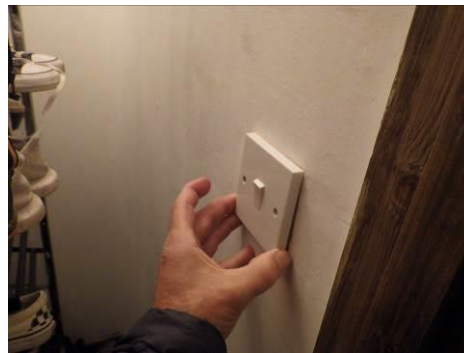
Light socket loose

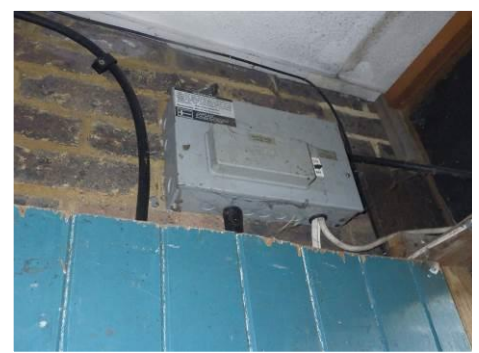
1960's-1980's Fuse board in right side area

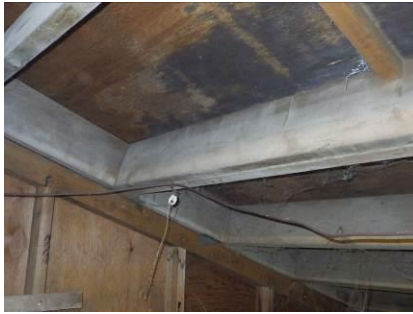
The roof is pitched and clad with flat concrete tiles and, from ground level, this looks in below average condition considering the roof's age, type and style. We can see dampness and mould within the roof space. The roof could be allowing wind driven rain in; please see our comments in the Executive Summary.

Mould to roof

**ACTION REQUIRED:** Please see our comments in the Executive Summary.

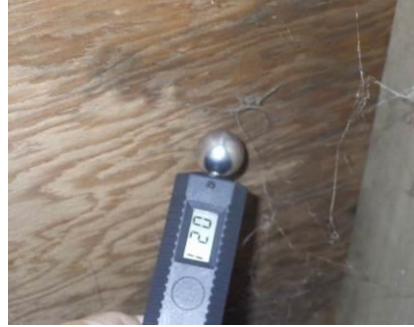
High damp meter reading of 120 in roof

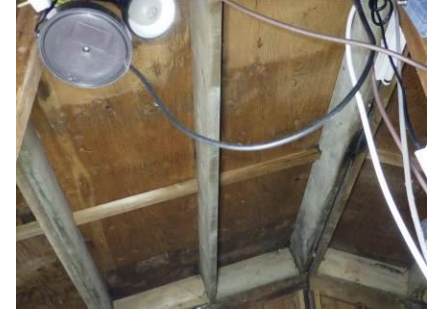
Dampness to main roof

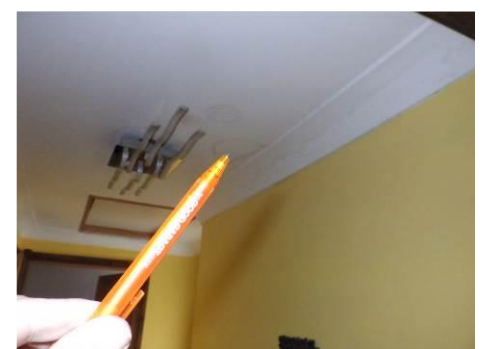
Water leak from toilet

**ACTION REQUIRED:** Please see our comments in the Executive Summary.

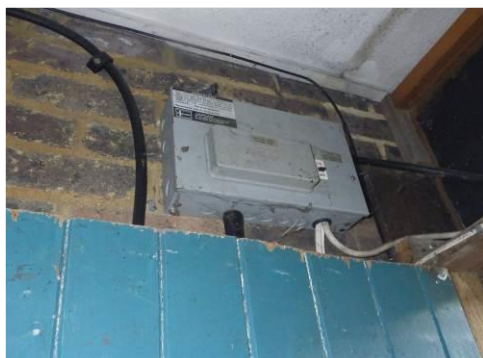
The fuse board looked dated and better are now available.

1960's-1980's Fuse board in right side area

**ACTION REQUIRED:** We recommend a test and report as this is a dated fuse board and we also noted other dated areas of electrics. We would also advise that the Institution of Engineering and Technology (IET) recommend a test and report as the property is changing occupancy. Any recommendations from the electrical report should be carried out by a NICEIC registered, or equivalent, approved electrical contractor or similarly approved.

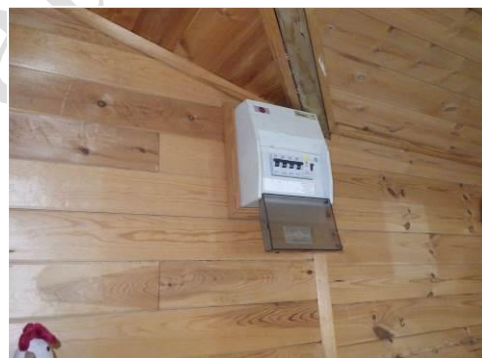
Electrics in bar

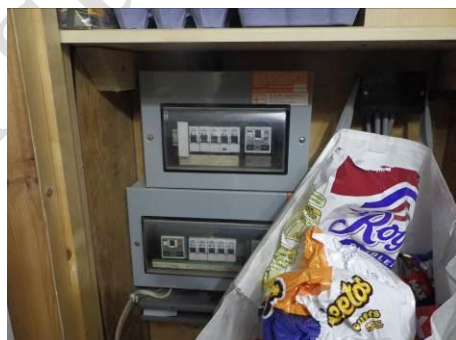
1980's-2000 fuse board in kitchen

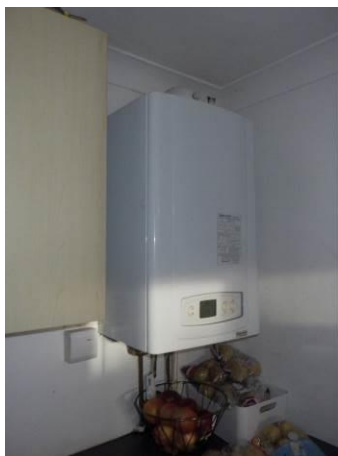
There is a wall mounted Glow worm gas boiler located in the utility room which is ran from gas canisters. In our vendors questionnaire the present owners advised the boiler was last serviced in 2020.

Glow worm boiler in utility room

Our limited inspection of the hot water and central heating system revealed no evidence to suggest any serious defects but we would nevertheless recommend that the system be tested and overhauled before exchange of contracts and that a regular maintenance contract be placed with an approved heating engineer.

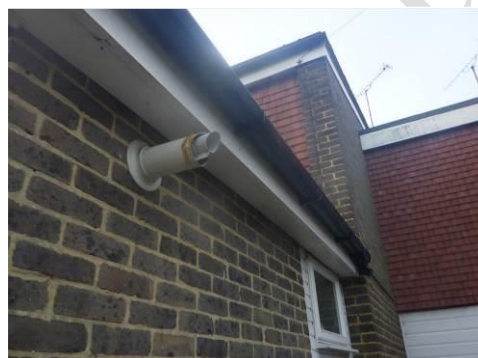
Flue from boiler

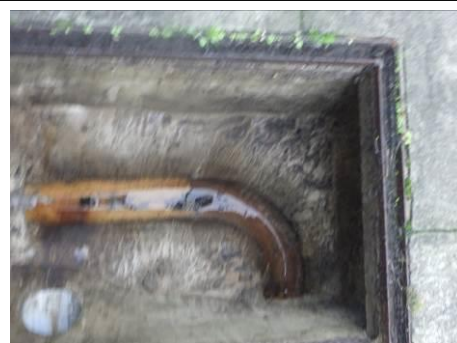
We duly lifted the cover and found it to be clear at the time of our inspection.

From what we could see it is finished with concrete.

Manhole four near path leading to bar and pool area

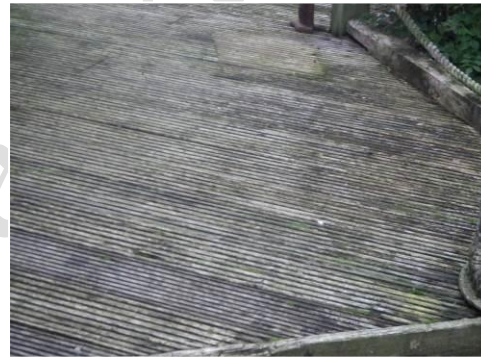
Moss on decking

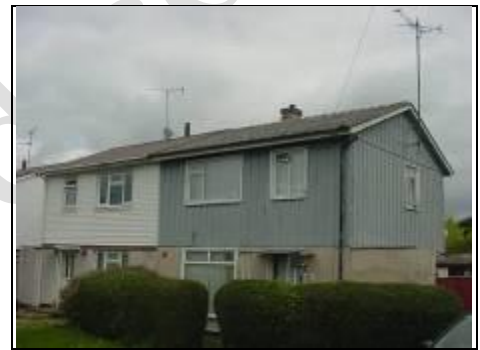
Asbestos roof on BISF house

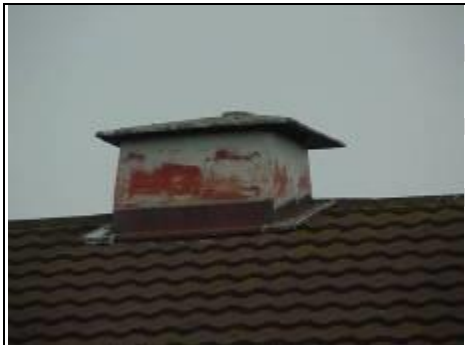
Asbestos original chimney non traditional house

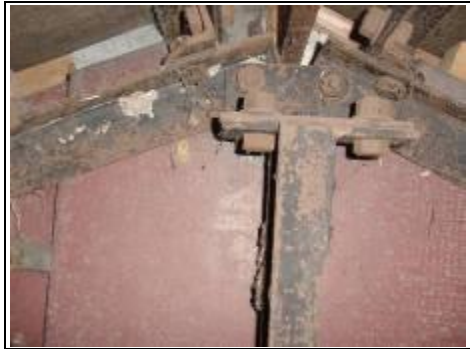
Rusting to a lightweight metal frame or damage or deterioration to the metal frame of a non-traditional house

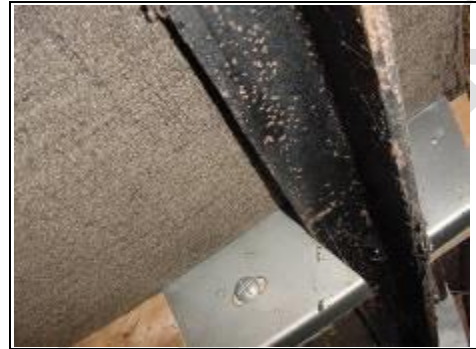
Some fixings replacements/repairs to a non-traditional house

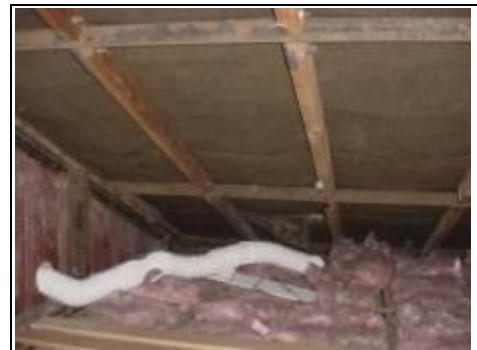
Extract vent to outside often discharges into roof which is essential that they do not in this type of roof

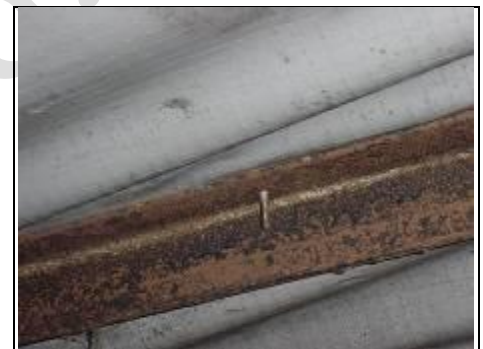
Rusting within the roof between the insulation and plastic protective underlayer

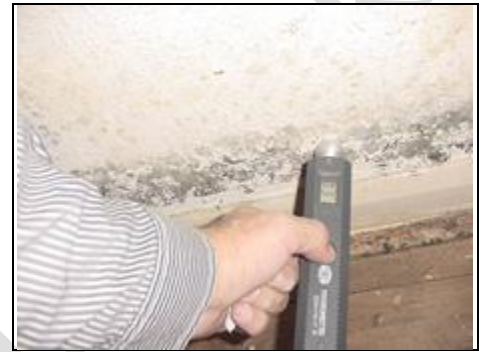
Black mould and high damp meter readings
