Non Traditional Example Residential Building Survey

NON TRADITIONAL CONSTRUCTION STRUCTURAL FRAME HOUSE

BISF FRAME

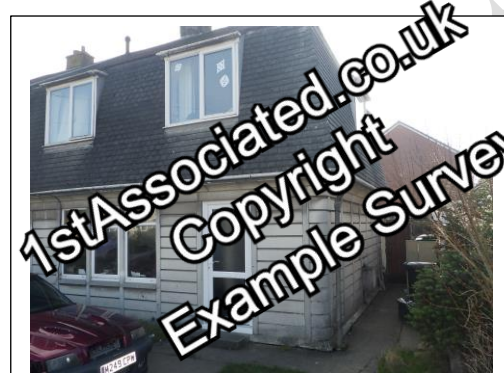
From our database search the Cornish housing type is coming up as Designated Defective, which means in its original form you generally cannot get a mortgage on it, although this does depend on how the market is at the time, therefore will need checking if you do wish to proceed.

Example of non-traditional Cornish house nearby

ACTION REQUIRED: If you do decide to proceed we recommend that your solicitor asks the existing owner for photographic evidence of what work has been carried out and/or open up the structure to confirm how it has been built, as well as the written evidence that they advise that it has been forwarded to us.

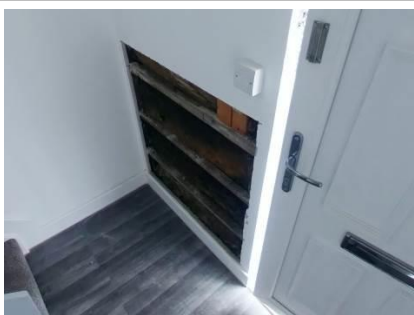
Opening One by the front door
(Not your property)

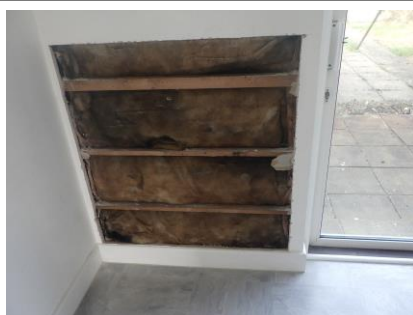
Opening Two next to rear
sliding door
(Not your property)

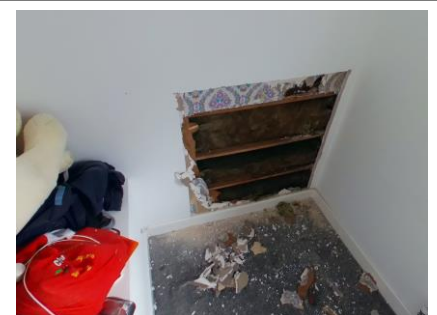
Opening Three in front right
bedroom
(Not your property)

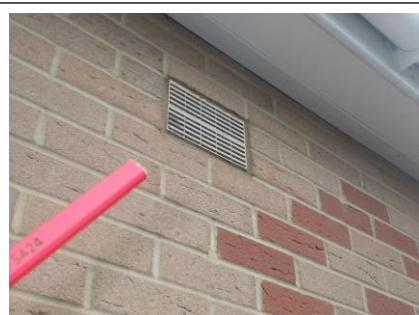
If you recall we showed you an air vent in the kitchen on the left hand wall which is a natural air vent, plus an extract over the cooker but this is purely a filter rather than air removal.

Air vent from kitchen on left hand wall

ACTION REQUIRED: We recommend humidity controlled extract fans are added, also an air removal air filter in the kitchen.

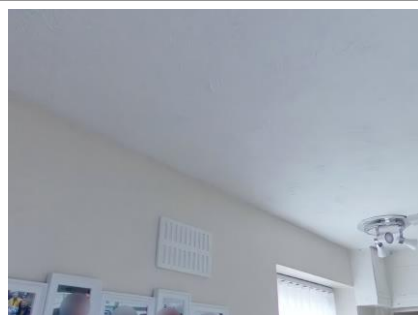
Air vent in kitchen

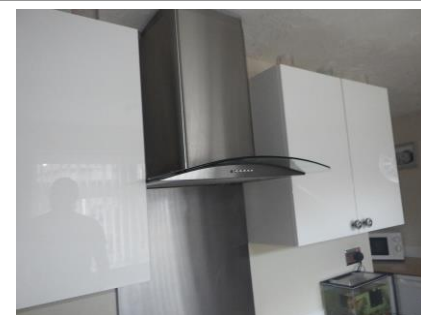
Air filter over cooker

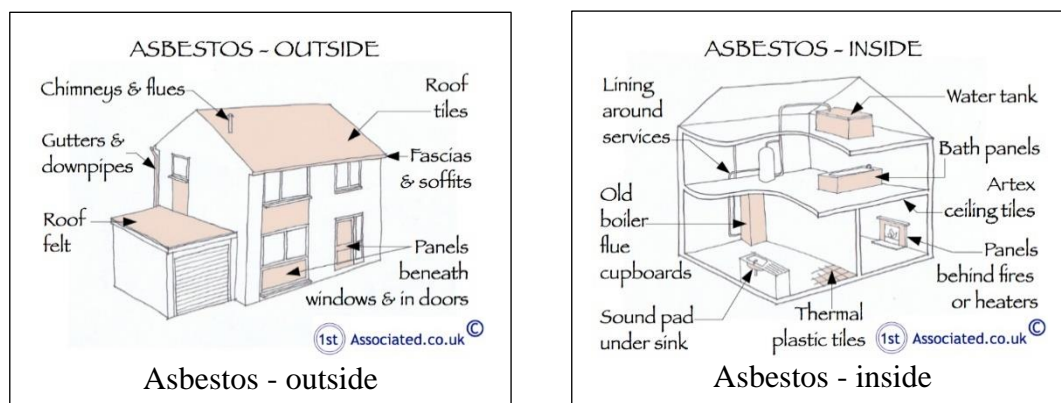
The generic sketches show typical areas where asbestos can be found in these properties.

ACTION REQUIRED:

- 1) Your legal advisor to specifically ask in writing if insulation has been added to the cavity.
- 2) Your legal advisor to specifically ask if asbestos reports have been carried out and if so what date and whether the asbestos test took samples. If they have not then you need to carry out an asbestos report with samples taken and the recommended action carried out.

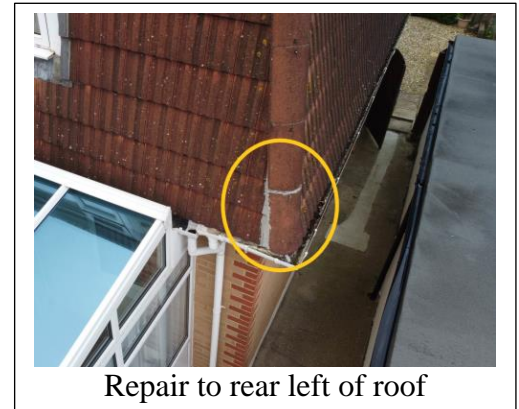
The rear left corner roof tile has come away, we have had experience of this before and it is where the wind catches the tile. Unfortunately, we would classify this as a characteristic of this type of building that you have to be happy with and expect some repairs to the Mansard roof.

ACTION REQUIRED: Periodic inspection.

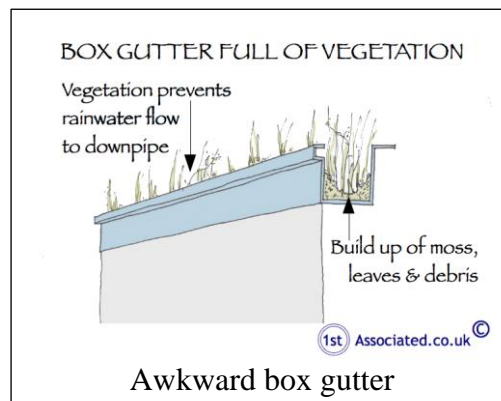
7.0) Awkward box gutter

There is an awkward box gutter between the main building and the rear conservatory. Due to the way the roof is finished (known as a hipped mansard roof) it means it is an awkward detail where the conservatory meets the main roof, in fact it doesn't meet the main roof as there is a box gutter separating them. This can get blocked over time if not regularly cleaned. There were no obvious signs of staining at the time of our inspection but the area did look to have opened up slightly.

ACTION REQUIRED: Regularly keep the box gutter clean to ensure that it doesn't block particularly during the autumn and winter months (when leaves, etc fall). If you have a window cleaner you could ask them to clean it (we would recommend you get them to take a photograph of the clean gutter).

ANTICIPATED COST: A few hundred pounds per year. You just need to make sure you have someone to regularly carry out cleaning of the box gutter, or indeed that you do this, but you do need to make sure it is carried out regularly as it a job that can be forgotten. Please obtain quotations before legally committing to purchase the property.

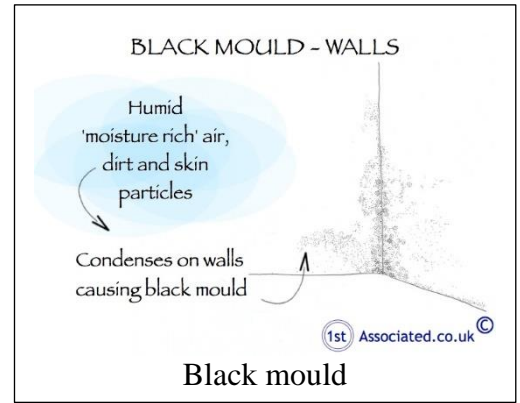
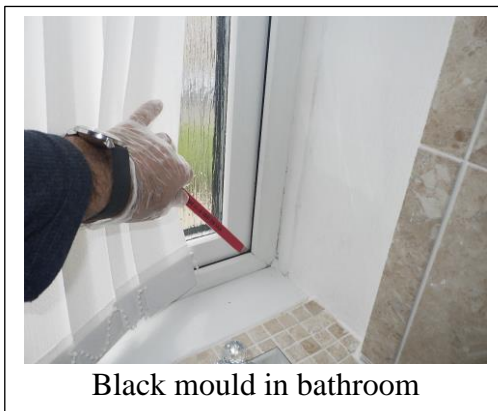
As mentioned, black mould/condensation is more likely in this type of building than a traditional building.

Black mould in bathroom

ACTION REQUIRED: It is best to remove humidity as quickly as possible and we would recommend large good quality humidity controlled extract fans are added to the kitchen, bathrooms, plus any humidity generating areas:

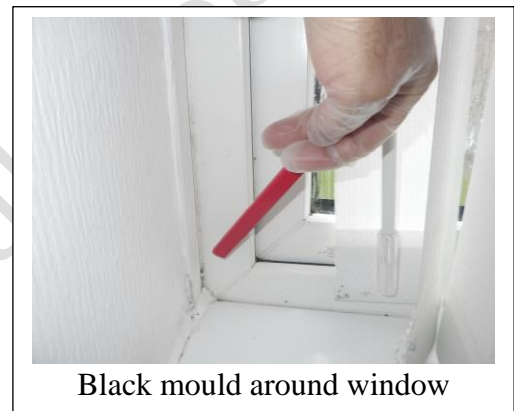
Black mould around window

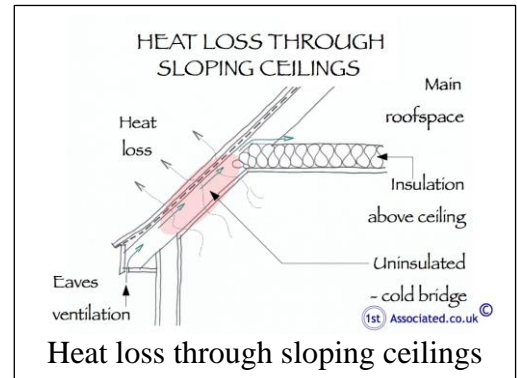
- 1) The rooms are built partly within the roof and have what is known as cold bridging.

Heat loss through sloping ceilings

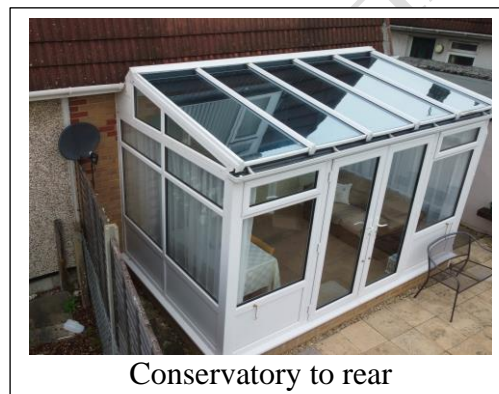
Whilst it is a benefit as you have the additional extra space and natural light you do need to be aware that conservatories can be particularly warm during the winter and this heat can affect the rest of the house from solar heat gain and also alternatively during the winter months these can also be a cold area. If we recall correctly, there isn't any central heating in the area, there is just a portable electric heater that has been added.

Conservatory to rear

ACTION REQUIRED: There are ways to improve the environment of this type of conservatory such as adding blinds and/or similar to the roof to reduce the heat gain and heat loss.

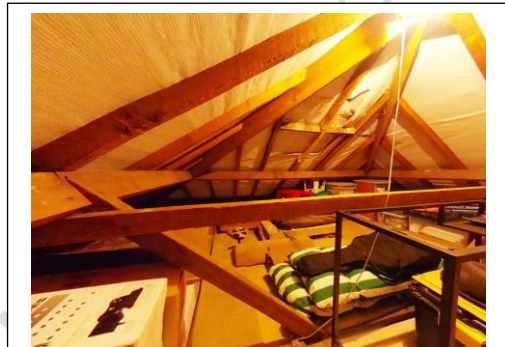
We could see from within the roof space that a chimney has been removed.

Roof space removed chimney

ACTION REQUIRED: It should have in theory had permission. Your legal adviser to check and confirm and advise us if there are any problems with regard to this area.

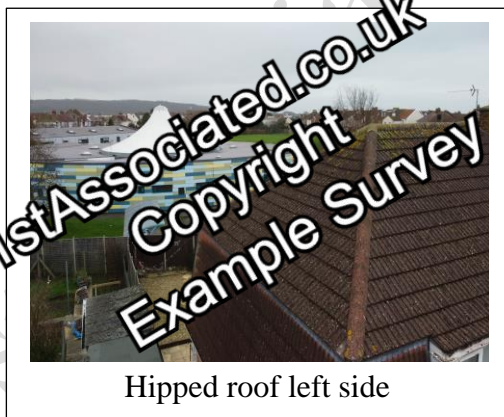
The property has a hipped roof which are integrally not as stable as gable end roofs as they effectively sit upon themselves.

The roof is clad with a concrete tile and, from ground level, this looks in slightly below average condition considering the roofs age, type and style. We noted a repair to the rear left.

Hipped roof left side

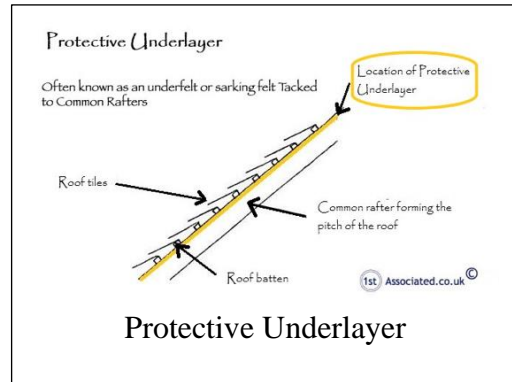
When we inspected the loft space, we found a modern breathable protective underlayer. This type of protective underlayer, as far as we are aware, has been used since 2002 and is meant to allow the roof to breathe and to minimise condensation, which is becoming more prevalent in highly insulated properties. We generally found it to be in average condition with damage in some areas which is what we typically find.

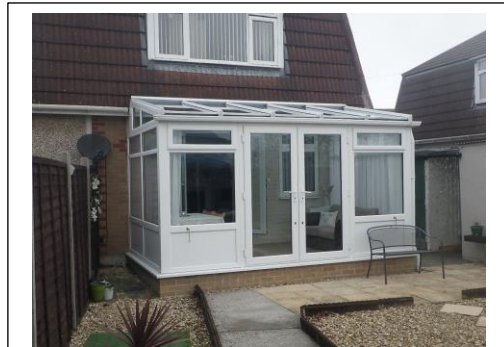
Conservatory

The conservatory roof is glazed.

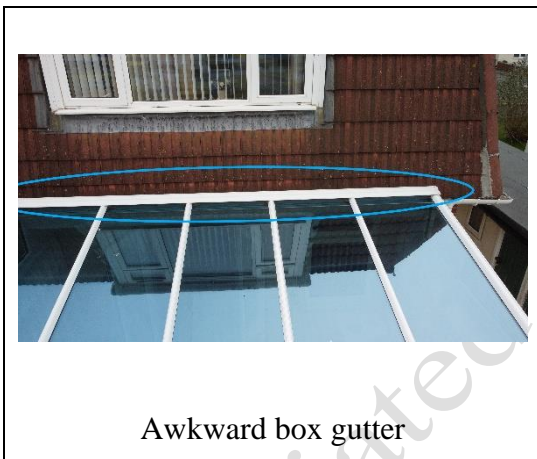
Awkward box gutter

ACTION REQUIRED: Please see our comments in the Executive Summary with regards to the awkward detail behind the roof.

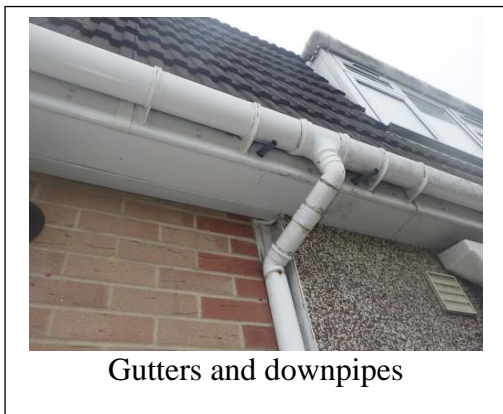
The property has plastic hopper heads, gutters and downpipes. They are in average condition for their age, type and style.

There may be some minor leaks but most people would be happy to live with these providing repairs are carried out within the next six to twelve months.

Gutters and downpipes

ACTION REQUIRED: We would recommend you stand outside the property next time it rains heavily and see how well the drains cope with the rainwater particularly looking at the guttering and the joints.

We also recommend that the gutters and downpipes are cleaned out, the joints are checked and the alignment checked to ensure that the gutters fall towards the downpipes.

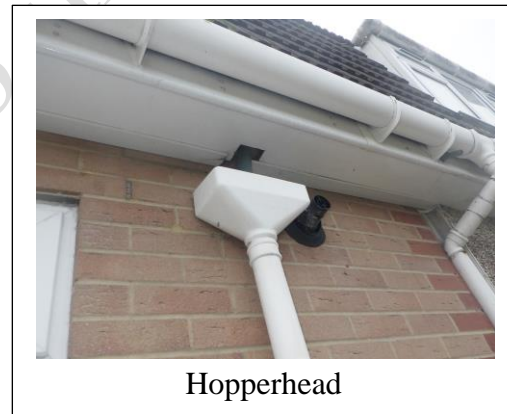
Hopperhead

Downpipes feed directly into the ground

We also recommend gullies are added where the water goes directly into the ground.

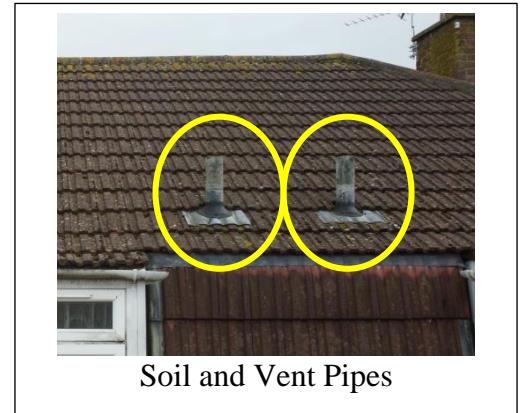
The property has internal (assumed) soil and vent pipes to the front. They look asbestos where seen at roof level, as was common in this type of property.

Internal soil and vent pipes work well, apart from if they leak, as they are hidden from view so a leak is not normally discovered.

ACTION REQUIRED: Please see our comments in the Executive Summary regarding asbestos. We recommend any asbestos be removed.

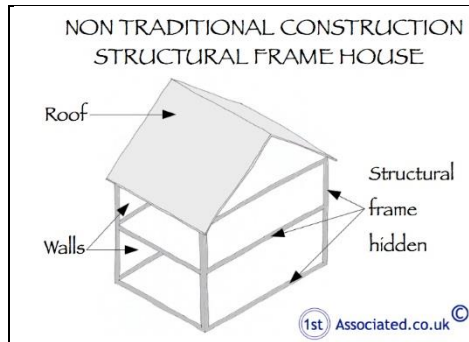
This house has been built using a pre-cast concrete structural frame, with cladding panels. The upper part has been formed within a Mansard roof.

Non-traditional construction

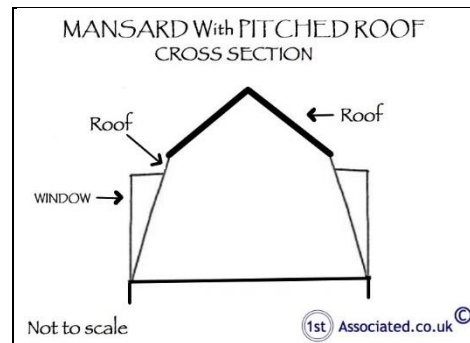
Mansard roof

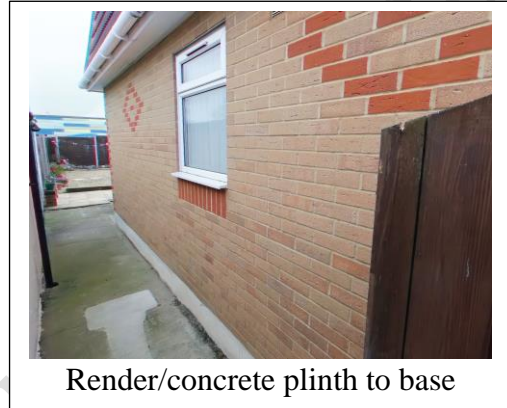
All modern properties should incorporate a damp proof course (DPC) and good building practice dictates that a differential of 150mm (6 inches) should be maintained between the damp proof course and ground levels. In this case we cannot see a DPC due to the render/concrete plinth to the base of the wall, which could have incorporated a DPC.

Render/concrete plinth to base

ACTION REQUIRED: Again, opening up the structure and/or photos during construction would help us confirm and advise on the construction.

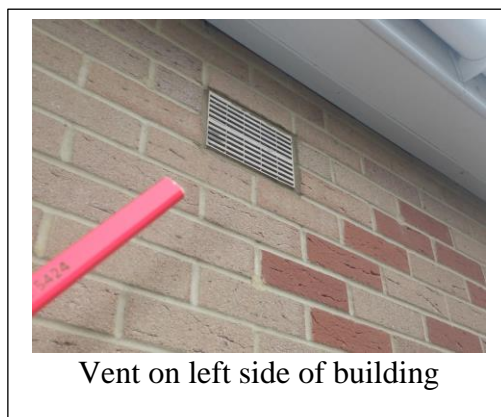
Vent on left side of building

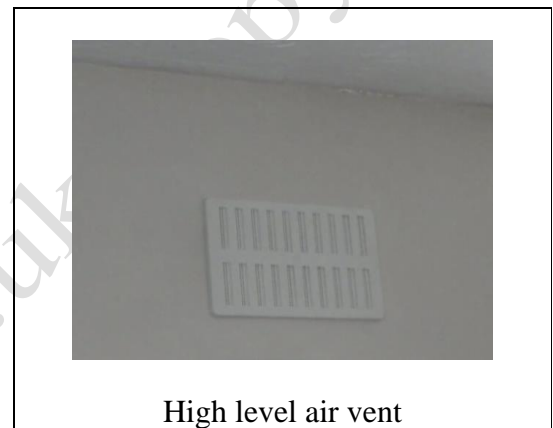
High level air vents are to help air circulation within the property. In this case, there are vents at high level in the kitchen which we were pleased to see, as it is better than nothing.

High level air vent

ACTION REQUIRED: We recommend adding a humidity controlled extract fan in the kitchen; see our comments in the Executive Summary.

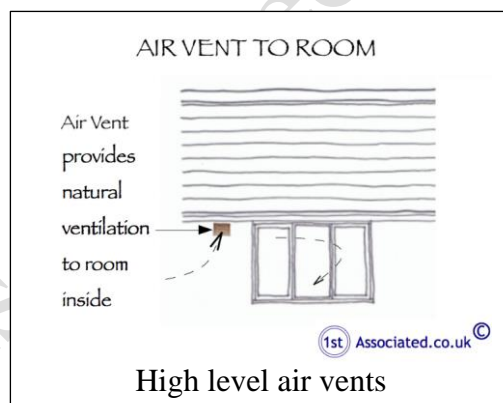
High level air vents

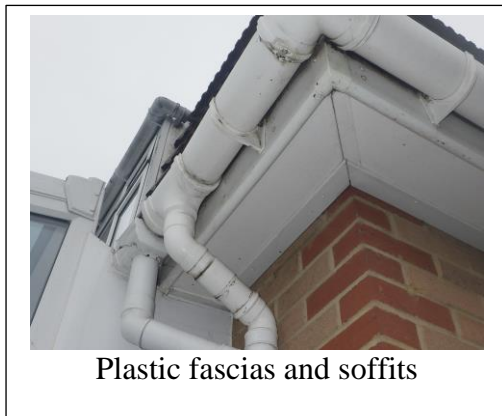
The fascias and soffits are finished in plastic. We have not opened them up but we think it may be on top of a horizontal pre-cast reinforced concrete beam, unless this has been removed.

Plastic fascias and soffits

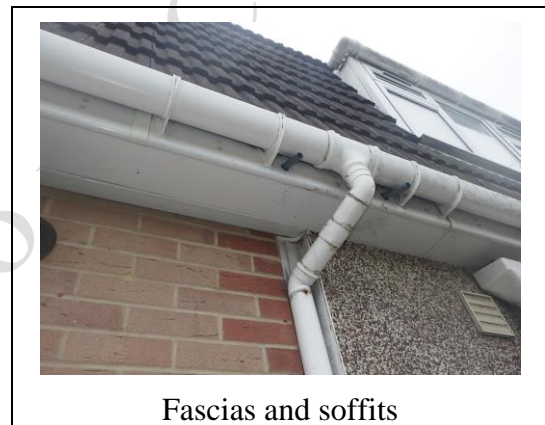
Fascias and soffits

A known problem on these properties is cracking to the first floor ring beam so it could be hiding defects. However, without opening up we cannot confirm further.

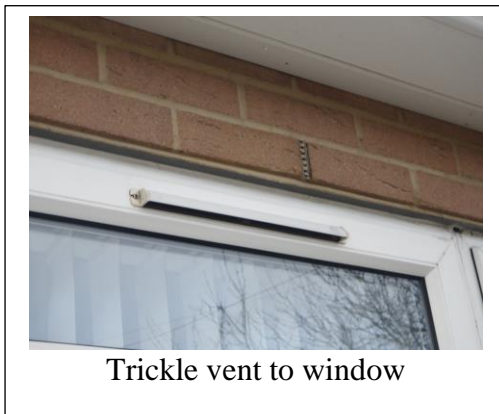
Trickle vent to window

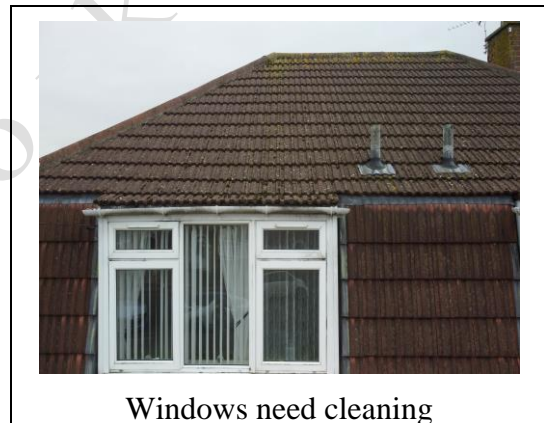
The property has plastic double glazed windows with trickle vents. Generally we would comment they are slightly below average quality for their age, type and style. They would benefit from a good clean.

Windows need cleaning

ACTION REQUIRED: Clean windows with a suitable detergent.

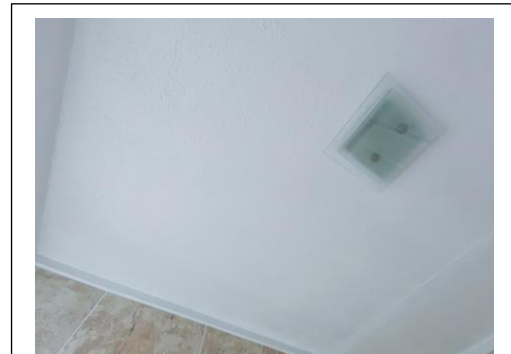
In this case in the bathroom we noticed the older style textured paint. Care should be taken with textured paint as textured paint prior to 1984 may contain an element of asbestos.

Older style textured paint ceiling in bathroom possibly asbestos

We advise we are not asbestos surveyors and we recommend asbestos surveyors are instructed and that you have your own asbestos survey carried out.

ACTION REQUIRED: The only way to be one hundred percent certain with regards to Asbestos in a property is to have an Asbestos report with samples taken and the recommended action carried out.

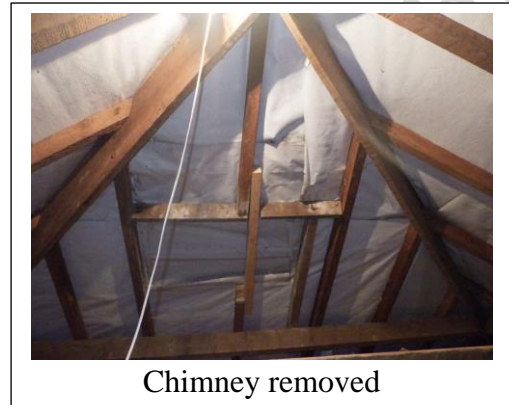
We note a chimney has been removed. In theory this should have had building regulations permission to remove it.

ACTION REQUIRED: Your legal adviser to check and confirm.

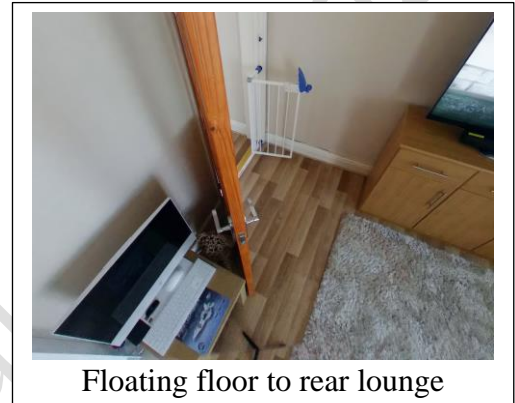
There is a floating floor/engineering floor finish, which has soft spots in it.

ACTION REQUIRED: Please see our comments in the Executive Summary.

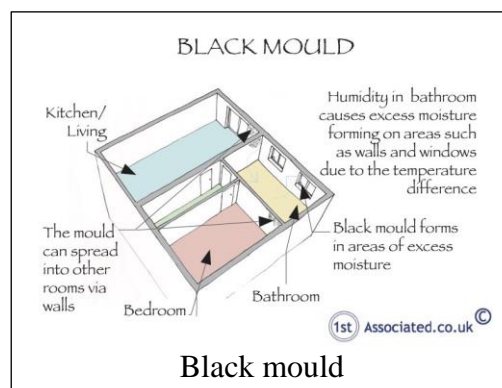
At the time of the inspection there were significant signs of condensation/black mould. Condensation depends upon how you utilise the building. If you do your washing and then dry it in a room without opening a window you will, of course, get condensation. You need to have a balance between heating, cooling and ventilation of properties and opening windows to air the property regularly.

ACTION REQUIRED: We would recommend large good quality humidity controlled extract fans be added to kitchen, bathroom and any rooms where you intend to dry clothes.

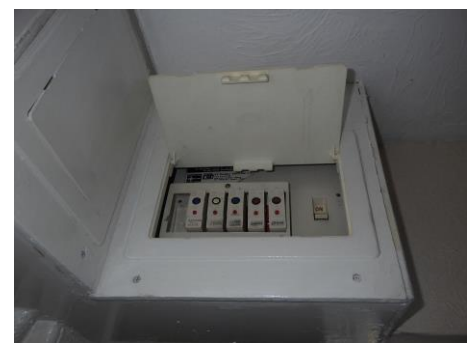
The electric fuses and consumer units were located in the kitchen. It looks 1980's-2000's, possibly even older.

The fuse board looked dated and better are now available.

1980's-2000 fuse board

ACTION REQUIRED: We recommend a test and report and as this is a dated fuse board and we also noted other dated areas of electrics. We would also advise that the Institution of Engineering and Technology (IET) recommend a test and report as the property is changing hands. Any recommendations should be carried out by a NICEIC registered, or equivalent, approved electrical contractor or similarly approved.

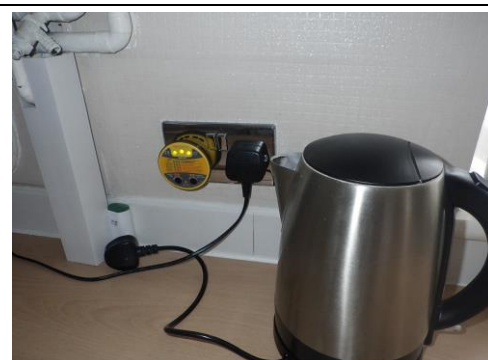
We carried out an earth test in the kitchen area to the socket point that is normally used for the kettle; this proved satisfactory.

Earth test

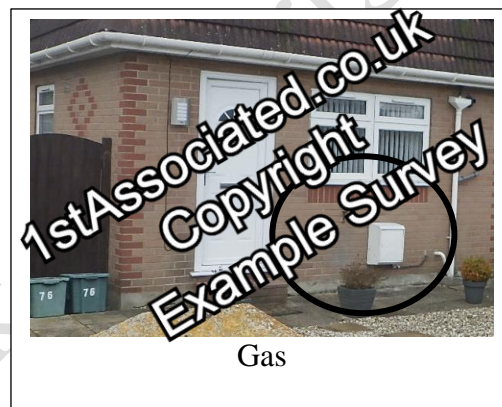
We believe that the property has mains gas.
The consumer unit is located to the front of the property.

ACTION REQUIRED: As a matter of course, it is recommended that the entire gas installation is inspected and made good, as necessary, by a Gas Safe registered contractor. Thereafter the installation should be serviced annually.

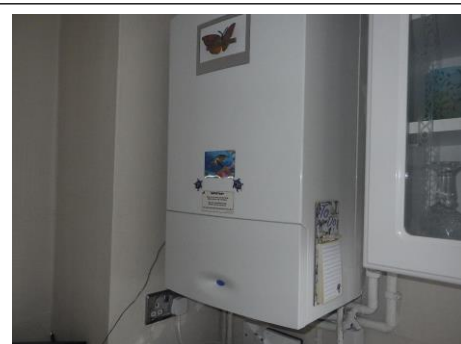
There is a wall mounted Worcester boiler located in the kitchen.

Our limited inspection of the hot water and central heating system revealed no evidence to suggest any serious defects but we would nevertheless recommend that the system be tested and overhauled before exchange of contracts and that a regular maintenance contract be placed with an approved heating engineer.

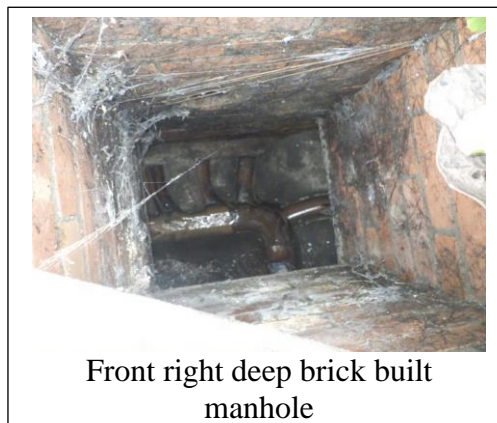
We duly lifted the cover and found it to be free flowing at the time of our inspection.

From what we could see it is finished with brick and was relatively deep.

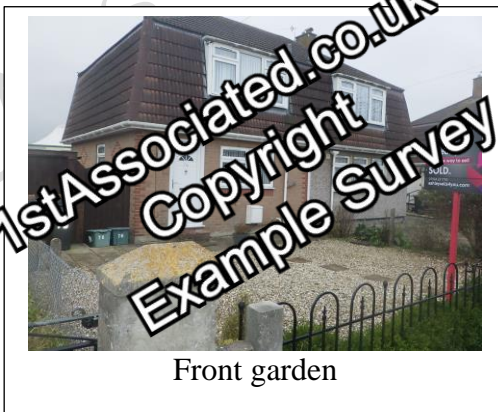
Front garden

The garden to the front is relatively level and has been covered with shingle and is considered a low maintenance garden.

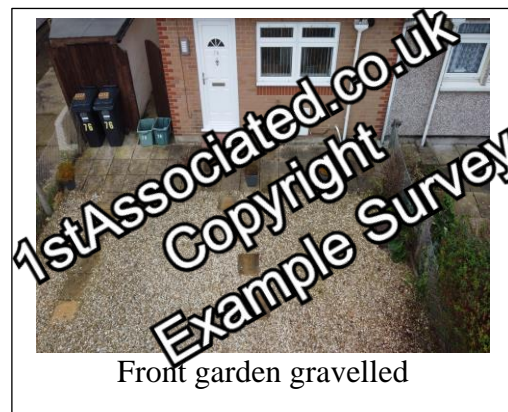
Front garden gravelled

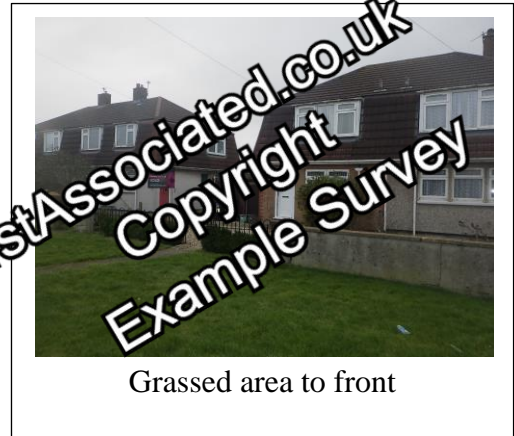
There is a grassed area to the front of the property. Typically this is maintained by the Local Authority.

ACTION REQUIRED: Your legal adviser to check and confirm.

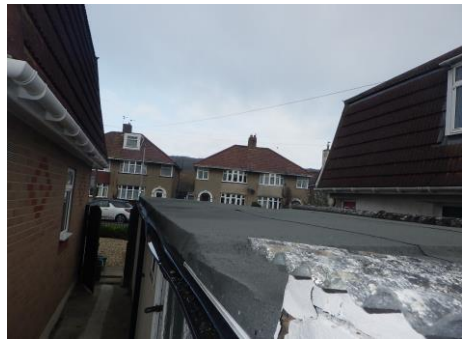
Outbuilding roof basic with felt tacked on

Over your outbuilding is a mineral felt which has been tacked in position, from what we can see. This would probably be our least favoured way of fixing felt. We much prefer a three layer bonded system, although we do appreciate why people do not have this type of system on outbuildings.

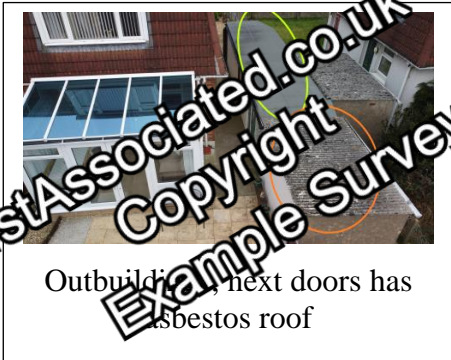
Outbuilding next doors has asbestos roof

ACTION REQUIRED: We recommend you chat to the neighbours.

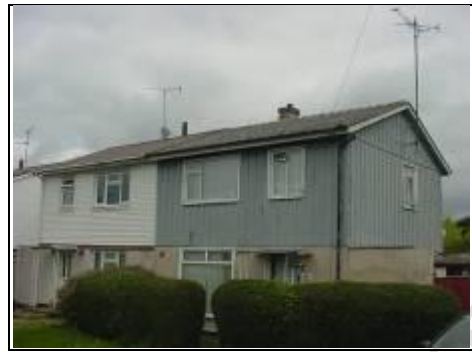
Asbestos roof on BISF house

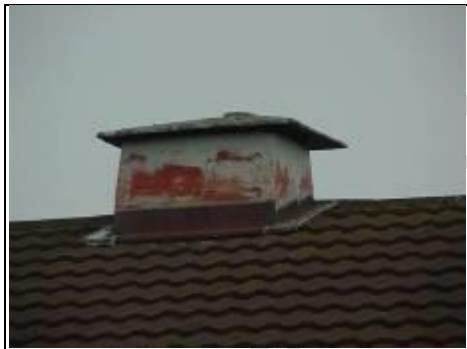
Asbestos original chimney non traditional house

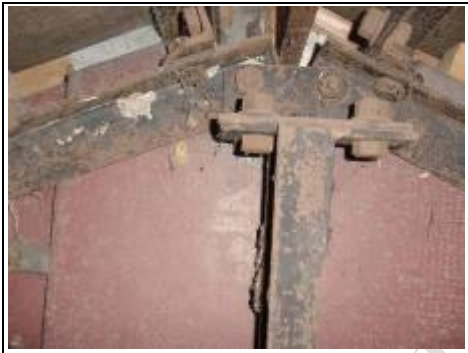
Rusting to a lightweight metal frame or damage or deterioration to the metal frame of a non-traditional house

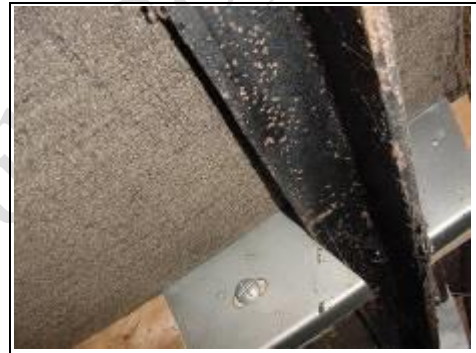
Some fixings replacements/repairs to a non-traditional house

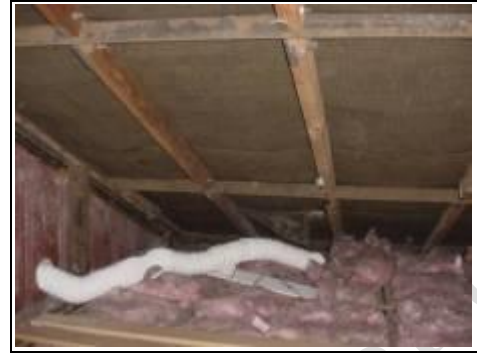
It is very common these days to have a shower/bathroom with an extract system. Does that extract system discharge into the roof or does it discharge out of the building? If it discharges into the roof then there can be problems with rusting and corroding of metal and dampness to timber.

Extract vent to outside often discharges into roof which is essential that they do not in this type of roof

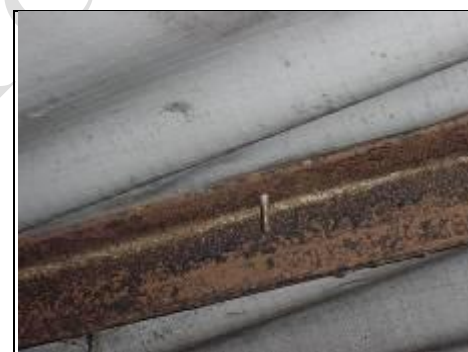
Rusting within the roof between the insulation and plastic protective underlayer

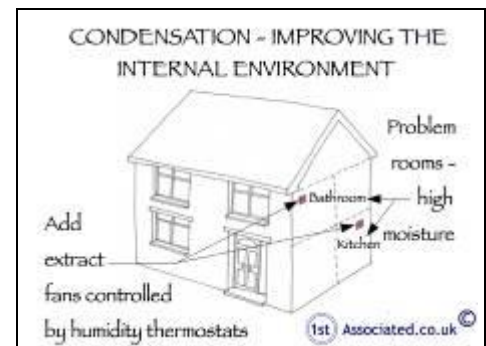
Condensation

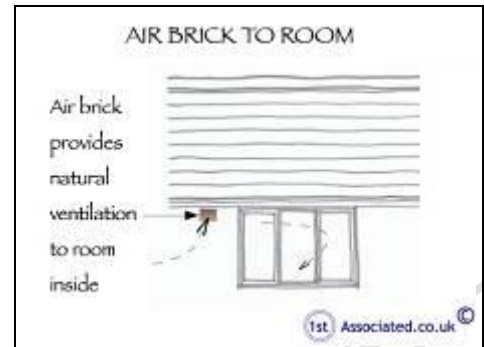
Air brick may not ventilate room enough
