# Non Traditional Example Residential Building Survey

## INTRODUCTION

Firstly, may we thank you for your instructions of xxx; we have now undertaken an independent Building Survey (formerly known as a Structural Survey) of the aforementioned property. This Survey was carried out on xxx.

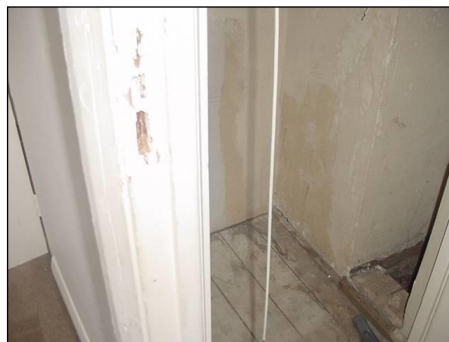
Airing cupboard

There is cracking in the airing cupboard which is located centrally around the chimney area so the cracking may be related to this as the chimney has been removed in part at first floor level.

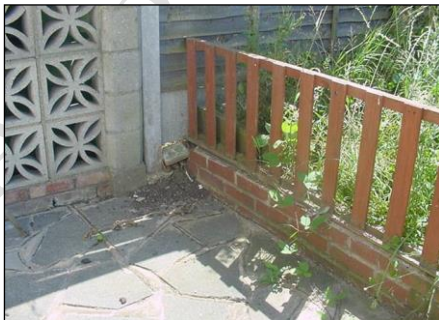
The boundary wall doesn't have any weep holes

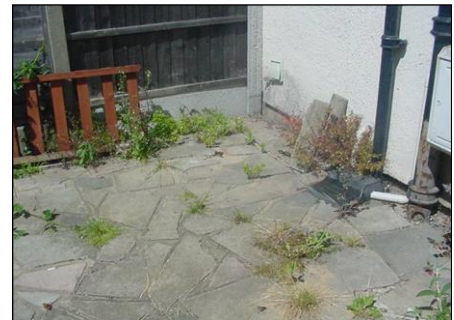
General undulations in crazy paving to rear

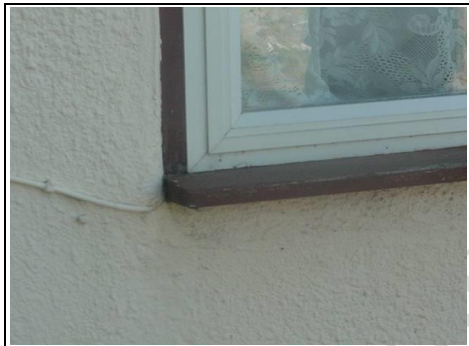
The front windows are plastic set within a timber frame. They are dated and they are also misting up.

Older style double glazed windows within timber frame

**ACTION REQUIRED:** Replace with a modern window with a trickle vent.

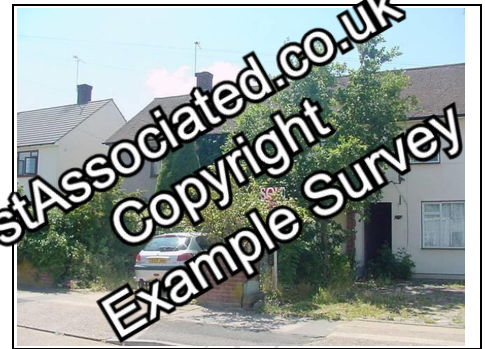
The tree in the front garden is fairly close to the property and would benefit from some maintenance. We would not recommend cutting it down as this can also affect the property.

Tree to front garden

**ANTICIPATED COST:** A few hundred pounds; please obtain quotes.

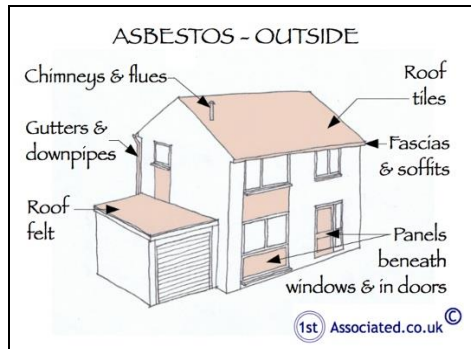
Asbestos - outside

**ACTION REQUIRED:** The only way to be certain all asbestos has been removed is to have an asbestos report carried out.

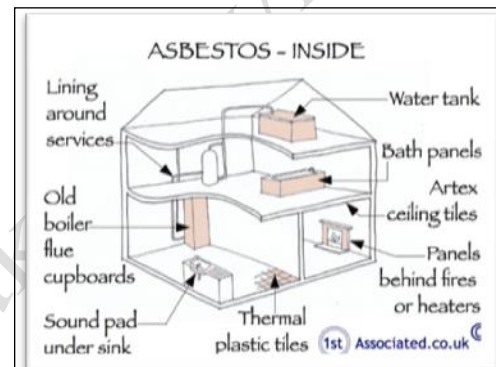
Asbestos inside

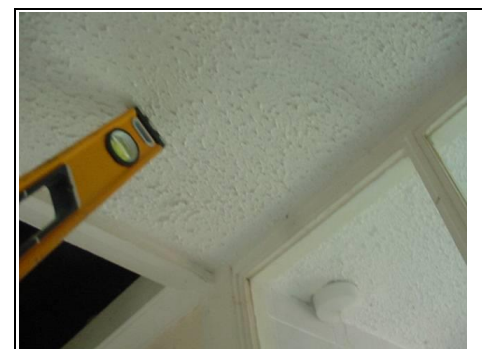
There is textured paint throughout the property which was very popular in the 1970's. It was also popular in the 1960's but tended to have an element of asbestos. Whilst the majority of the artex does not look like this type, the artex to the bottom of the stairs does look to have been moving towards the asbestos based type. It is not inconceivable that the original asbestos textured paint was painted over.

Artex/textured paint to ceiling

**ACTION REQUIRED:** We would recommend a skim-coat of plaster to all the artex. Whatever you do, do not rub it down; have a coat applied over the top of it and then redecoration. This should limit even the slightest chance of any problems.

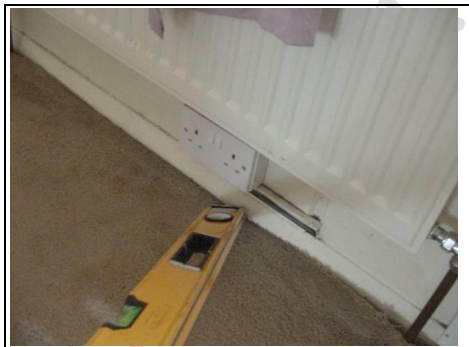
There looks to have possibly been some DIY electrics carried out where the conduits have come away from the wall. Although we would add that due to the hardness of the concrete walls it is difficult to fix and secure things on them.

Surface mounted electrics

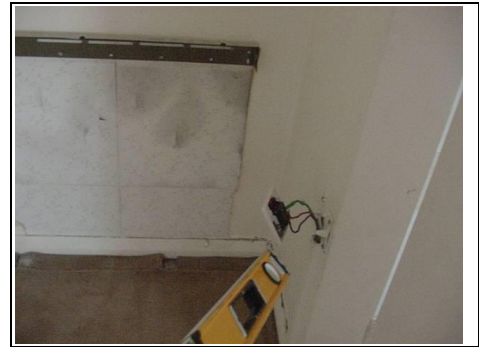
Electrics off wall in front bedroom

**ACTION REQUIRED:** We would have an electrician carry out an IEE (Institute of Electric Engineers) test and report and fix socket points that are off the wall.

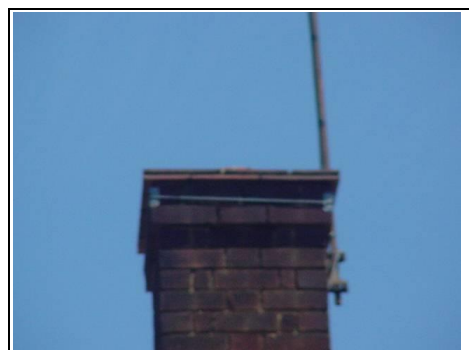
This chimney is brick finished with a lead flashing. From what we could see from ground level the pointing looked to be weathered and in below average condition considering its age, type and style with repointing required in due course.

Repointing required to rear

**ACTION REQUIRED:** Repoint by the summer of 2016 unless damp gets in before then. Periodically inspect the chimney in between that time.

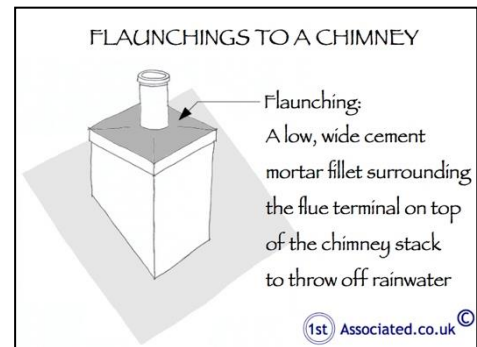
Unfortunately, we were unable to see the top of the chimney properly known as the flaunching, we therefore cannot comment upon them.

Flaunching

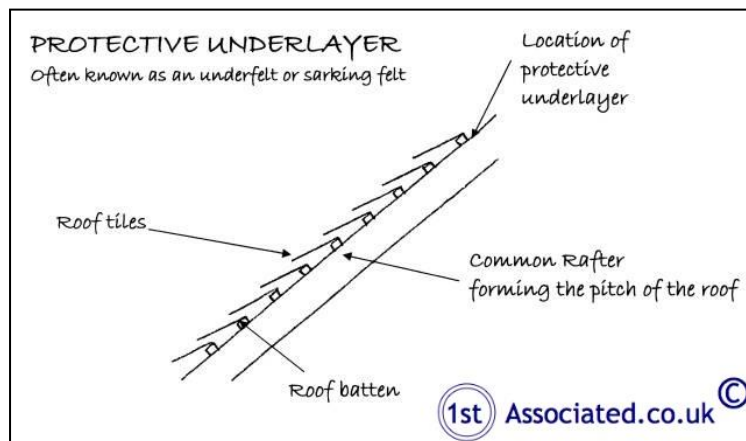
Protective Underlayer

When we inspected the loft space we found one of the older types of sarking felt that is made out of a bitumen-backed paper. This type of sarking felt was first used in the 1940s until the 1950s. We found it in poor condition even considering its age.

**ACTION REQUIRED:** It is very difficult to remove the defective sarking felt as you would have to re-roof the whole property, which, as you can no doubt understand, will be very expensive. We normally recommend a 'suck it and see' approach is taken where you carry out repairs and any dampness that gets into the property for as long as you possible, before you completely re-roof.

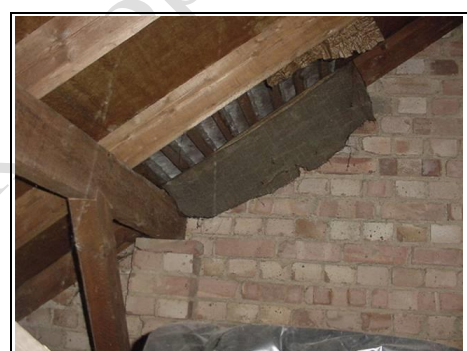
Purlin sits on brickwork

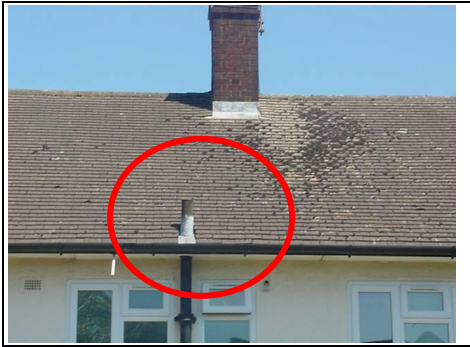
The property has cast iron soil and vent pipes. Cast iron of this age will need regular maintenance if not it will rust like next door's gutters.

Soil and vent pipe

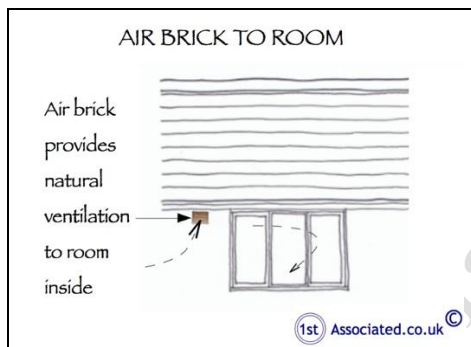
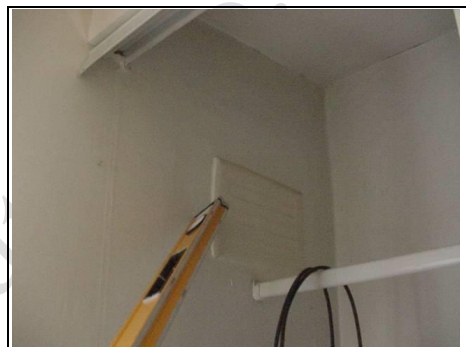
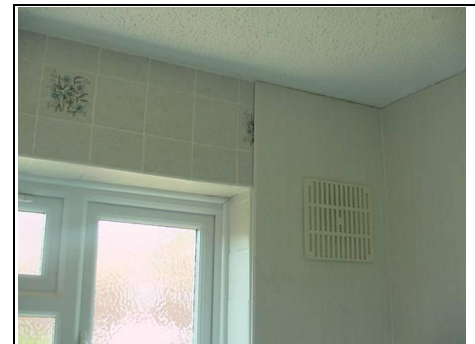
We noted the property has high level air bricks and these were relatively common due to the need to create air circulation to reduce condensation. We noted the vent to the front bedroom within the left hand cupboard had been blocked up and would recommend this is opened up and a hit and miss vent /sliding vent be added. Also replace the sliding vent in the bathroom with an extract fan.

High level airbrick

High level airbricks

Sliding vent sometimes known as a hit and miss vent

**ACTION REQUIRED:** Ensure the airbricks are clear.

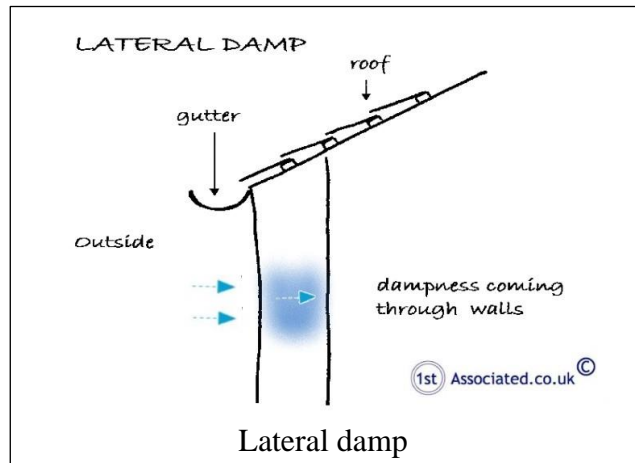
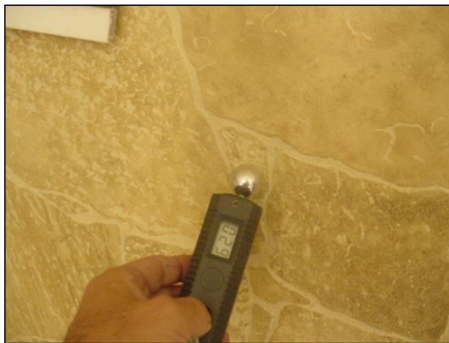
We used a resistance meter on the external walls. We have not found significant dampness. We would advise that our readings were limited in some areas due to the dry lining for example in the kitchen.

Testing for lateral dampness onto a dry-lined wall

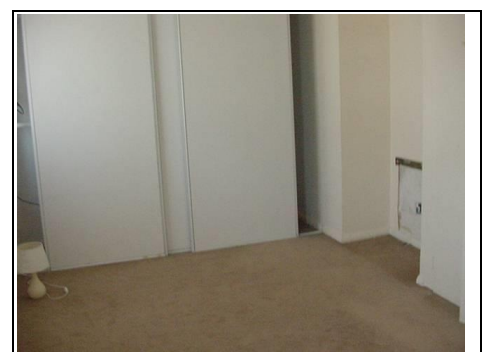
We were pleased to see built in cupboards although slightly dated.

There is also an airing cupboard.

Built in cupboards

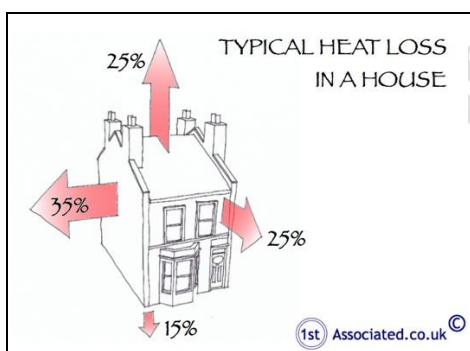
Generally there was 300mm of insulation within the roof which was to current Building Regulations. Our concern is condensation being caused by the mass of roof insulation.

Typical heat loss

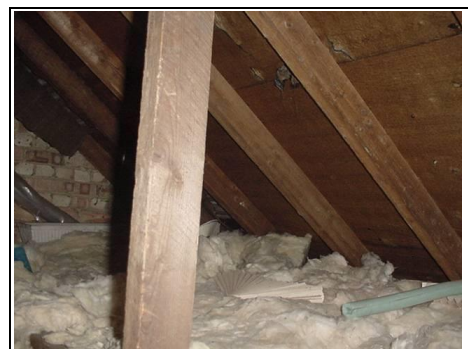
Mass of insulation

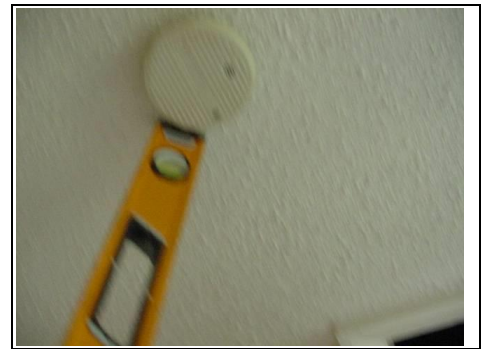
Some smoke detectors were noted we believe these to be battery operated. The current Building Regulations require that they be wired into the main power supply.

Smoke alarm

**ACTION REQUIRED:** We would recommend, for your own safety, that additional smoke detectors are installed. We would always recommend a hard wired fire alarm system and are also aware that some now work from a wireless signal which may be worth investigating. Whilst fire is relatively rare it is in a worst case scenario obviously devastating.

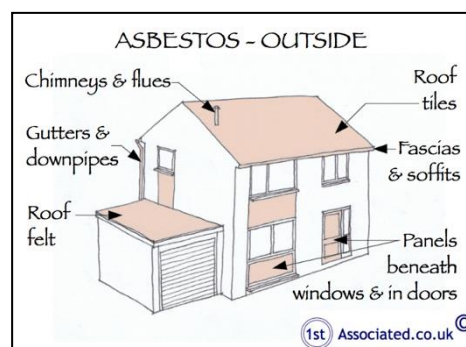
In a property of this type there was asbestos particularly to the roofs. There may also be other asbestos elements such as fascias and soffits, cladding, internal walls and ceilings and ductwork around services. In this case it is possible to the soffit boards and possibly within the artex.

Asbestos outside

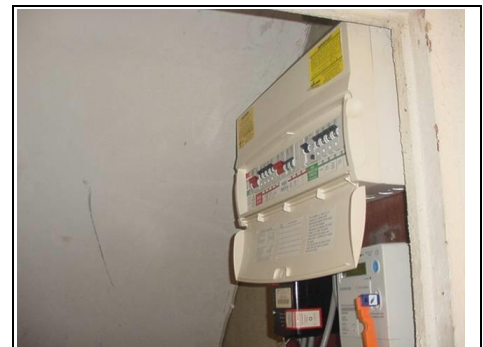
The electric fuses and consumer units were located under the stairs. The fuse board looked 1980's/1990's and better are now available.

Fuse Board

**ACTION REQUIRED:** We recommend a test and report and as this is a dated fuse board and we also noted other dated areas of electrics. We would also advise that the Institution of Engineering and Technology (IET) recommend a test and report as the property is changing hands. Any recommendations should be carried out by a NICEIC registered, or equivalent, approved electrical contractor or similarly approved.

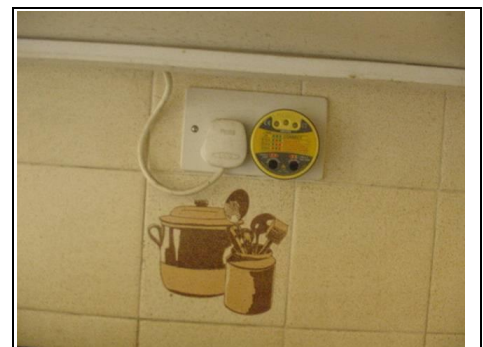
We usually carry out an earth test in the kitchen area to the socket point that is normally used for the kettle. In this case we were unable to test as the electricity was turned off.

Electricity turned off

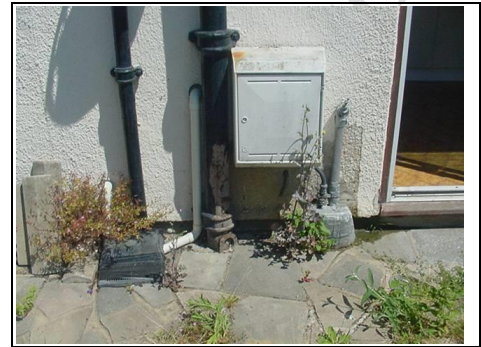
We are advised that the property has mains gas. The consumer unit is located to the rear of the property.

Gas cupboard to rear of property

**ACTION REQUIRED:** As a matter of course it is recommended that the entire gas installation is inspected and made good, as necessary, by a Gas Safe registered contractor. Thereafter the installation should be serviced annually.

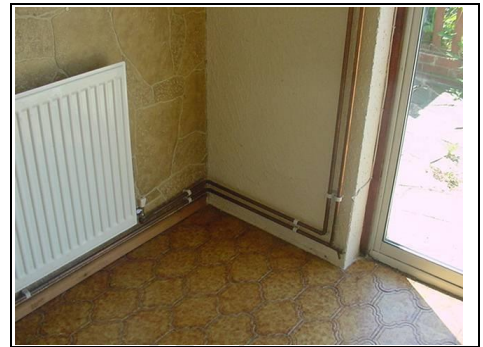
The plumbing, where visible were surface mounted pipes which tends to be the case in this type of property due to the walls being concrete and so hard to drill.

The plumbing mainly comprises copper piping. No significant leakage was noted on the surface, although some of the pipework is concealed in floors, walls and ducts.

Surface mounted pipes

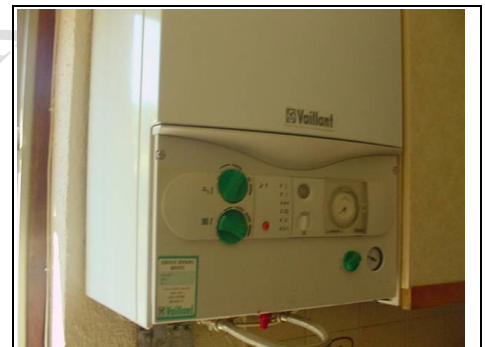
There should be a landlord's Gas Safety Certificate. The boiler was located in the kitchen, it is manufactured by Vaillant. It is an older style Vaillant boiler.

Our limited inspection of the hot water and central heating system revealed no evidence to suggest any serious defects but we would nevertheless recommend that the system be tested and overhauled before exchange of contracts and that a regular maintenance contract be placed with an approved heating engineer.

Vaillant boiler

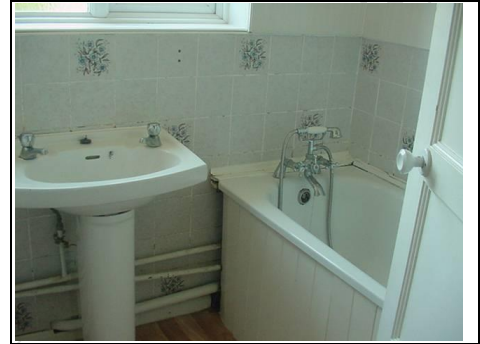
The property has a three piece bathroom suite, consisting of a bath, wash hand basin and WC, which looks in average condition.

Bathroom

Finally, although we may have already mentioned it above we would reiterate that it is important to ensure that seals are properly made and maintained at the junctions between wall surfaces and baths and showers etc. We normally recommend that it is one of the first jobs that you carry out as part of your DIY on the property, as water getting behind sanitary fittings can lead to unseen deterioration that can be costly, inconvenient and difficult to repair.

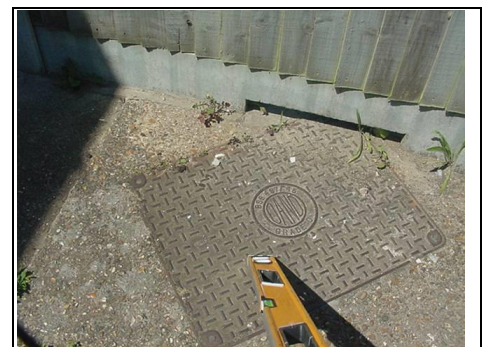
We were unable to lift the manhole as it was double sealed and we were unable to unscrew it. We were pleased to see that the fence had been amended to allow it to be lifted once unscrewed.

Manhole double sealed to front of property that we could not unscrew

**ACTION REQUIRED:** Please see our comments in the Executive Summary.

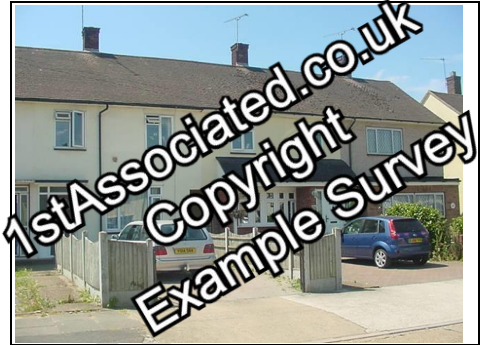
Off road parking

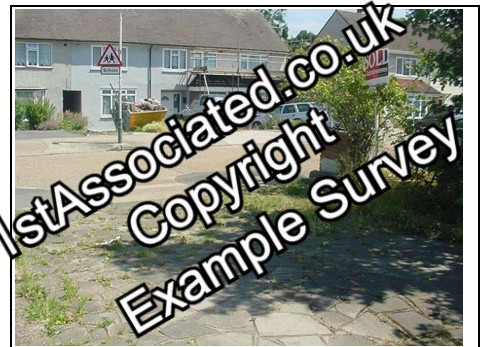
The front garden is paved and given over to parking

Front garden

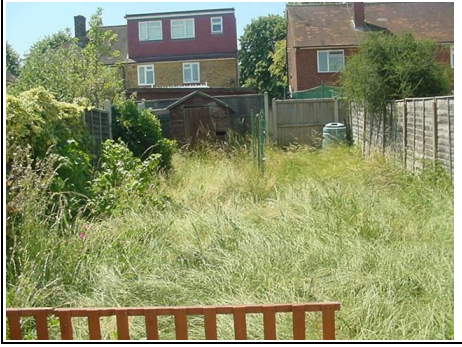
Rear garden

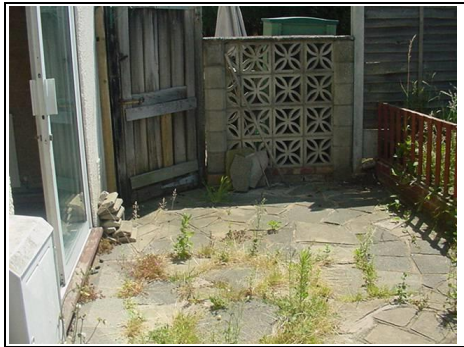
Patio area and access via side passageway

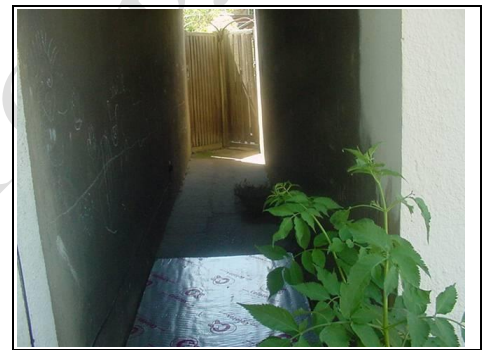
There is a passageway to the side of the property.

Passageway

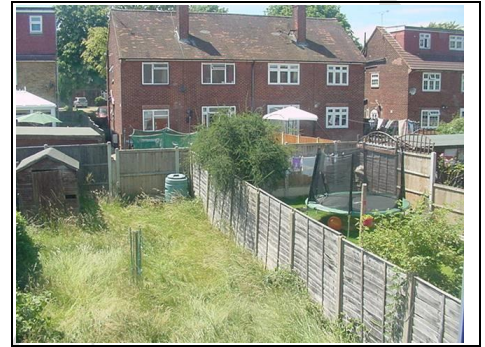
We spoke to them and they had no concerns. The right hand neighbours have a trampoline which can be a source of neighbourhood disputes as they can mean there is a lack of privacy depending upon how they are used.

Trampoline next door
