RESIDENTIAL BUILDING SURVEY

Non-evasive inspection

XXX
Corby,
Northants
NN17 XXX

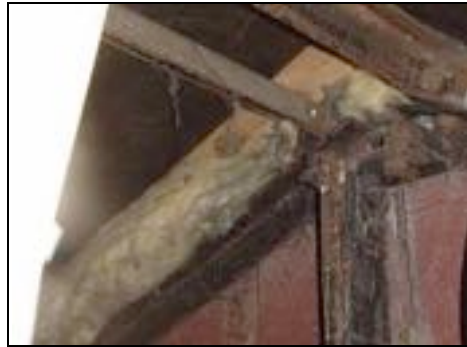
We found the level of rust to be slightly below average but we would not term this as being bad or excessive.

Rusting within your property which we classify as average to slightly below average.

ACTION REQUIRED: The only way to be 100% certain as to the condition of this structural frame is to open up the structure. As mentioned you will need to obtain permission from the owners to carry out this work but we are more than happy to return and inspect once the structure has been opened up. You need to have a builder close it up satisfactorily.

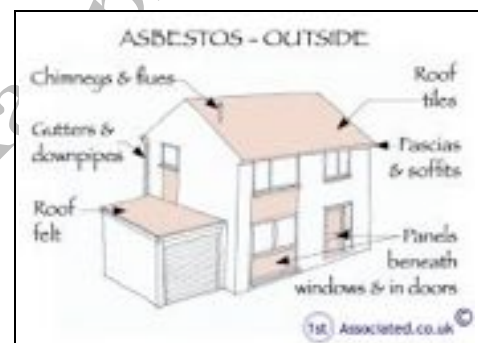
Asbestos - outside

ACTION REQUIRED: Your solicitor needs to make a formal written request to the Council for confirmation that all asbestos has been removed. If a survey report is not available from the Council the only way to be a hundred per cent certain with regards to Asbestos in a property is to have an Asbestos report with samples taken and the recommended action carried out.

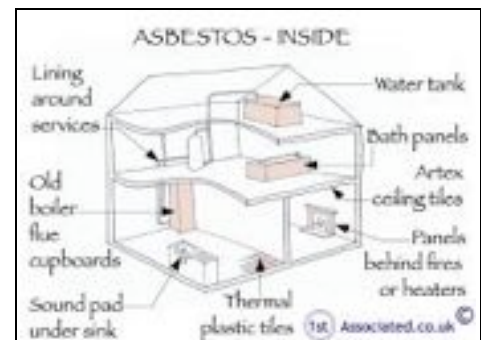
Asbestos - inside

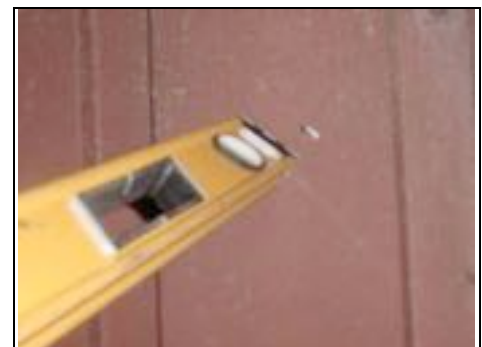
Fixing points in the roof void that have come through the cladding that has been added

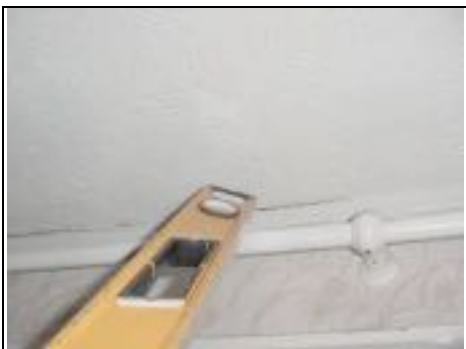
We noted cracking between the wall and ceiling structure and to the perimeter wall which is dry lined to the front right hand bedroom. This, we believe, may relate to differential movement and thermal expansion caused by the relatively poor air movement in the property.

Cracks corner of walls to ceiling

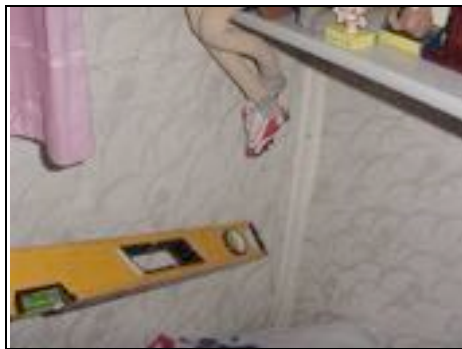
Crack corner of walls

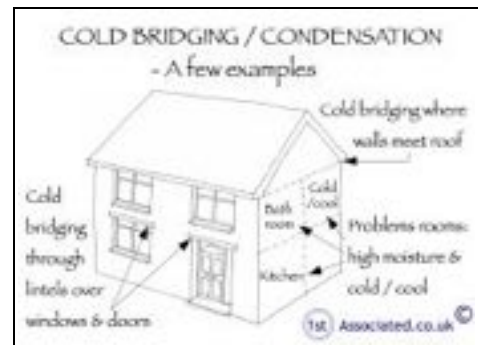
Cold bridging is caused by a colder element in the structure allowing coldness to pass through the structure much quicker when warm moist air is present in the property, often caused by things like having a shower or a bath, cooking or washing, particularly if you are drying washing on the radiators. This is also caused by the general climate, which results in condensation on the element.

Cold bridging

ACTION REQUIRED: This needs to be considered a characteristic of this type of property. Please refer to our Energy Efficiency Section of the report and the article in the appendices.

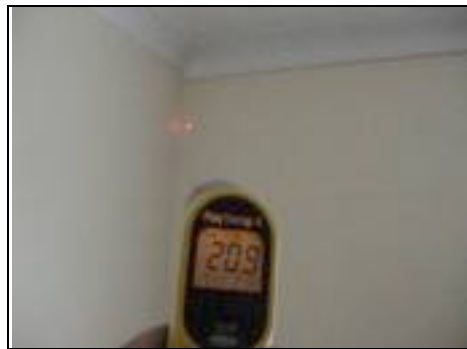
Surface temperature reading at high level in dining room

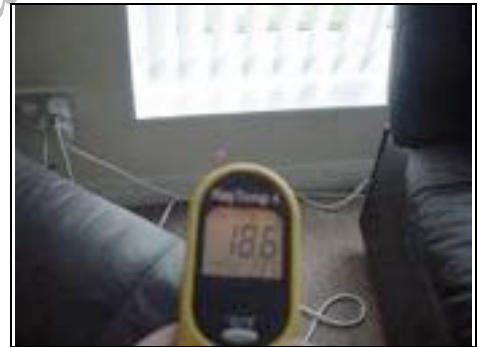
Surface temperature reading at low level

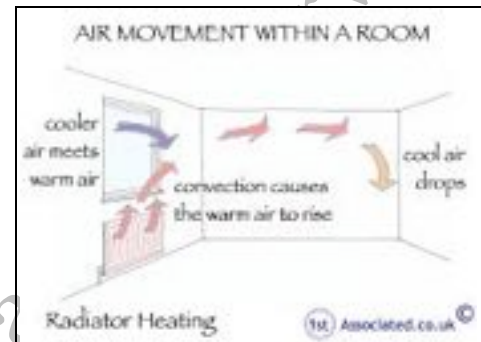
Air movement

With a reduced air movement in a property and higher insulation levels and higher heating levels you are more likely to get an element of condensation. This is why we have recommended large humidity controlled extract fans.

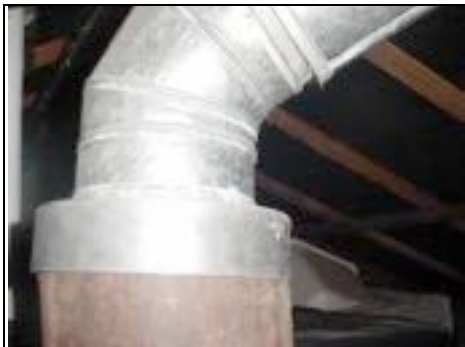
The property has two flues. It has a metal flue where visible within the roof, these were originally asbestos.

Possible asbestos to flue

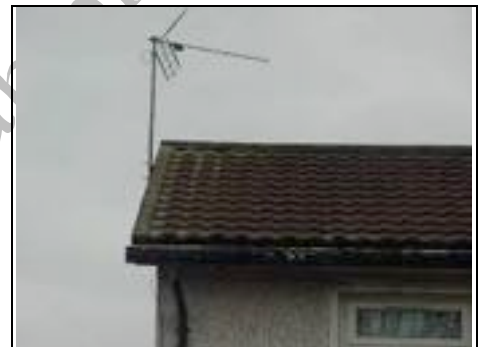
Main roof

The main roof is difficult to view due to the shallowness of the roof however we believe it is a shallow pitched proprietary prefinished metal profile sheet. From ground level, this looks in average condition considering the roofs age type and style.

Shallow roofs do get condensation which is why we are recommending that you have vented soffits.

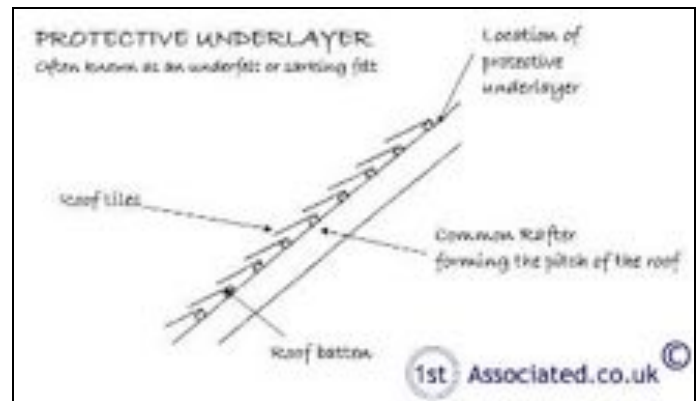
Protective underlayer

When we inspected the loft space we found a Hessian base Bitumen membrane. This type of membrane has been used since the 1960s. We generally found it to be in average condition, with damage in some areas which is what we typically find.

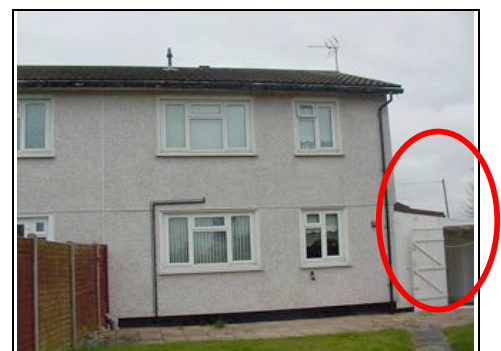
W.C. roof

We believe this is a shallow pitched proprietary prefinished metal profile sheet roof.

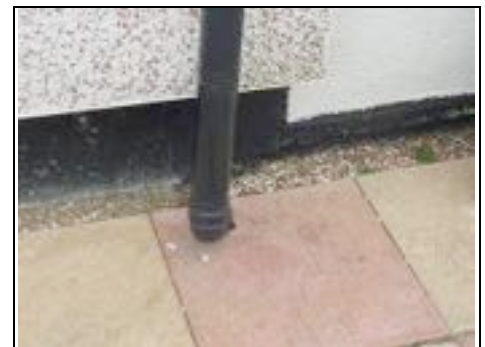
The downpipes feed directly into the ground so if there is a blockage then the drain would have to be opened up. This is a practice we are not particularly keen on; we would much prefer a gulley.

Downpipes feed directly into the ground

ACTION REQUIRED: Please see our comments in the executive summary.

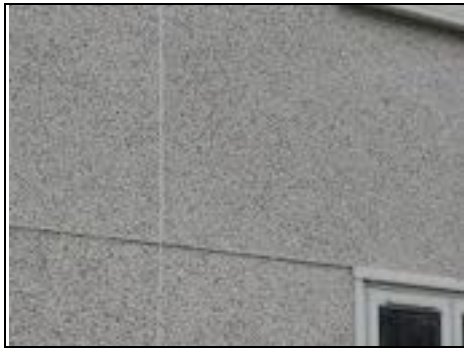
Movement joints within the panel construction that have been added

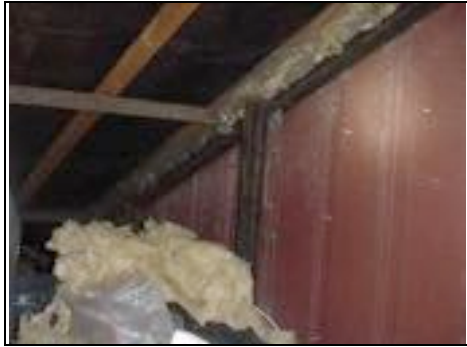
The only place that we could see the wall construction is to the gable end to the roof which was metal cladding.

Metal gable end to left

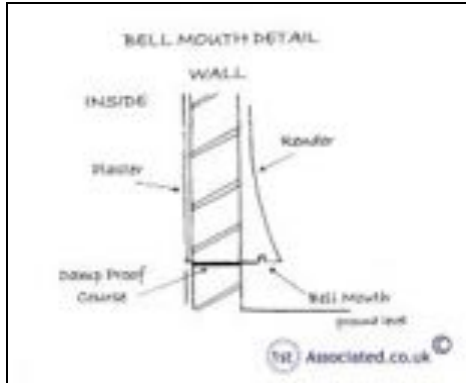
Bell mouth detail

To the base of the render there is typically no bell mouth detail to pebbledash render as there is on normal render although there is a step in.

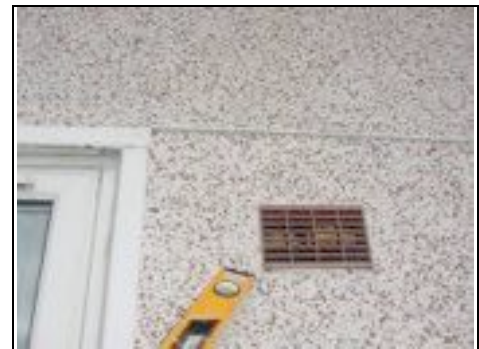
Old vents to rooms that are now blocked

ACTION REQUIRED: Ensure the airbricks are clear and in working order.

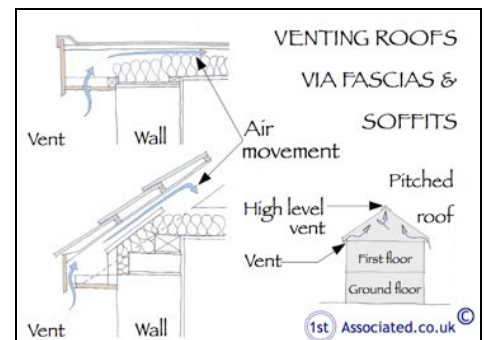
Venting roof via fascias and soffits

ACTION REQUIRED: We would recommend that the fascias and soffits are removed and replaced with vented fascias and soffits. Note the fascias and soffits could be asbestos so you do need to carry out an asbestos survey first.

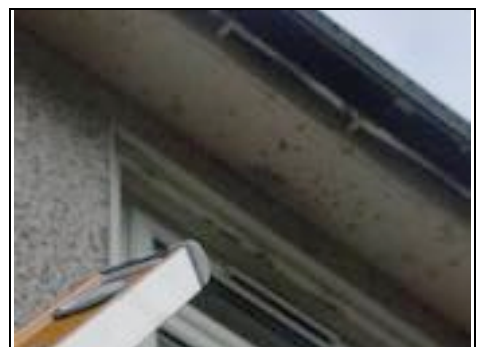
The property has plastic double glazed windows set within a frame, which forms a drip detail. There are no sills to some of the windows therefore pattern staining can occur around the windows without sills.

Frame around window

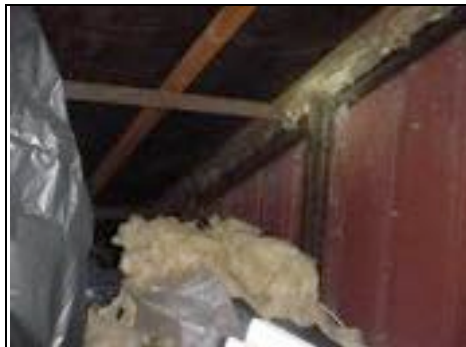
Current Building Regulations require 300mm of insulation. In this instance we noted in excess of 300mm, if anything there is a likelihood of condensation.

Mass of insulation

ACTION REQUIRED: We would recommend the removal of the insulation and re-laying it to 300mm maximum plus adding ventilation. In this type of property you have to be very careful if you insulate not to create a condensation situation as this is when we feel you get most accelerated rusting and deterioration to the roof frame and the structural frame.

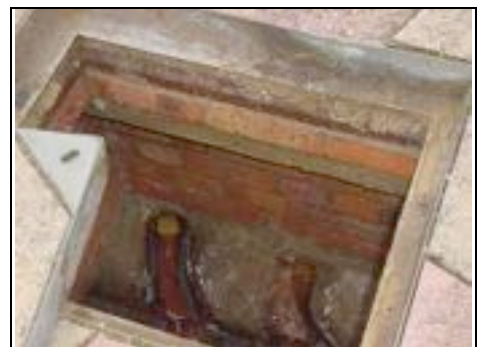
Manhole to rear

We duly lifted the cover and found it to be free flowing at the time of our inspection.

From what we could see it is brick built.

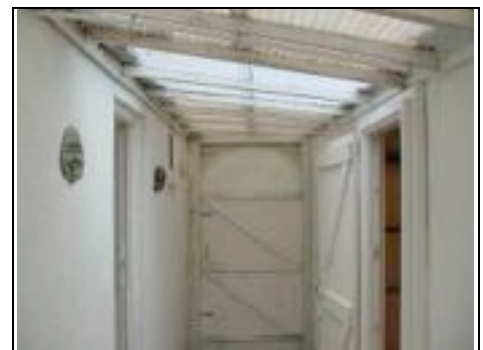
Lean-to that links to the garage

Please see our comments in the Roof Coverings Section.

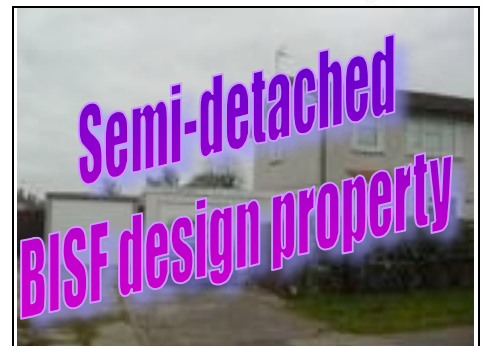
Front Garden

The property has a driveway to the left hand side.

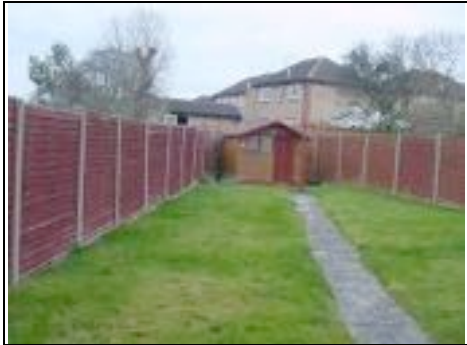
Rear garden

The rear garden is a triangular-ish shape with a patio, lawn and shed, on a slight slope.

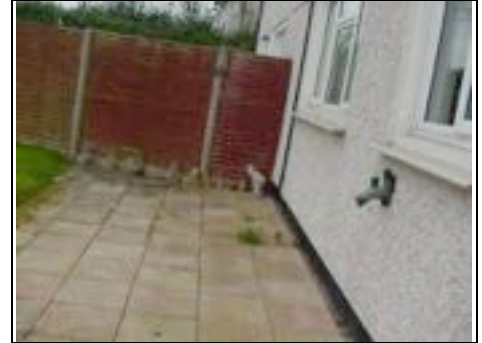
Patio to rear garden

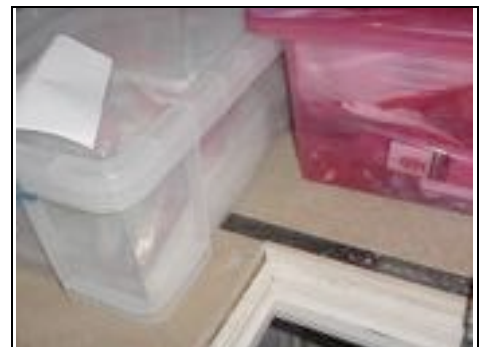
- 1) We did not have a full view of the roof due to the insulation covering the ceiling joists, the boarding, the general configuration of the roof and the stored items.
- 2) We did not open up the walls as we could not see a way of doing this without causing damage.
- 3) We did not open up the ground floor or the first floor as we could not see a way to do it without causing damage.

Boarding in roof

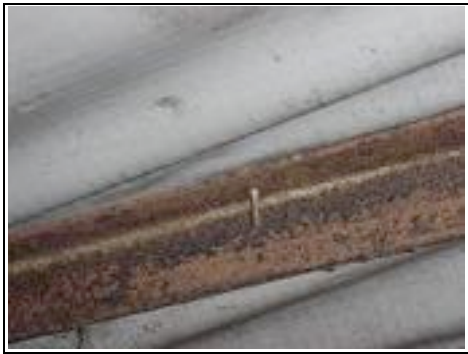
Example of excessive rusting that we have seen in the roof of a metal framed building compared with the rusting in your house which is less than this

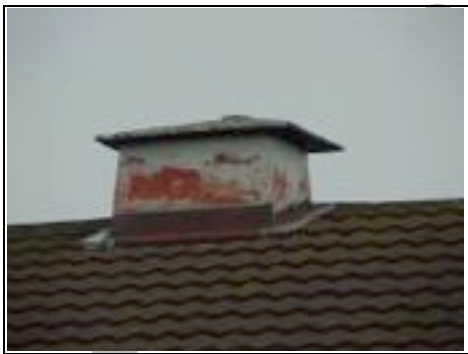
Asbestos original chimney non traditional house

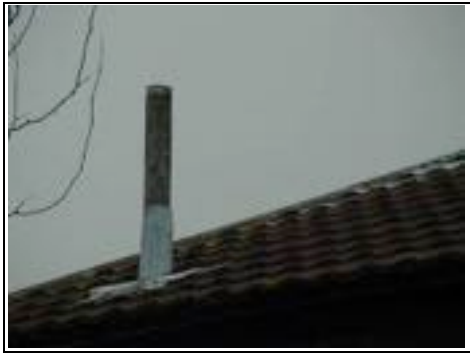
Original asbestos soil and vent pipe on a non-traditional house

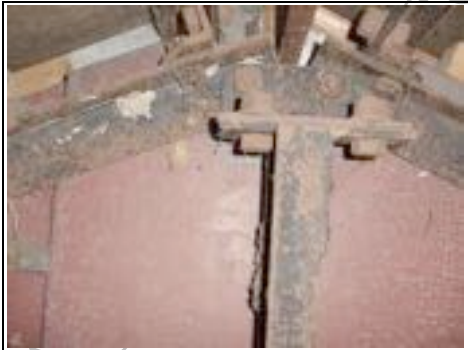
Rusting to a lightweight metal frame or damage or deterioration to the metal frame of a non-traditional house

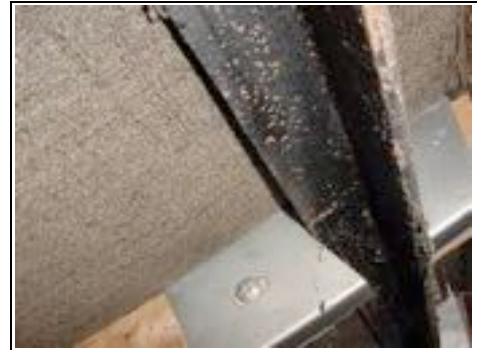
Some fixings replacements/repairs to a non-traditional house

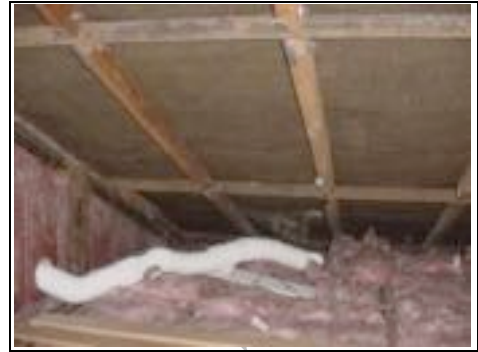
Extract vent to outside often discharges into roof which is essential that they do not in this type of roof

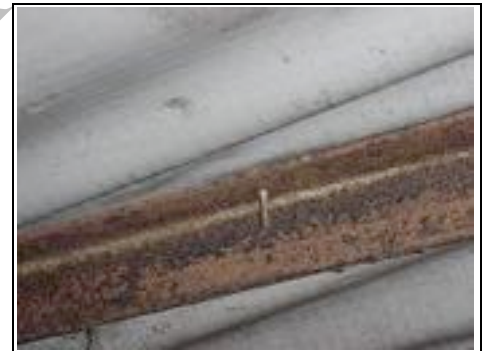
Rusting within the roof between the insulation and plastic protective underlayer

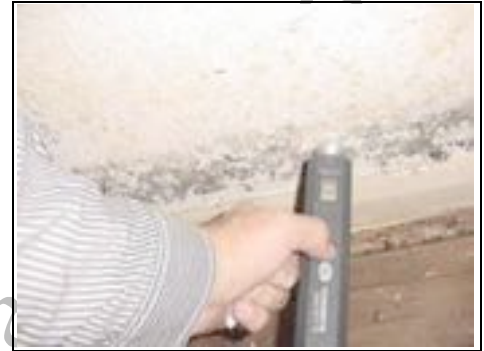
Black mould and high damp meter readings

There are limited things you can do with regards to cold bridging as it is about the original design of the property and needs to be considered as a characteristic. However, we do always recommend large humidity controlled extract fans are added into the bathrooms, kitchens and any areas that you intend to carry out drying of clothes to ensure moisture is removed as quickly as possible.
