# Non Traditional Example Residential Building Survey

NON TRADITIONAL CONSTRUCTION STRUCTURAL FRAME HOUSE

## BISF FRAME

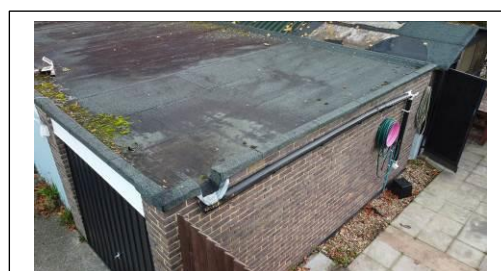
Garage felt roof

The garage has a mineral felt roof. We could see this is weathered as the black is coming through. What the mineral felt normally has is a protective green layer which tends to be a smaller stone-like material. Where this is missing and you can see the darker areas you tend to get blistering during the hotter weather. The roof looked to be allowing water in from our aerial photographs.

**ACTION REQUIRED:** It may be possible to patch repair this roof but in the long term you should look to re-roof. Again, it depends upon what you will ultimately be using this for.

**ANTICIPATED COST:** To re-roof £2,000 - £4,000 depending upon the quality of the roof that you want and the amount of roof decking which needs to be repaired.

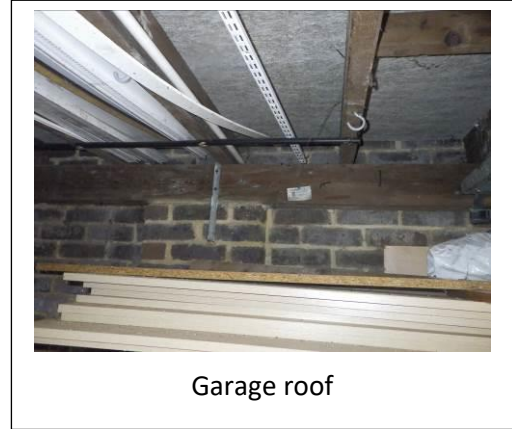
Garage roof

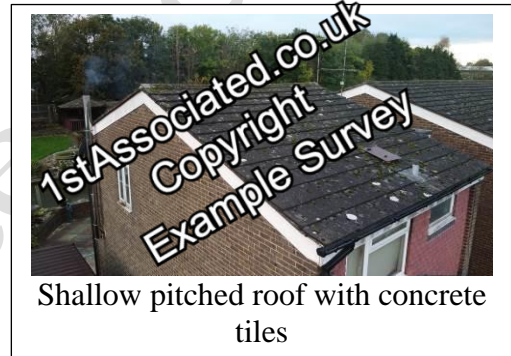
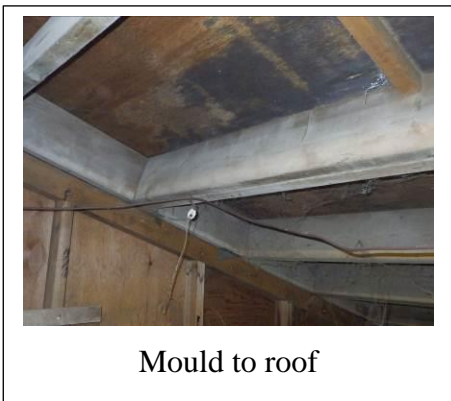
The property has a shallow pitched roof clad with flat concrete tiles which is letting in water. We can see areas of dampness from within the roof space and we could see popping and deterioration of the plasterboard ceilings.

The roof is pitched and clad with flat concrete tiles and, from ground level, this looks in below average condition considering the roof's age, type and style. We can see dampness and mould within the roof space. The roof could be allowing wind driven rain in; please see our comments in the Executive Summary.

**ACTION REQUIRED:** The roof is obviously letting dampness in in one way or another. We would start by removing the moss from the roof which there seems to be quite a lot of and see whether there are any obvious cracked tiles, etc and replace these as necessary to leave the roof watertight. If there isn't any obvious defects then it may be that you are getting wind driven rain. If this is the case there is a major defect in the roof, there is certainly black mould visible in the roof.

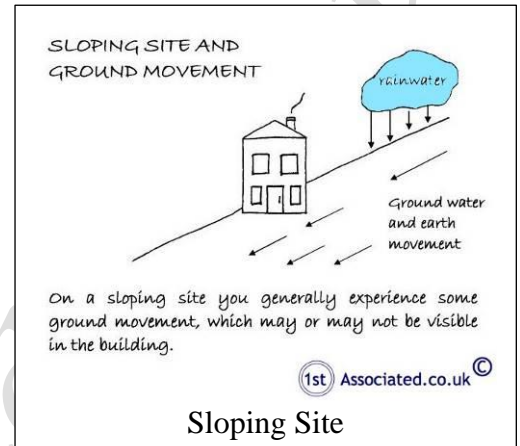
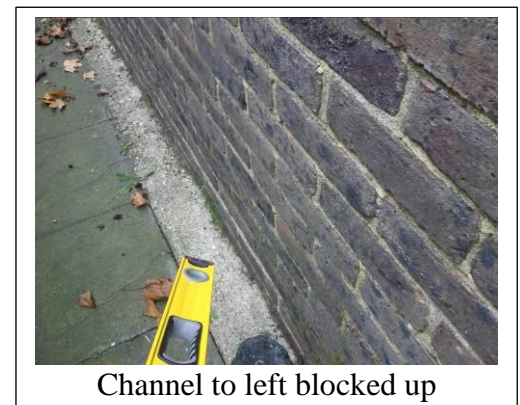
The property sits on a sloping site and because of this rainwater and ground water need to travel from the top of the site to the bottom with the building in the way. Sloping sites are not as good as level sites and buildings on them are integrally unstable. You need to understand this is a characteristic of any building sitting on a sloping site.

Water needs to be managed around the property. It looks like there was a drainage channel which has then been blocked up. We would prefer a French drain into a drain which is a fair amount of work. The reason for doing this is we are concerned there may be dampness getting into the timber structure.

**ACTION REQUIRED:** We recommend a series of French drains/land drains that take the water away from the property ideally discharging into a manhole (subject to obtaining approval) and/or a soakaway added (which will be additional cost) to divert water around the property which will help reduce some of the effects of the sloping site.

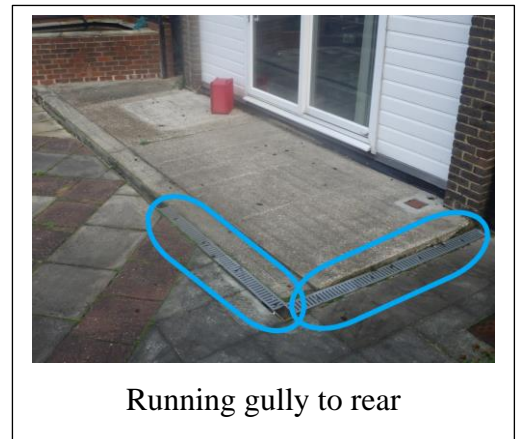
We believe this is a known about problem as we could see a running gully to the rear which indicates that the sloping site/water discharging towards the property is a known about problem.

Running gully to rear

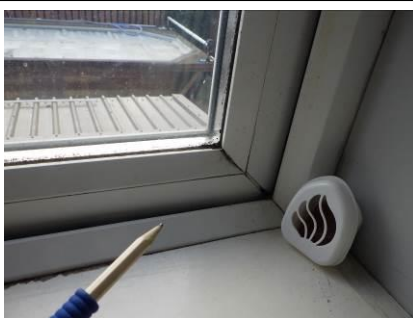
Black mould around window

**ACTION REQUIRED:** We would recommend large good quality humidity controlled extract fans are added to the kitchen, the bathroom and any areas that are used for drying clothes internally during winter months (we would assume that clothes will be dried externally during the warmer months). By large extract fans we mean 150mm.

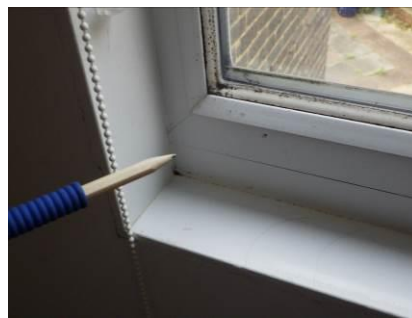
Window black mould

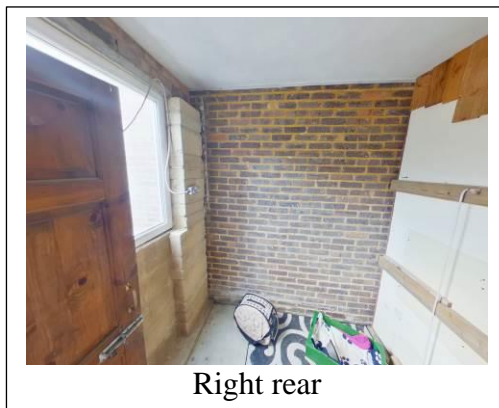
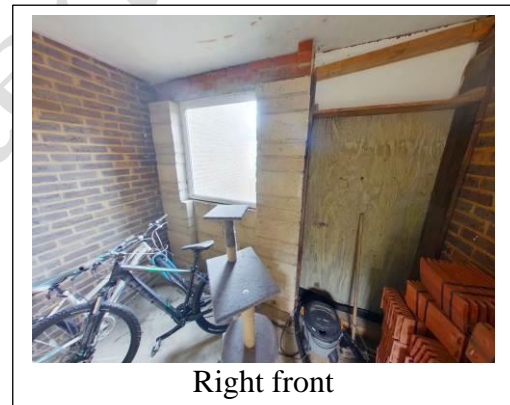
The ground floor is incomplete and open to the elements.

**ACTION REQUIRED:** Work needs to be completed. Work depends upon the specifications and what purpose you want for this area but it certainly needs sealing up and adding heating to it which would make the bedroom above warmer.

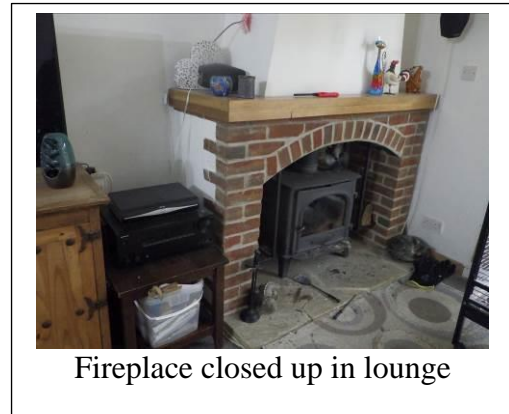
A chimney for a real fire has been added and a flue. We would comment it is very important to check that this has been carried out properly and that whoever did it knew that this is a timber frame construction.

**ACTION REQUIRED:** Your legal advisor needs to check the HETAS register [www.hetas.co.uk](http://www.hetas.co.uk) and also confirm this has Building Regulations / local authority approval.

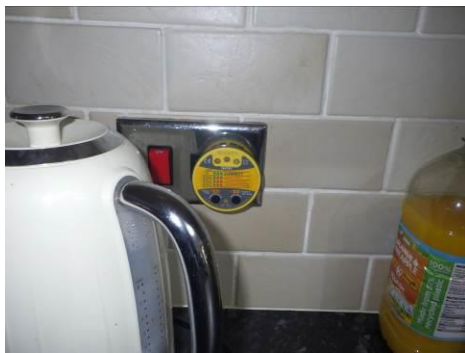
Dated electrics

**ACTION REQUIRED:** We recommend a new fuse board with a metal casing; modern standards require half hour to one hour fire resistant casing around a fuse board.

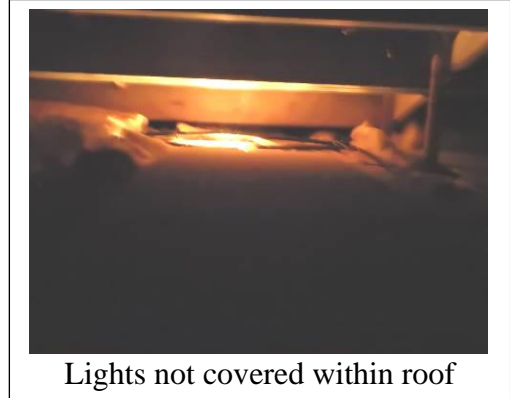
The property has older style/1970s-1980s electric lights to the ceiling.

In some instances, these can cause problems as the heat given off has in some cases led to outbreaks of fire; these tend to be in the older type of ceiling lights. We recommend that where ceiling lights are used that the rear of the light is not covered; this is particularly the case in rooms with a loft space above it where stored items are placed in it.

We noted the bathroom lights are not working. This could relate to roof leaks.

**ACTION REQUIRED:** We recommend replacing older style ceiling lights (once the roof leaks/condensation have been resolved).

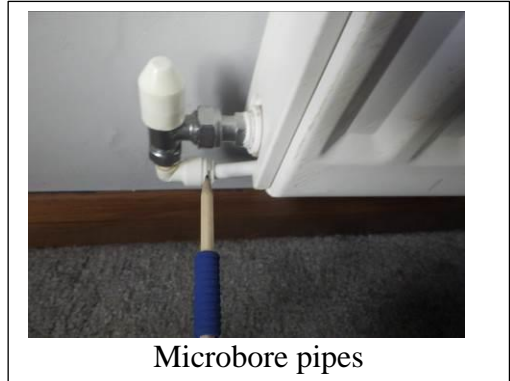
We spoke about the heating and you advised that you did not think all the radiators were working. The heating was on during the course of the survey however we did note that the heating system has what is known as microbore pipes which are narrow pipes. From our experience, these tend to get blocked more easily than a traditional heating system that uses a 12/13mm pipe. However, microbore pipes are cheaper than a traditional system and easier to install from a plumber's point of view, which is possibly why they are so popular with plumbers!

**ACTION REQUIRED:** We recommend a power flush from time to time to ensure they are working satisfactorily. You need to be aware that we generally do not feel they work as well as a traditional system.

Ideally, we would replace the microbore pipes with traditional piping for the best results.

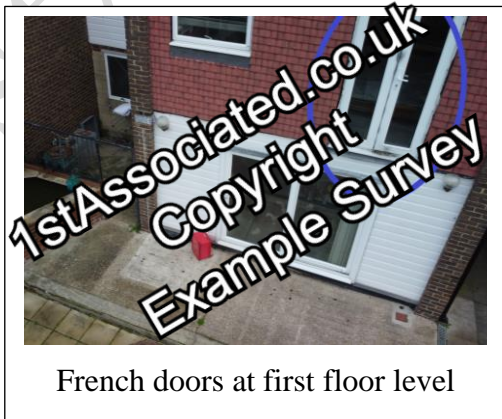
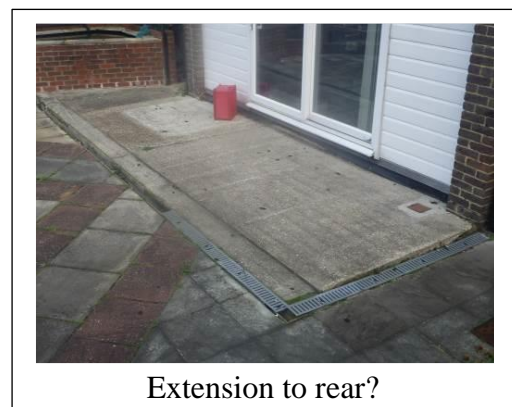
### Rear extension?

It looks like there has been a rear extension or at least some preparation work for it to be carried out. There are currently French doors that need at the very least some sort of safety barrier, possibly in the form of a Juliet balcony, perhaps even a more traditional balcony if you wish to have one built.

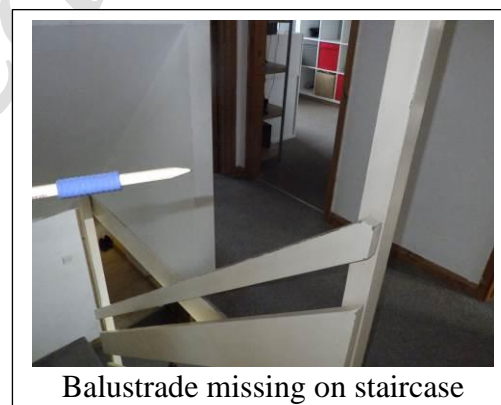
### **Staircase alterations**

We spoke about altering the staircase and you mentioned a floating staircase. We would recommend you look into this but you need to remember that this is a non-traditional building and as such weight cannot be supported on the walls in the usual way and the floating staircase would probably have to be a self-supporting structure.

We would also add that handrails, newel posts, etc are important to Building Regulations and should have a maximum 100mm gap so you need to improve these.

**ANTICIPATED COST:** For staircase newel and balustrade improvements £500 - £1,500; please obtain quotations before you legally commit to purchase the property.

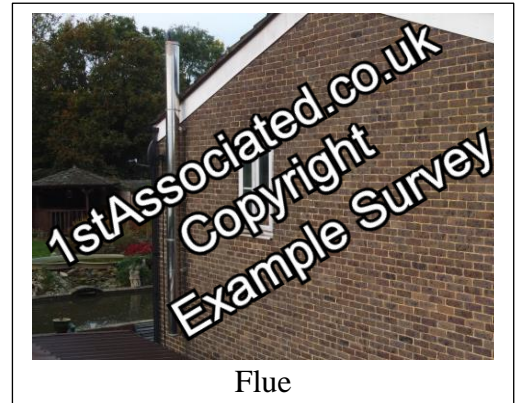
Flue

The property has a flue to the rear left.

**ACTION REQUIRED:** Your legal advisor needs to check the HETAS register [www.hetas.co.uk](http://www.hetas.co.uk) and also confirm this has Building Regulations / local authority approval.

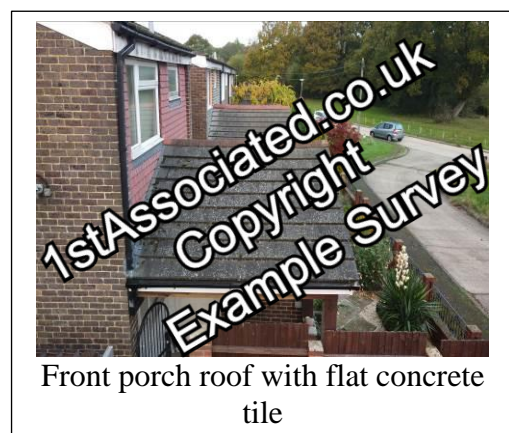
### Front Entrance Roof

This roof is pitched and clad with flat concrete tiles. We viewed inside this roof but it was lined and we could not actually see the decking. It has not got the same moss covering as the main roof so we believe it is likely to be in average condition however we were unable to see it internally.

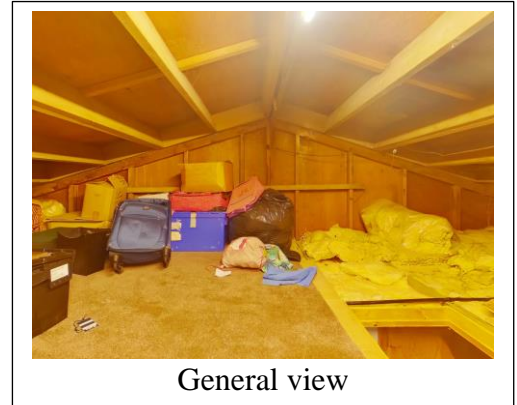
General view

The gable ends are timber indicating that this is a timber framed property. Please see our earlier comments.

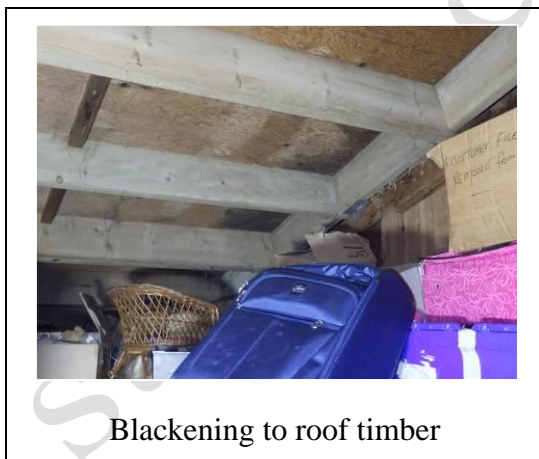
Blackening to roof timber

**ACTION REQUIRED:** Ask the existing owners are they aware of any repairs carried out to the roof. Please note the only way to be one hundred percent certain is to have the roof cleared and checked.

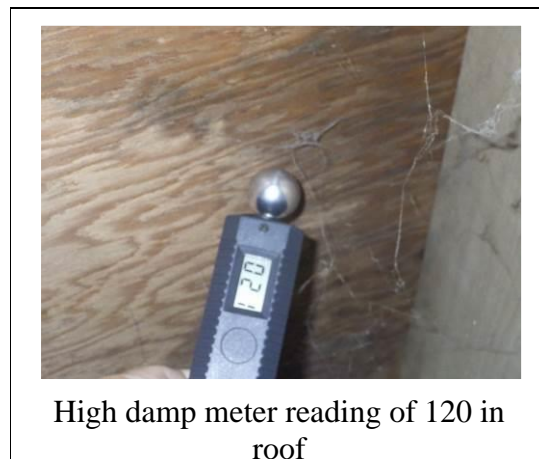
High damp meter reading of 120 in roof

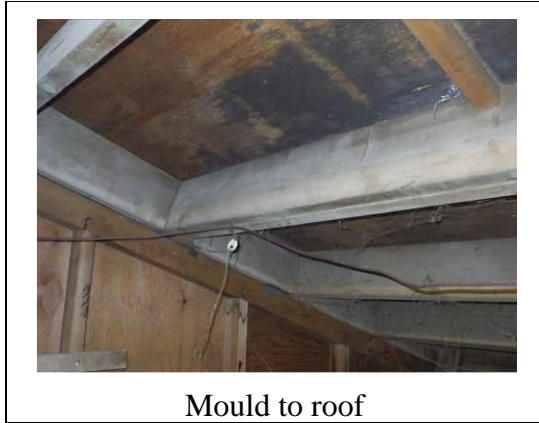
Mould to roof

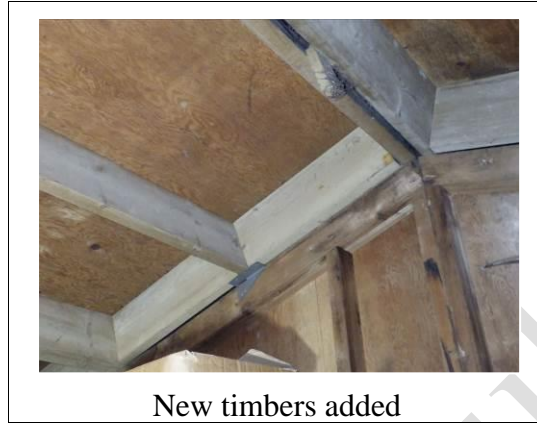
New timbers added

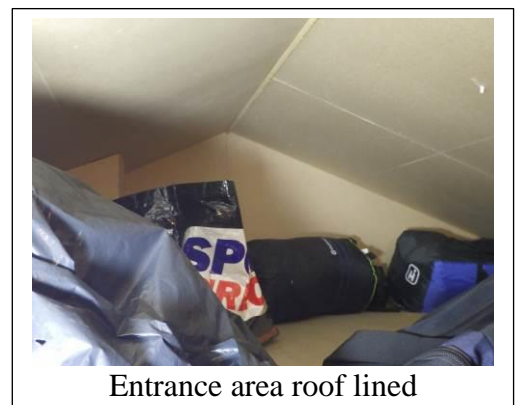
We were unable to view the entrance area roof due to the lining.

Entrance area roof lined

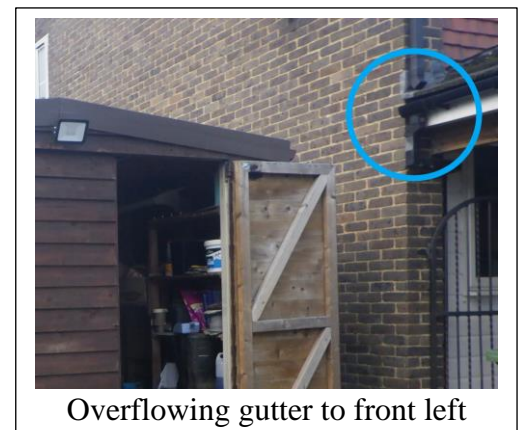
Overflowing gutter to front left

**ACTION REQUIRED:** The gutters need cleaning.

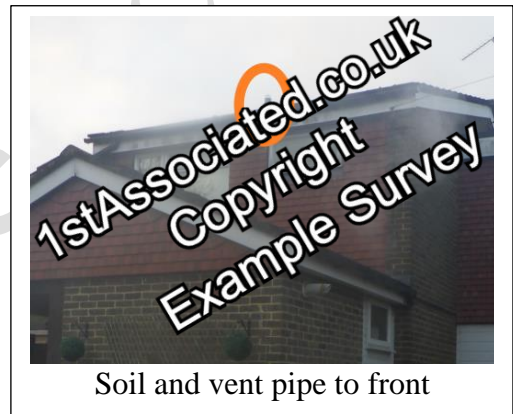
## **SOIL AND VENT PIPE**

We assume the property has internal soil and vent pipes, where visible at roof level it is plastic. Internal soil and vent pipes can work well, apart from if they leak, as they are hidden from view so a leak is not normally discovered.

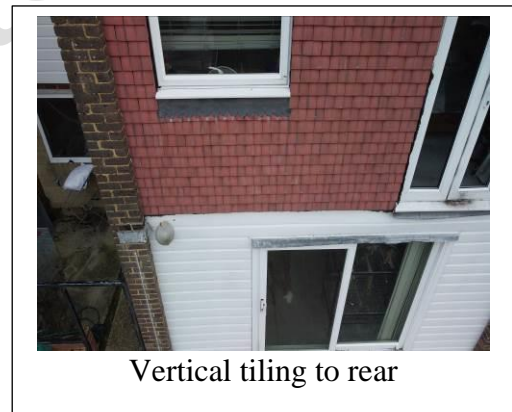
Vertical tiling to rear

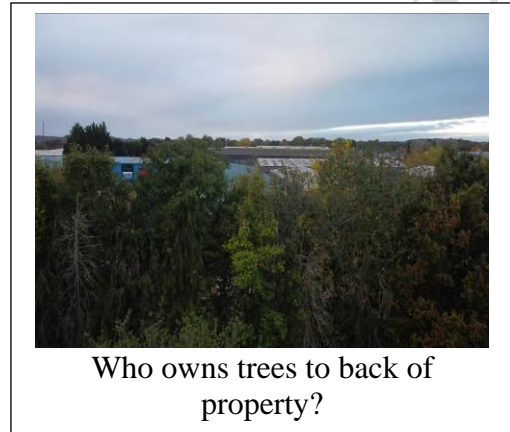
Who owns trees to back of property?

Your legal advisor to check and confirm who owns the trees and has responsibility/liability.

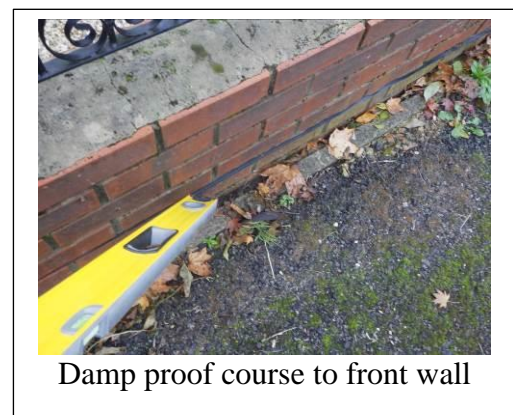
Unusually there is a damp proof course to the front garden wall.

Damp proof course to front wall

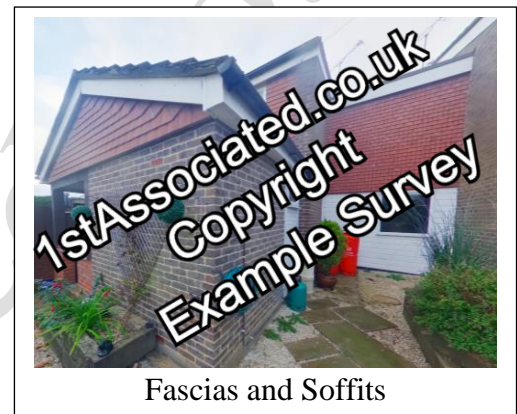
The fascias and soffits are plastic and we would comment they are in average condition for their age, type and style. There are no vents to the soffits, we believe that adding vents would benefit the roof.

Fascias and Soffits

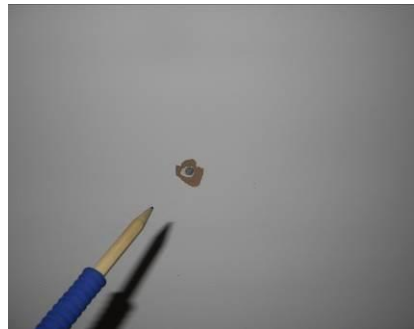
Popping plaster

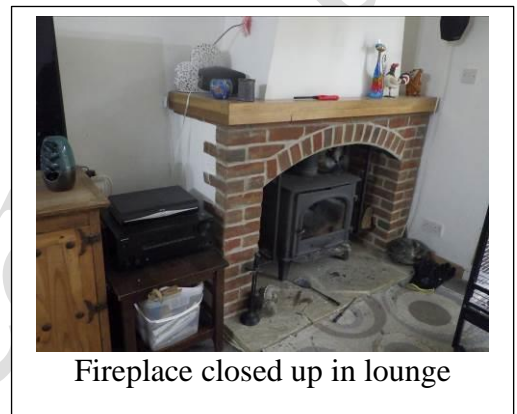
A chimney for a real fire has been added and a flue. We would comment it is very important to check that this has been carried out properly and that whoever did it knew that this is a timber frame construction.

Fireplace closed up in lounge

**ACTION REQUIRED:** Your legal advisor needs to check the HETAS register [www.hetas.co.uk](http://www.hetas.co.uk) and also confirm this has Building Regulations / local authority approval.

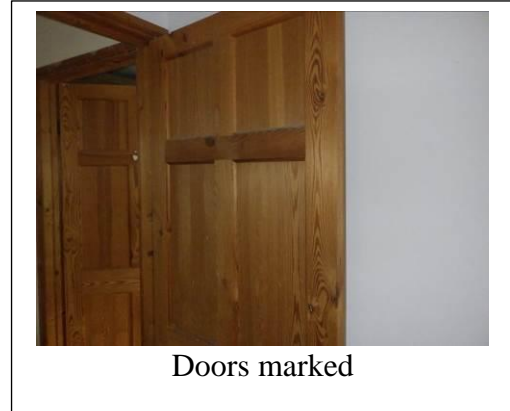
The property has timber panel doors which are marked.

Doors marked

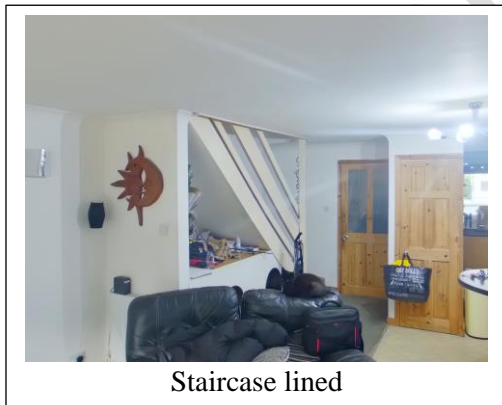
We were unable to examine the underside of the stair timbers due to it being lined where we could see it, which precluded our inspection, so we cannot comment further upon the stair structure. We can, however, say that the lining gives a resistance to the spread of fire if such circumstances were to occur.

Staircase lined

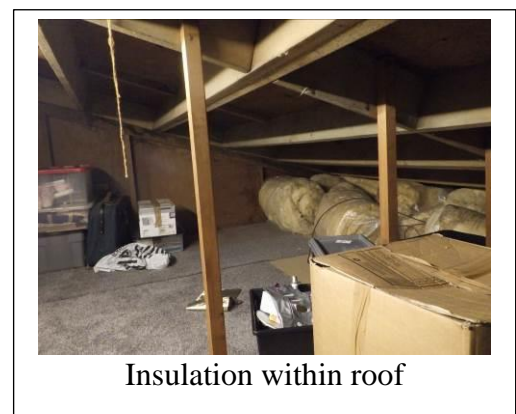
The property had boarding throughout which limited our view. There were rolls of insulation in the roof. Current Building Regulations require 300mm of insulation.

**ACTION REQUIRED:** You need to check the level of insulation in the roof. You need to bear in mind that over insulating in a timber property without good ventilation can cause problems.

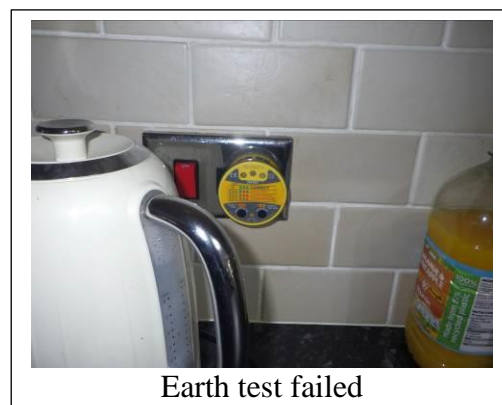
We carried out an earth test in the kitchen area to the socket point that is normally used for the kettle; this proved unsatisfactory.

**ACTION REQUIRED:** We recommend a test and report as this is a dated fuse board and we also noted other dated areas of electrics. We would also advise that the Institution of Engineering and Technology (IET) recommend a test and report as the property is changing occupancy. Any recommendations from the electrical report should be carried out by a NICEIC registered, or equivalent, approved electrical contractor or similarly approved.

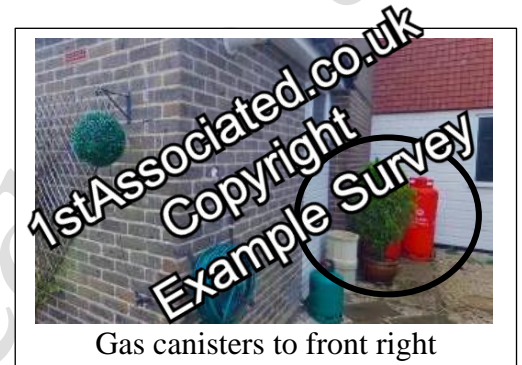
Gas canisters to front right

**ACTION REQUIRED:** The canisters need chaining/securing.

**ACTION REQUIRED:** As a matter of course, it is recommended that the entire gas installation is inspected and made good, as necessary, by a Gas Safe registered contractor. Thereafter the installation should be serviced annually.

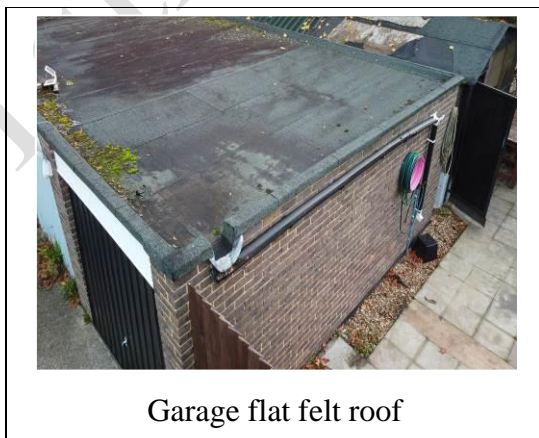
Please see our comments in the Executive Summary with regards to the roof. The roof decking may be a stramit board, we are not one hundred percent certain. This was a board used in the 1970's which unfortunately if it gets damp can deteriorate and not have any strength therefore you may need to replace some of the decking when you re-roof.

Garage flat felt roof

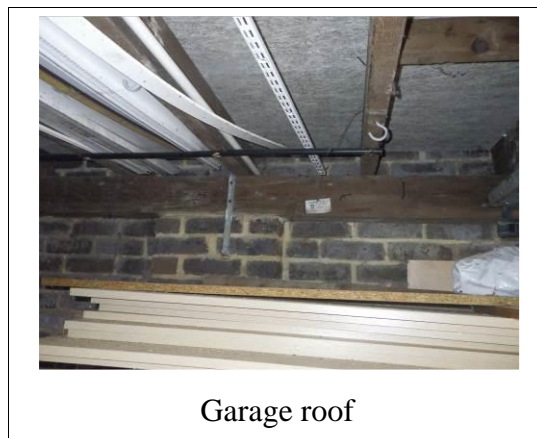
Garage roof

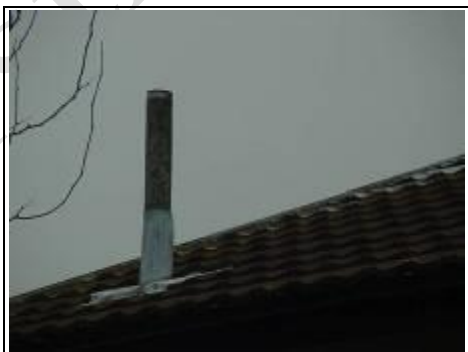
Original asbestos soil and vent pipe on a non-traditional house
